Atlanta Public Schools/Charter Schools

Waters ES (KIPP Visions Academy)

School Assessment Report

March 12, 2021

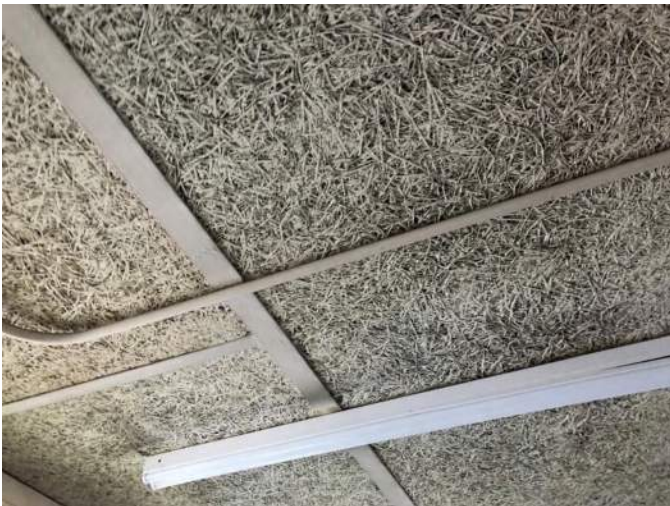
System: C3030 - Ceiling Finishes

Location: Throughout building
Distress: Beyond Expected Life
Category: Deferred Maintenance
Priority: 3 - Necessary (Years 2-5)
Correction: Renew System
Qty: 16,682.00
Unit of Measure: S.F.
Estimate: \$183,502.00
Assessor Name: Eduardo Lopez
Date Created: 02/22/2020

The acoustic ceilings are aged and stained and should be scheduled for replacement.

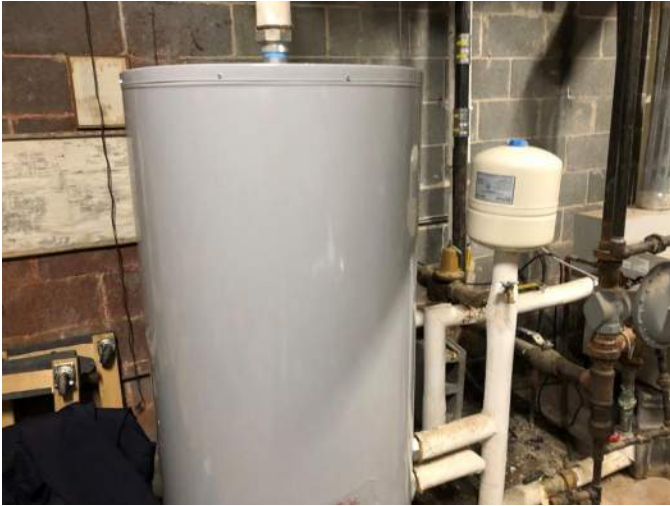
System: D2020 - Domestic Water Distribution

Location: Throughout building
Distress: Beyond Expected Life
Category: Deferred Maintenance
Priority: 3 - Necessary (Years 2-5)
Correction: Renew System
Qty: 33,365.00
Unit of Measure: S.F.
Estimate: \$28,994.00
Assessor Name: Eduardo Lopez
Date Created: 02/22/2020

The domestic water distribution system consists of galvanized and copper pipes, valves and domestic water supply. The system is beyond its expected life cycle and upgrades are recommended.

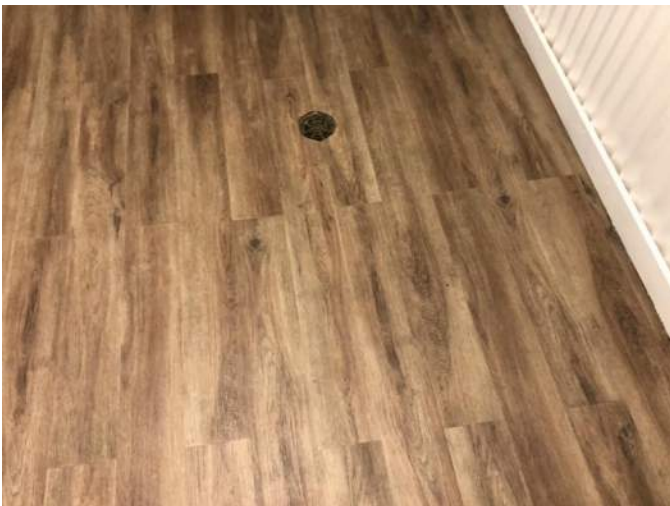
System: D2030 - Sanitary Waste

Location: Throughout building
Distress: Beyond Expected Life
Category: Deferred Maintenance
Priority: 3 - Necessary (Years 2-5)
Correction: Renew System
Qty: 33,365.00
Unit of Measure: S.F.
Estimate: \$69,366.00
Assessor Name: Eduardo Lopez
Date Created: 02/22/2020

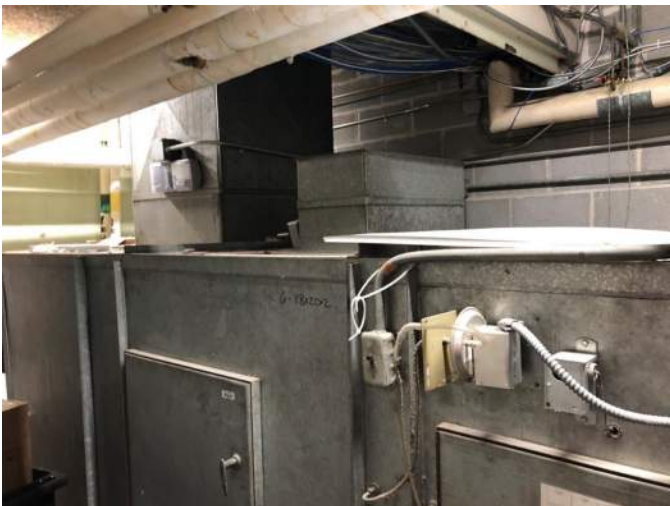
System: D3040 - Distribution Systems

Location: Throughout building
Distress: Beyond Expected Life
Category: Deferred Maintenance
Priority: 3 - Necessary (Years 2-5)
Correction: Renew System
Qty: 33,365.00
Unit of Measure: S.F.
Estimate: \$433,445.00
Assessor Name: Eduardo Lopez
Date Created: 02/22/2020

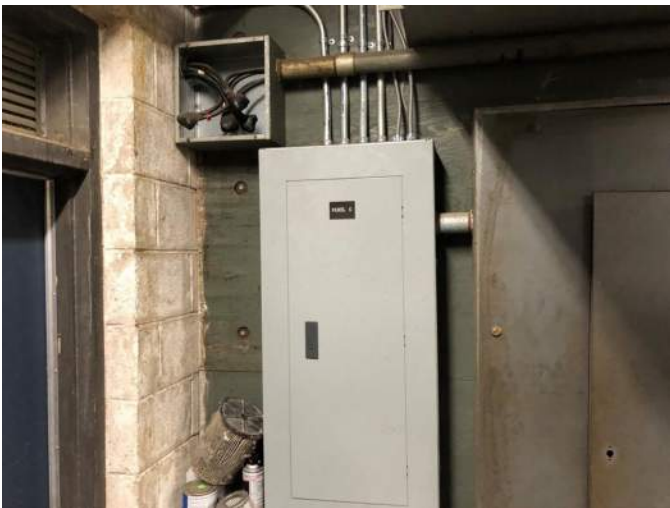
System: D5020 - Branch Wiring

Location: Throughout building
Distress: Beyond Expected Life
Category: Deferred Maintenance
Priority: 3 - Necessary (Years 2-5)
Correction: Renew System
Qty: 33,365.00
Unit of Measure: S.F.
Estimate: \$193,784.00
Assessor Name: Eduardo Lopez
Date Created: 02/22/2020

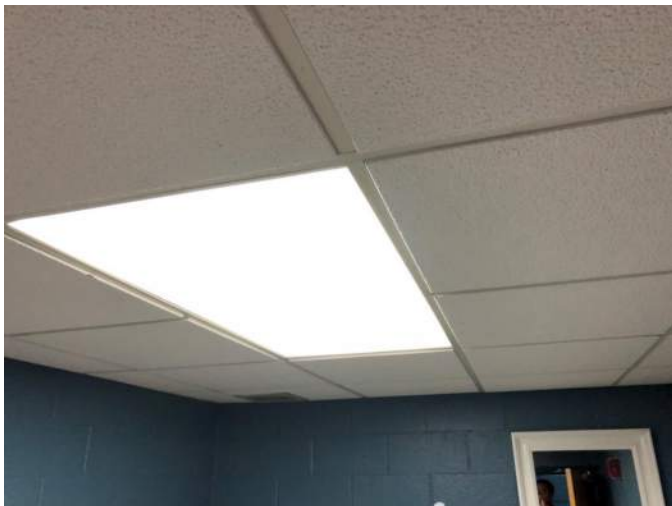
System: D5020 - Lighting

Location: Throughout building
Distress: Beyond Expected Life
Category: Deferred Maintenance
Priority: 3 - Necessary (Years 2-5)
Correction: Renew System
Qty: 16,682.00
Unit of Measure: S.F.
Estimate: \$145,334.00
Assessor Name: Eduardo Lopez
Date Created: 02/14/2020

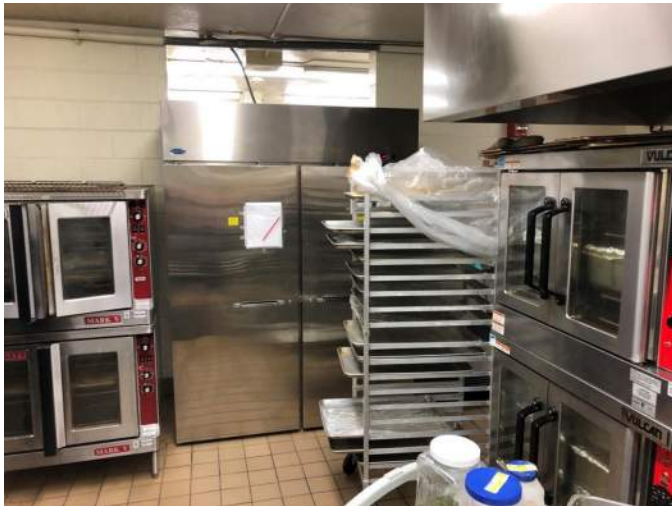
System: E1090 - Other Equipment

Location: Kitchen
Distress: Beyond Expected Life
Category: Deferred Maintenance
Priority: 3 - Necessary (Years 2-5)
Correction: Renew System
Qty: 33,365.00
Unit of Measure: S.F.
Estimate: \$31,930.00
Assessor Name: Eduardo Lopez
Date Created: 02/22/2020

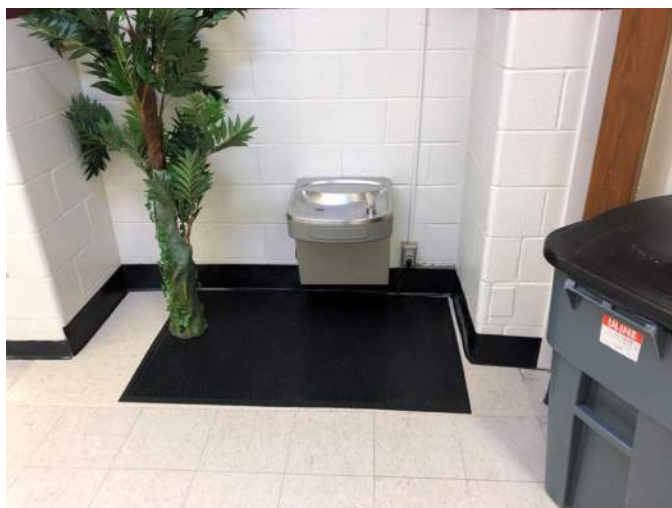
System: D2020 - Domestic Water Distribution

Location: Throughout building
Distress: Beyond Expected Life
Category: ADA Compliance
Priority: 3 - Necessary (Years 2-5)
Correction: Renew System
Qty: 16,477.00
Unit of Measure: S.F.
Estimate: \$14,319.00
Assessor Name: Eduardo Lopez
Date Created: 02/22/2020

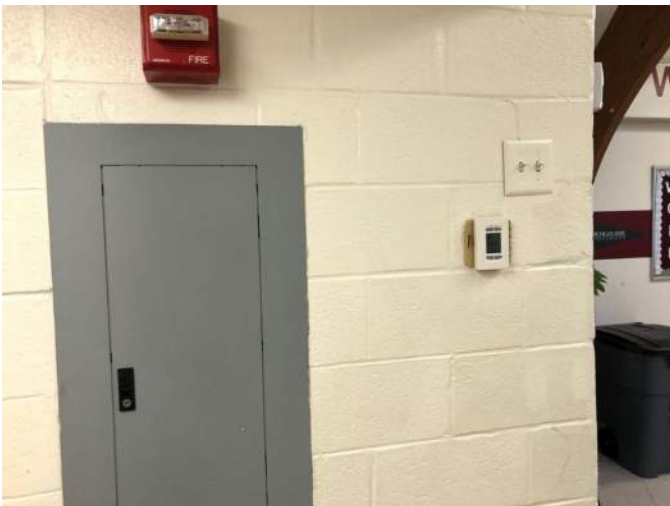
System: D5020 - Branch Wiring

Location: Throughout building
Distress: Beyond Expected Life
Category: Deferred Maintenance
Priority: 3 - Necessary (Years 2-5)
Correction: Renew System
Qty: 16,477.00
Unit of Measure: S.F.
Estimate: \$95,698.00
Assessor Name: Eduardo Lopez
Date Created: 02/22/2020

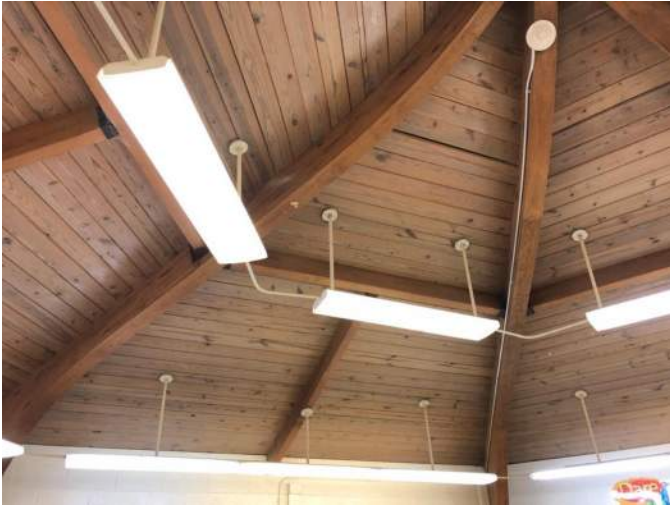
System: D5020 - Lighting

Location: Throughout building
Distress: Beyond Expected Life
Category: Deferred Maintenance
Priority: 3 - Necessary (Years 2-5)
Correction: Renew System
Qty: 16,477.00
Unit of Measure: S.F.
Estimate: \$143,548.00
Assessor Name: Eduardo Lopez
Date Created: 02/14/2020

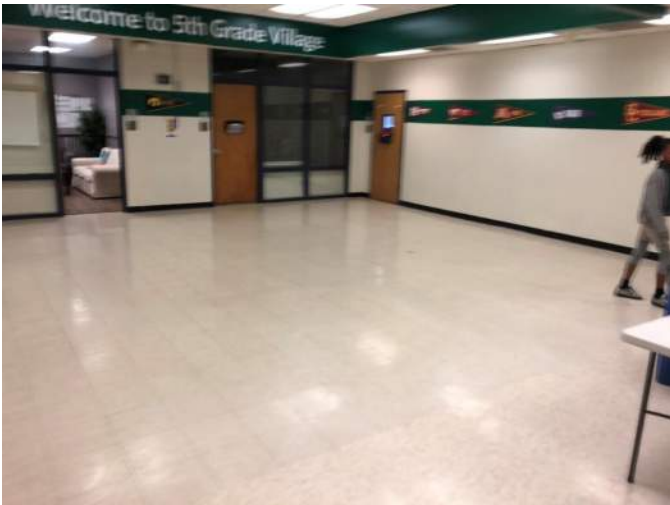
Location: Throughout building
Distress: Beyond Expected Life
Category: Deferred Maintenance
Priority: 3 - Necessary (Years 2-5)
Correction: Renew System
Qty: 30,146.00
Unit of Measure: S.F.
Estimate: \$162,608.00
Assessor Name: Eduardo Lopez
Date Created: 02/12/2020

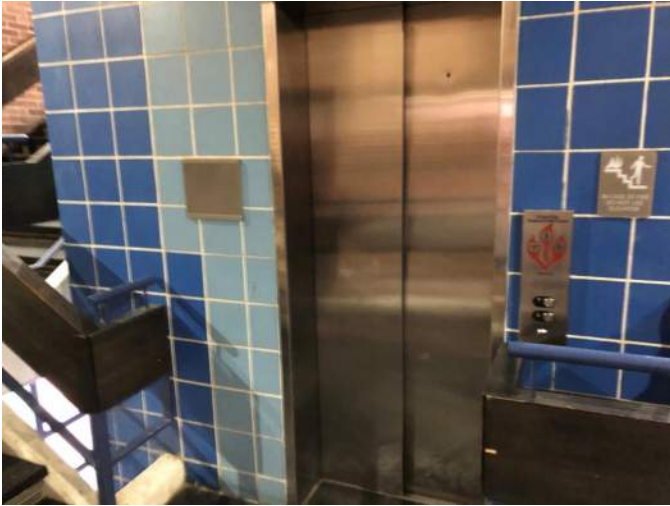
Location: Elevator
Distress: Beyond Expected Life
Category: Deferred Maintenance
Priority: 3 - Necessary (Years 2-5)
Correction: Renew System
Qty: 37,146.00
Unit of Measure: S.F.
Estimate: \$51,076.00
Assessor Name: Eduardo Lopez
Date Created: 02/22/2020

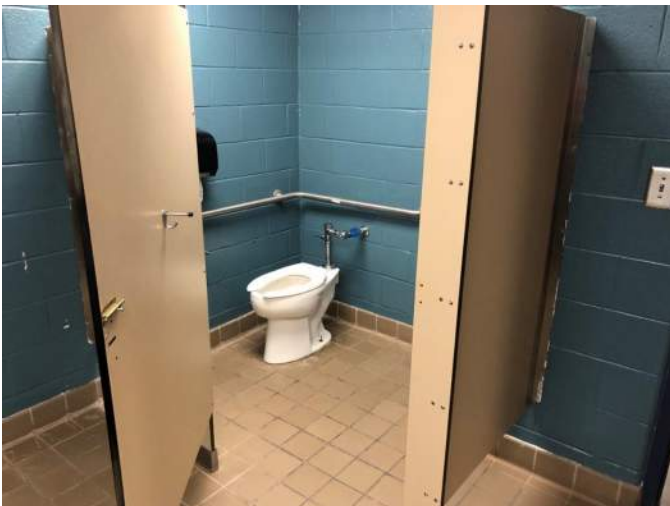
Location: Throughout building
Distress: Beyond Expected Life
Category: ADA Compliance
Priority: 3 - Necessary (Years 2-5)
Correction: Renew System
Qty: 37,146.00
Unit of Measure: S.F.
Estimate: \$260,282.00
Assessor Name: Eduardo Lopez
Date Created: 02/22/2020

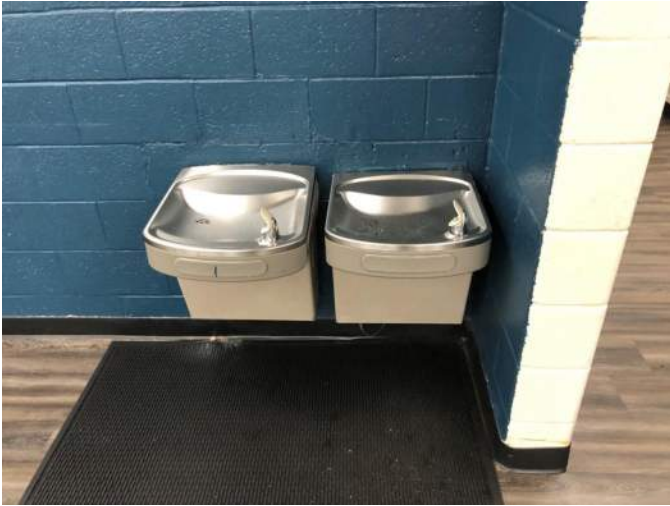
Location: Throughout building
Distress: Beyond Expected Life
Category: Deferred Maintenance
Priority: 3 - Necessary (Years 2-5)
Correction: Renew System
Qty: 37,146.00
Unit of Measure: S.F.
Estimate: \$29,420.00
Assessor Name: Eduardo Lopez
Date Created: 02/22/2020

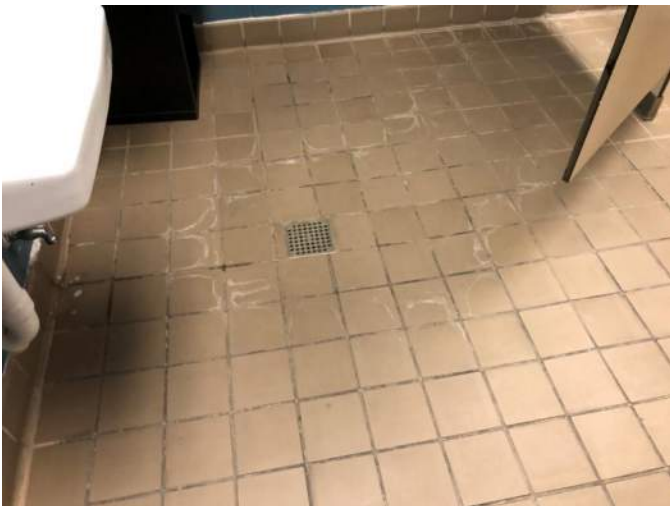
Location: Restroom
Distress: Beyond Expected Life
Category: Deferred Maintenance
Priority: 3 - Necessary (Years 2-5)
Correction: Renew System
Qty: 37,146.00
Unit of Measure: S.F.
Estimate: \$69,054.00
Assessor Name: Eduardo Lopez
Date Created: 02/22/2020

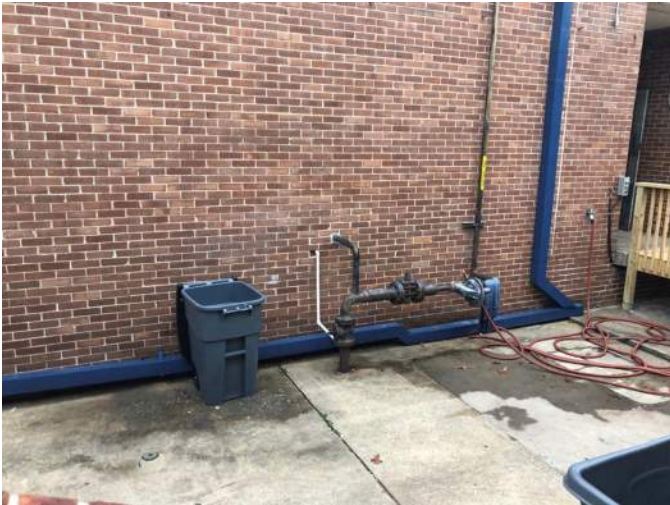
Location: Throughout building
Distress: Beyond Expected Life
Category: Deferred Maintenance
Priority: 3 - Necessary (Years 2-5)
Correction: Renew System
Qty: 37,146.00
Unit of Measure: S.F.
Estimate: \$147,098.00
Assessor Name: Eduardo Lopez
Date Created: 02/14/2020

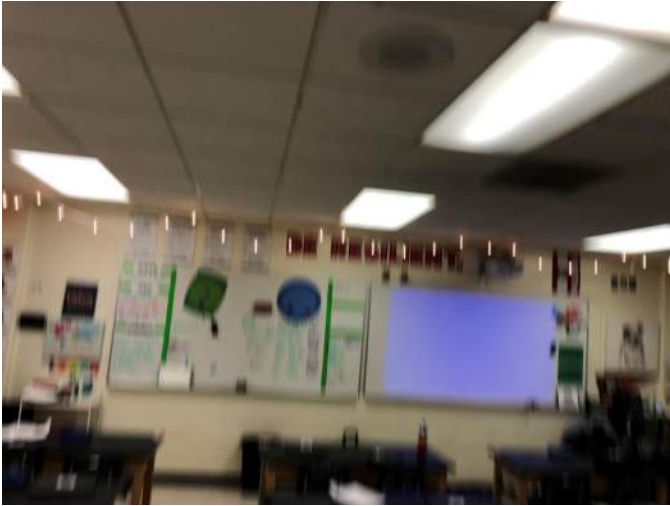
Location: Throughout building
Distress: Beyond Expected Life
Category: Deferred Maintenance
Priority: 3 - Necessary (Years 2-5)
Correction: Renew System
Qty: 37,146.00
Unit of Measure: S.F.
Estimate: \$433,940.00
Assessor Name: Eduardo Lopez
Date Created: 02/22/2020

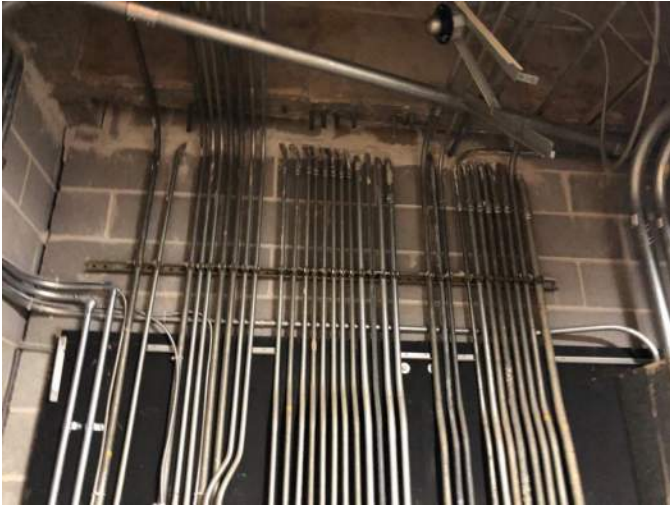
Location: Throughout building
Distress: Beyond Expected Life
Category: Deferred Maintenance
Priority: 3 - Necessary (Years 2-5)
Correction: Renew System
Qty: 37,146.00
Unit of Measure: S.F.
Estimate: \$194,088.00
Assessor Name: Eduardo Lopez
Date Created: 02/14/2020

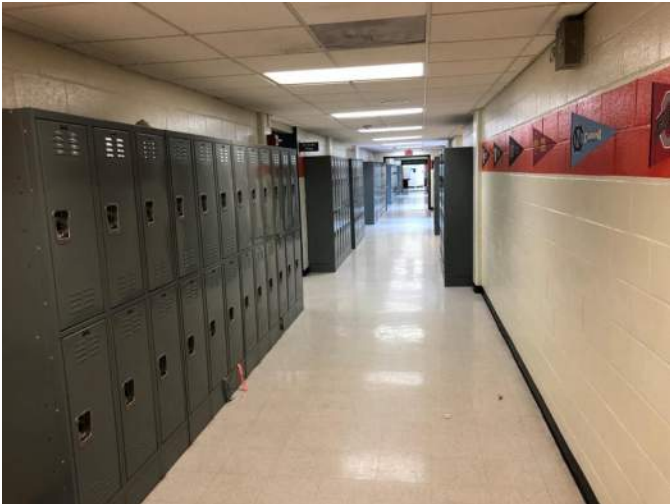
Location: Throughout building
Distress: Beyond Expected Life
Category: Deferred Maintenance
Priority: 3 - Necessary (Years 2-5)
Correction: Renew System
Qty: 16,682.00
Unit of Measure: S.F.
Estimate: \$130,837.00
Assessor Name: Eduardo Lopez
Date Created: 02/14/2020

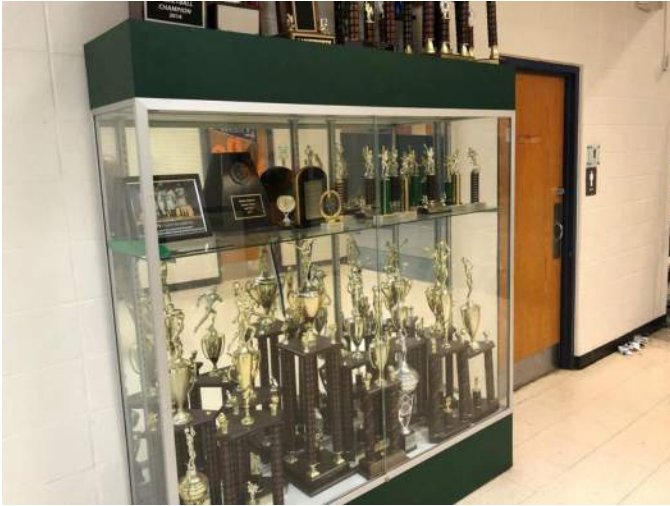
Location: Throughout building
Distress: Beyond Expected Life
Category: Deferred Maintenance
Priority: 3 - Necessary (Years 2-5)
Correction: Renew System
Qty: 37,146.00
Unit of Measure: S.F.
Estimate: \$78,044.00
Assessor Name: Eduardo Lopez
Date Created: 02/22/2020

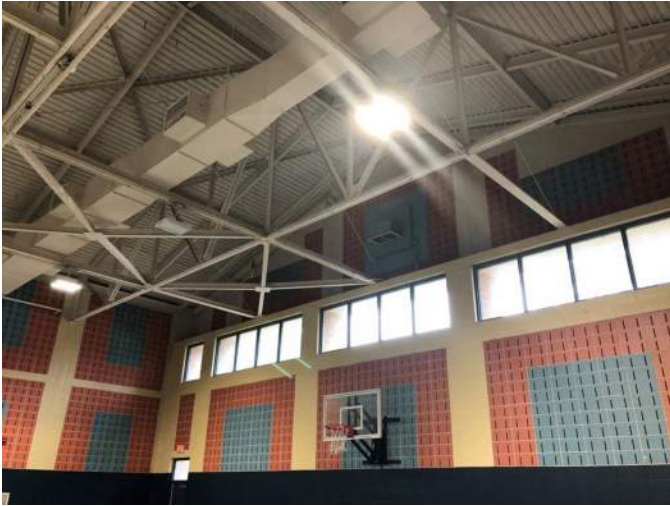
Location: Throughout building
Distress: Beyond Expected Life
Category: Deferred Maintenance
Priority: 3 - Necessary (Years 2-5)
Correction: Renew System
Qty: 10,506.00
Unit of Measure: S.F.
Estimate: \$198,311.00
Assessor Name: Eduardo Lopez
Date Created: 02/14/2020

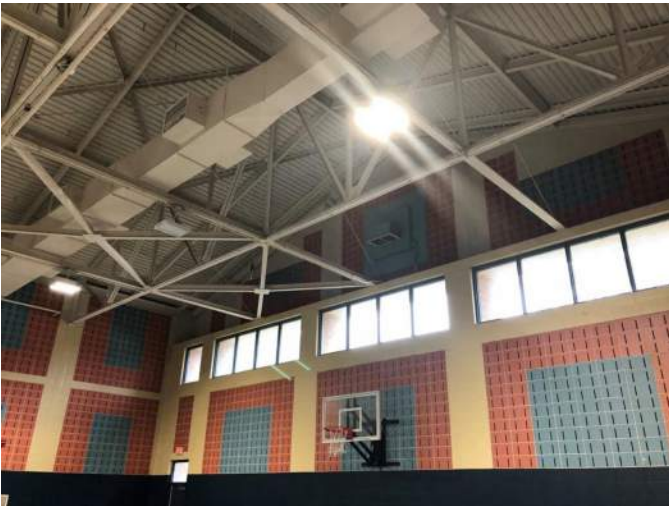
Location: Throughout building
Distress: Beyond Expected Life
Category: Deferred Maintenance
Priority: 3 - Necessary (Years 2-5)
Correction: Renew System
Qty: 10,506.00
Unit of Measure: S.F.
Estimate: \$126,597.00
Assessor Name: Eduardo Lopez
Date Created: 02/14/2020

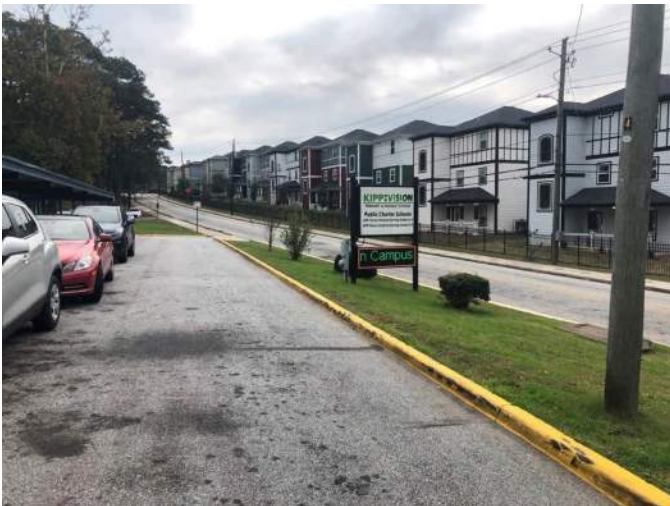
Location: Site
Distress: Beyond Expected Life
Category: ADA Compliance
Priority: 3 - Necessary (Years 2-5)
Correction: Renew System
Qty: 97,494.00
Unit of Measure: S.F.
Estimate: \$857,947.00
Assessor Name: Hayden Collins
Date Created: 02/22/2020

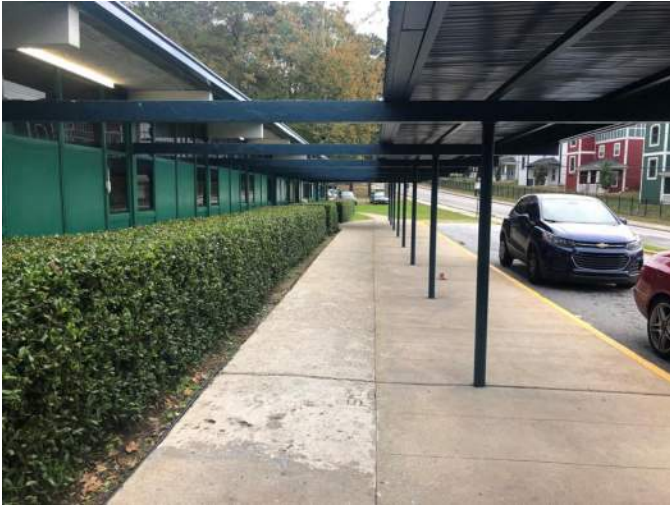
Location: Site
Distress: Beyond Expected Life
Category: ADA Compliance
Priority: 3 - Necessary (Years 2-5)
Correction: Renew System
Qty: 97,494.00
Unit of Measure: S.F.
Estimate: \$249,877.00
Assessor Name: Hayden Collins
Date Created: 02/22/2020

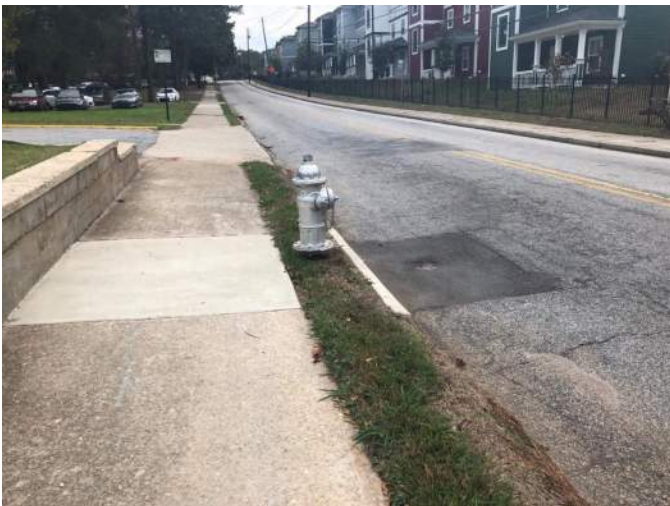
Location: Site
Distress: Beyond Expected Life
Category: Deferred Maintenance
Priority: 3 - Necessary (Years 2-5)
Correction: Renew System
Qty: 97,494.00
Unit of Measure: S.F.
Estimate: \$116,895.00
Assessor Name: Hayden Collins
Date Created: 02/22/2020

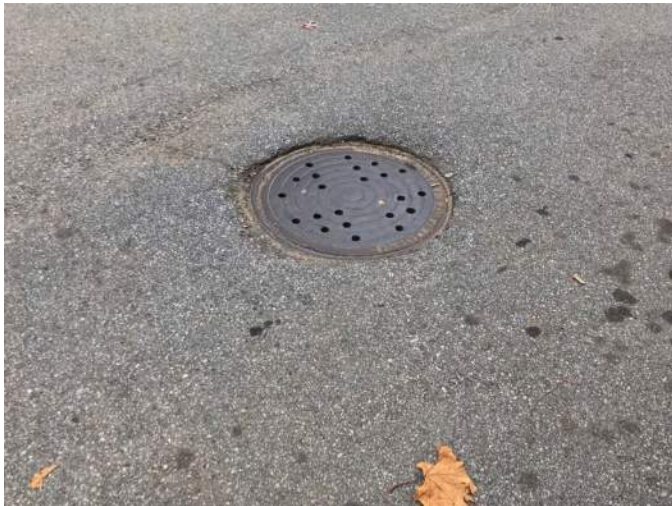
Location: Site
Distress: Beyond Expected Life
Category: Deferred Maintenance
Priority: 3 - Necessary (Years 2-5)
Correction: Renew System
Qty: 97,494.00
Unit of Measure: S.F.
Estimate: \$235,935.00
Assessor Name: Hayden Collins
Date Created: 02/22/2020
