School Assessment Report

School: Waters ES (KIPP Vision)

Report: Nov 17, 2015

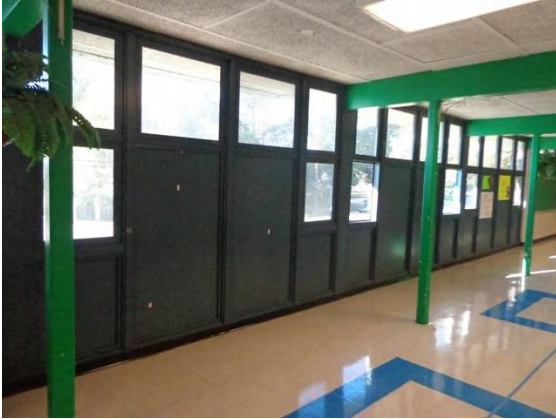
System: B2020 - Exterior Windows

Analysis: The system age is either beyond expected life or does not meet its intended performance under the Guidelines. The system may be in service and functioning but it is recommended to be replaced due to probable increased condition budget needs, the potential failure of its components, or in order to meet the performance Guidelines for this system. The system was installed in 1958. It has a 30-year service life which expired in 1988.

Location: 1958 Bldg A

Notes: The windows in the classrooms were replaced in 2012 however most are original to the building age and should be replaced.

Recomm.: The system should be replaced.

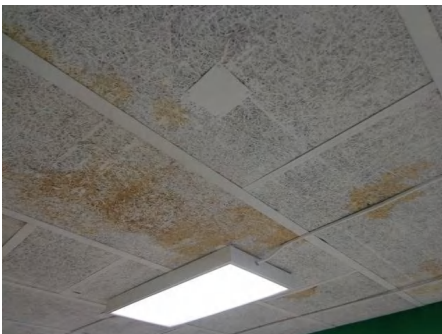
Analysis: The system age is either beyond expected life or does not meet its intended performance under the Guidelines. The system may be in service and functioning but it is recommended to be replaced due to probable increased condition budget needs, the potential failure of its components, or in order to meet the performance Guidelines for this system. The system was installed in 1990. It has a 20-year service life which expired in 2010.

Location: 1958 Bldg A

Recomm.: The system should be replaced.

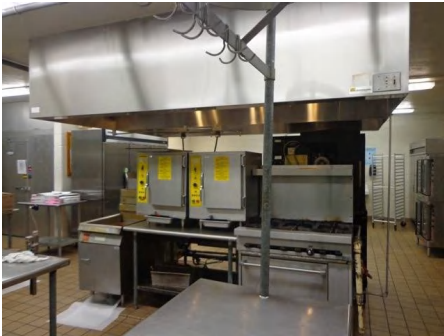
Analysis: The system age is either beyond expected life or does not meet its intended performance under the Guidelines. The system may be in service and functioning but it is recommended to be replaced due to probable increased condition budget needs, the potential failure of its components, or in order to meet the performance Guidelines for this system. The system was installed in 1990. It has a 20-year service life which expired in 2010.

Location: 1958 Bldg A

Recomm.: The system should be replaced.

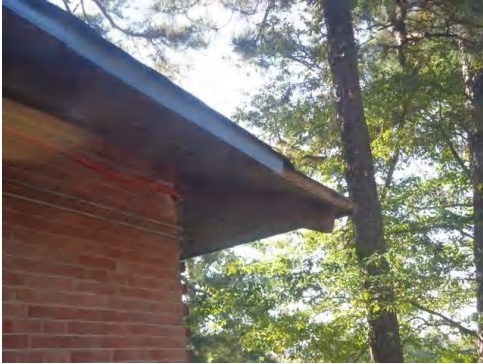
Analysis: The system is in use and functioning with an estimated remaining service life as indicated in the report section "Condition/Replacement Budget Detail". The system was installed in 1998. It has a 20-year service life. However, in the assessment, it was found to be currently deficient.

Location: 1964 Bldg B
Material: Roof Covering
Distress: Damaged
Category: Deferred Maintenance
Priority: 1 - Critical Immediate Need
Correction: Roof and flashing repair.
Qty: 2,000-S.F.
Condition Budget: \$20,016

Recomm.: The system should be replaced.

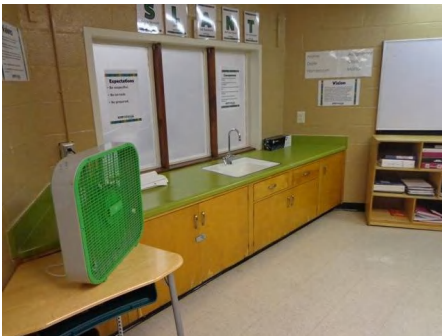
Analysis: The system age is either beyond expected life or does not meet its intended performance under the Guidelines. The system may be in service and functioning but it is recommended to be replaced due to probable increased condition budget needs, the potential failure of its components, or in order to meet the performance Guidelines for this system. The system was installed in 1980. It has a 20-year service life which expired in 2000.

Location: 1964 Bldg B

Recomm.: The system should be replaced.

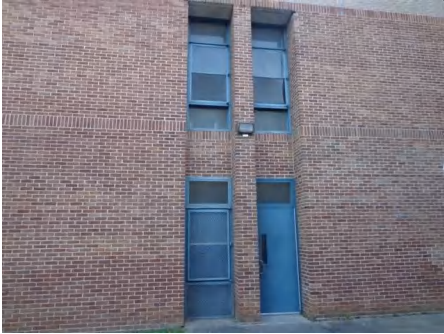
System: B2020 - Exterior Windows

Analysis: The system age is either beyond expected life or does not meet its intended performance under the Guidelines. The system may be in service and functioning but it is recommended to be replaced due to probable increased condition budget needs, the potential failure of its components, or in order to meet the performance Guidelines for this system. The system was installed in 1970. It has a 30-year service life which expired in 2000.

Location: 1970 Bldg C
Distress: Beyond Expected Life
Category: Deferred Maintenance
Priority: 3 - Necessary (Years 2-5)
Correction: Renew System
Qty: 1-Ea.
Condition Budget: \$132,164

Recomm.: The system should be replaced.

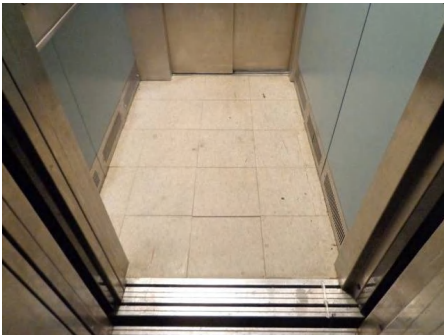
Analysis: The system age is either beyond expected life or does not meet its intended performance under the Guidelines. The system may be in service and functioning but it is recommended to be replaced due to probable increased condition budget needs, the potential failure of its components, or in order to meet the performance Guidelines for this system. The system was installed in 1970. It has a 20-year service life which expired in 1990.

Location: 1970 Bldg C
Distress: Beyond Expected Life
Category: Deferred Maintenance
Priority: 3 - Necessary (Years 2-5)
Correction: Renew System
Qty: 1-Ea.
Condition Budget: \$48,108

Recomm.: The system should be replaced.

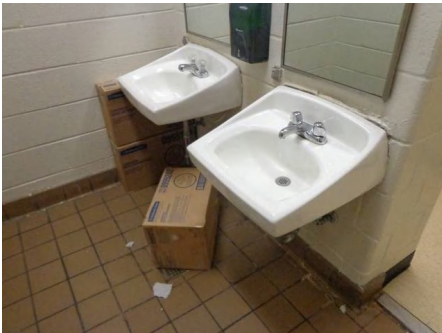
Analysis: The system age is either beyond expected life or does not meet its intended performance under the Guidelines. The system may be in service and functioning but it is recommended to be replaced due to probable increased condition budget needs, the potential failure of its components, or in order to meet the performance Guidelines for this system. The system was installed in 1970. It has a 30-year service life which expired in 2000.

Location: 1970 Bldg C
Distress: Beyond Expected Life
Category: Deferred Maintenance
Priority: 3 - Necessary (Years 2-5)
Correction: Renew System
Qty: 1-Ea.
Condition Budget: \$24,847

Recomm.: The system should be replaced.

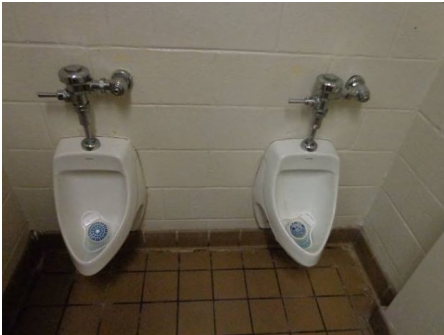
Analysis: The system age is either beyond expected life or does not meet its intended performance under the Guidelines. The system may be in service and functioning but it is recommended to be replaced due to probable increased condition budget needs, the potential failure of its components, or in order to meet the performance Guidelines for this system. The system was installed in 1970. It has a 30-year service life which expired in 2000.

Location: 1970 Bldg C
Distress: Beyond Expected Life
Category: Deferred Maintenance
Priority: 3 - Necessary (Years 2-5)
Correction: Renew System
Qty: 1-Ea.
Condition Budget: \$64,496

Recomm.: The system should be replaced.

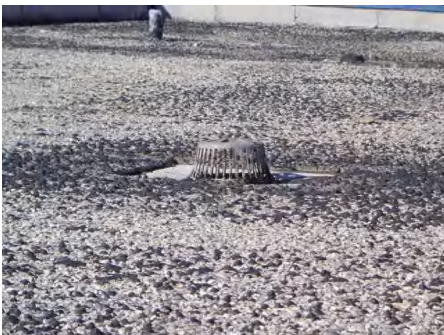
Analysis: The system age is either beyond expected life or does not meet its intended performance under the Guidelines. The system may be in service and functioning but it is recommended to be replaced due to probable increased condition budget needs, the potential failure of its components, or in order to meet the performance Guidelines for this system. The system was installed in 1970. It has a 20-year service life which expired in 1990.

Location: 1970 Bldg C
Distress: Beyond Expected Life
Category: Deferred Maintenance
Priority: 3 - Necessary (Years 2-5)
Correction: Renew System
Qty: 1-Ea.
Condition Budget: \$14,802

Recomm.: The system should be replaced.

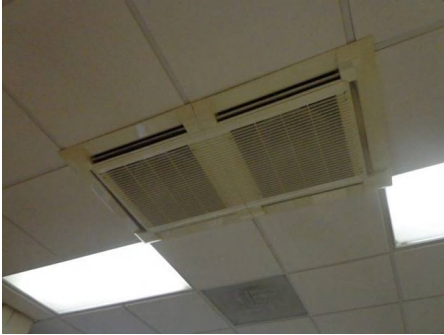
Analysis: The system age is either beyond expected life or does not meet its intended performance under the Guidelines. The system may be in service and functioning but it is recommended to be replaced due to probable increased condition budget needs, the potential failure of its components, or in order to meet the performance Guidelines for this system. The system was installed in 1970. It has a 20-year service life which expired in 1990.

Location: 1970 Bldg C
Distress: Beyond Expected Life
Category: Deferred Maintenance
Priority: 3 - Necessary (Years 2-5)
Correction: Renew System
Qty: 1-Ea.
Condition Budget: \$366,886

Recomm.: The system should be replaced.

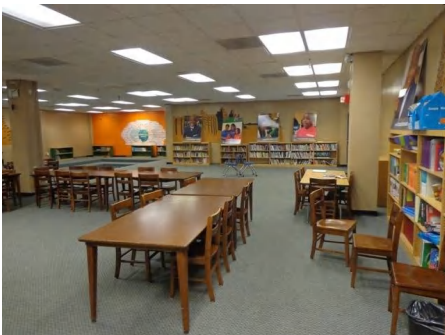
Analysis: The system age is either beyond expected life or does not meet its intended performance under the Guidelines. The system may be in service and functioning but it is recommended to be replaced due to probable increased condition budget needs, the potential failure of its components, or in order to meet the performance Guidelines for this system. The system was installed in 1970. It has a 20-year service life which expired in 1990.

Location: 1970 Bldg C
Distress: Beyond Expected Life
Category: Deferred Maintenance
Priority: 3 - Necessary (Years 2-5)
Correction: Renew System
Qty: 1-Ea.
Condition Budget: \$111,017

Recomm.: The system should be replaced.

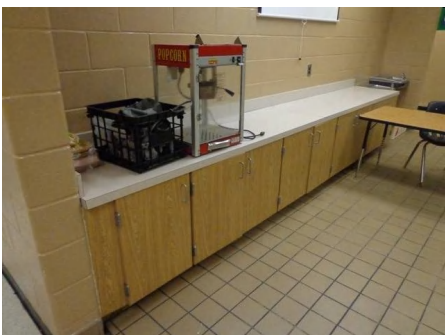
Location: 1970 Bldg C
Distress: Beyond Expected Life
Category: Deferred Maintenance
Priority: 3 - Necessary (Years 2-5)
Correction: Renew System
Qty: 1-Ea.
Condition Budget: \$68,725

Recomm.: The system should be replaced.

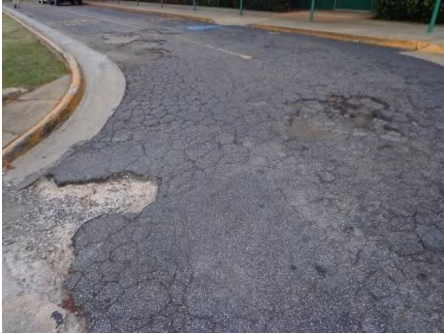
Location: Site
Distress: Beyond Expected Life
Category: Deferred Maintenance
Priority: 3 - Necessary (Years 2-5)
Correction: Renew System
Qty: 1-Ea.
Condition Budget: \$248,365

Recomm.: The system should be replaced.

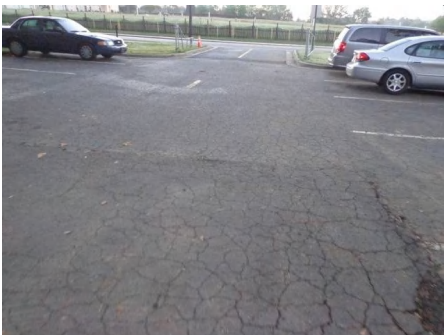
Location: Site
Distress: Beyond Expected Life
Category: Deferred Maintenance
Priority: 3 - Necessary (Years 2-5)
Correction: Renew System
Qty: 1-Ea.
Condition Budget: \$828,347

Recomm.: The system should be replaced.

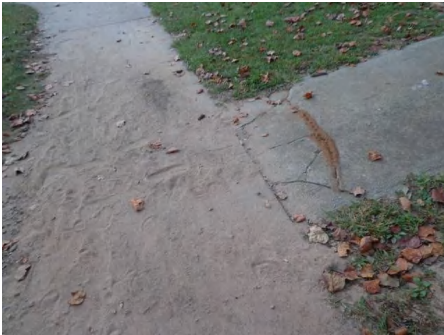
Location: Site
Distress: Beyond Expected Life
Category: Deferred Maintenance
Priority: 3 - Necessary (Years 2-5)
Correction: Renew System
Qty: 1-Ea.
Condition Budget: \$226,165

Recomm.: The system should be replaced.

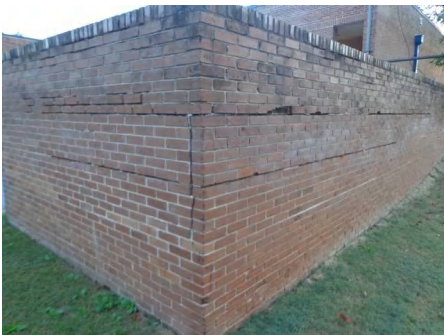
Location: Site
Distress: Beyond Expected Life
Category: Deferred Maintenance
Priority: 3 - Necessary (Years 2-5)
Correction: Renew System
Qty: 1-Ea.
Condition Budget: \$484,243

Recomm.: The system should be replaced.
