Atlanta Public Schools/ Mays Cluster

West Manor Elementary School

School Assessment Report

November 10, 2020

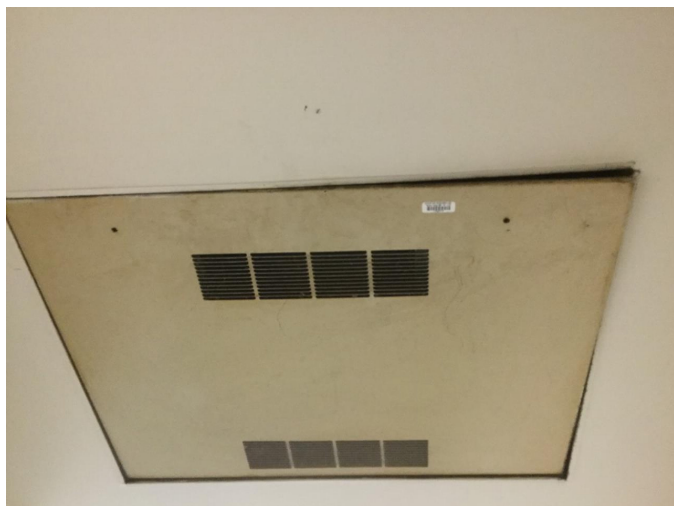
System: D3040 - Distribution Systems

Location: Throughout Building
Distress: Failing
Category: Deferred Maintenance
Priority: 3 - Necessary (Years 2-5)
Correction: Replace 3 Ton Fan Coil Unit 2 pipe
Qty: 12.00
Unit of Measure: Ea.
Estimate: \$103,103.96
Assessor Name: Jejuan Hall
Date Created: 08/05/2013

Notes: Many fan coil units are leaking from drain pans and/or "sweating" from pipes and unit. School principal indicates this is an ongoing problem.

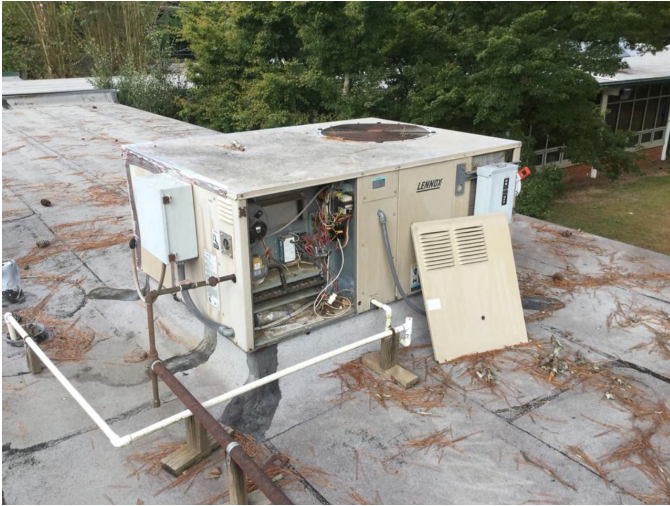
System: D3050 - Terminal & Package Units

Location: Roof
Distress: Beyond Expected Life
Category: Deferred Maintenance
Priority: 3 - Necessary (Years 2-5)
Correction: Renew System
Qty: 31,845.00
Unit of Measure: S.F.
Estimate: \$283,389.00
Assessor Name: Hayden Collins
Date Created: 08/05/2013

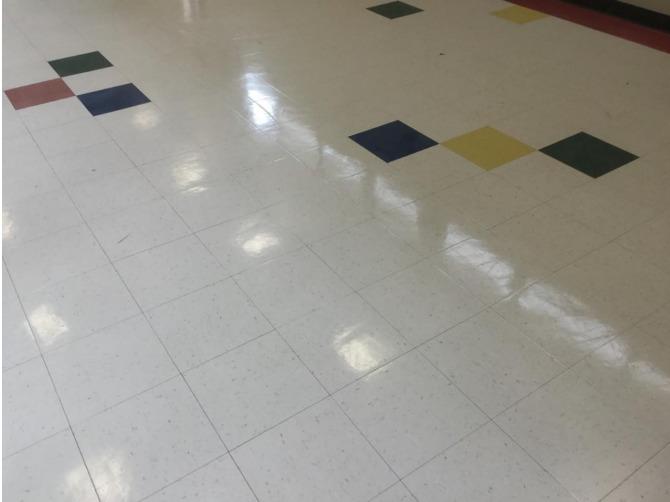
System: C3020903 - VCT

Location: Throughout building
Distress: Beyond Expected Life
Category: Deferred Maintenance
Priority: 4 - Recommended (Years 6-10)
Correction: Renew System
Qty: 27,345.00
Unit of Measure: S.F.
Estimate: \$147,499.00
Assessor Name: Hayden Collins
Date Created: 10/17/2019

Notes: The vinyl tile finish is original to the buildings construction. This finish is damaged and nearing the end of its useful life. This finish is recommended for upgrade based on life cycle.

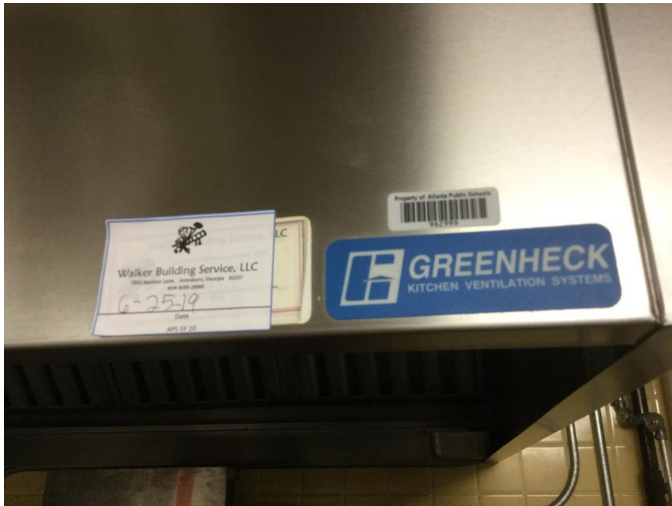
System: D4090 - Other Fire Protection Systems

Location: Kitchen
Distress: Beyond Expected Life
Category: Deferred Maintenance
Priority: 4 - Recommended (Years 6-10)
Correction: Renew System
Qty: 31,845.00
Unit of Measure: S.F.
Estimate: \$22,769.00
Assessor Name: Hayden Collins
Date Created: 09/17/2015

Notes: ANSUL directional extinguisher system is located in the kitchen. This system is nearing the end of its useful life and recommended for upgrade.

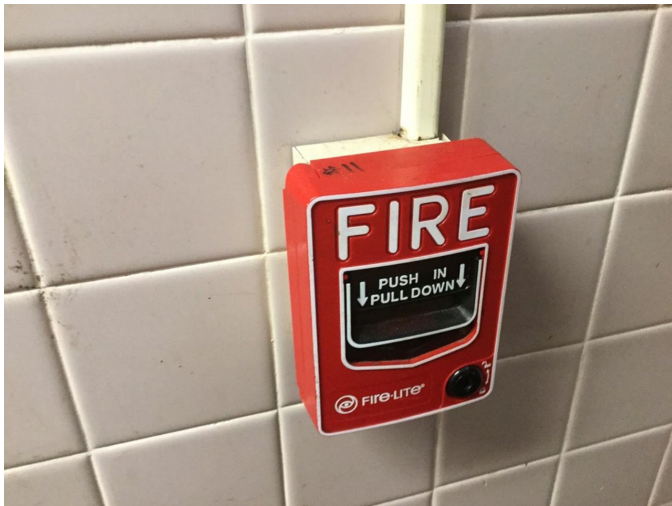
System: D5030910 - Fire Alarm Systems

Location: Throughout building
Distress: Beyond Expected Life
Category: Deferred Maintenance
Priority: 4 - Recommended (Years 6-10)
Correction: Renew System
Qty: 31,845.00
Unit of Measure: S.F.
Estimate: \$95,981.00
Assessor Name: Hayden Collins
Date Created: 10/15/2019

Notes: This facility is protected by a central fire alarm system. The point addressable fire alarm control panel was Manufactured by Honeywell. The devices that serve this system include manual pull stations, audible/visible devices, and smoke detectors. Although the main board was upgraded the components and systems are beyond the expected life for this application. The system is recommended for upgrade.

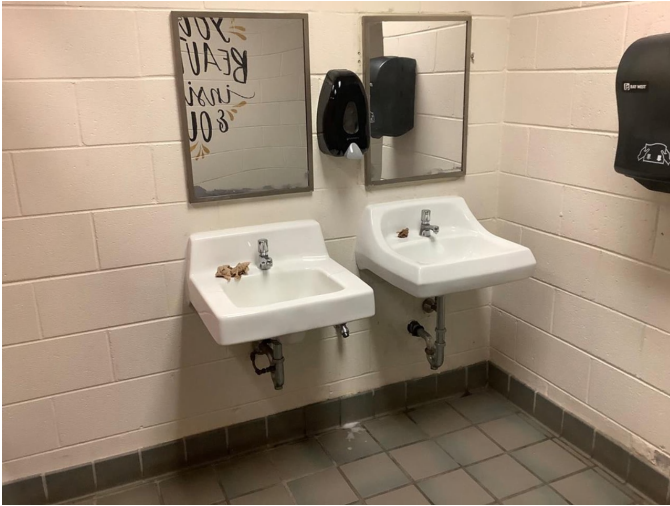
System: D2010 - Plumbing Fixtures

Location: Restroom
Distress: Beyond Expected Life
Category: ADA Compliance
Priority: 3 - Necessary (Years 2-5)
Correction: Renew System
Qty: 5,305.00
Unit of Measure: S.F.
Estimate: \$45,750.00
Assessor Name: Jejuan Hall
Date Created: 08/13/2014

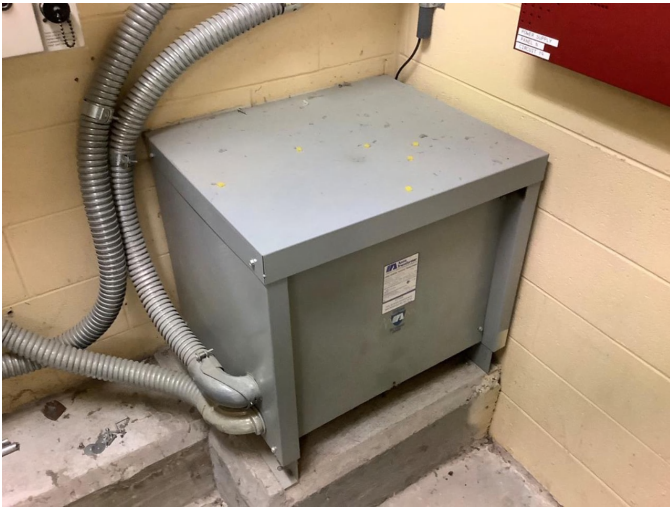
System: D5010 - Electrical Service/Distribution

Location: Throughout building
Distress: Beyond Expected Life
Category: Deferred Maintenance
Priority: 3 - Necessary (Years 2-5)
Correction: Renew System
Qty: 5,305.00
Unit of Measure: S.F.
Estimate: \$16,514.00
Assessor Name: Jejuan Hall
Date Created: 08/13/2014

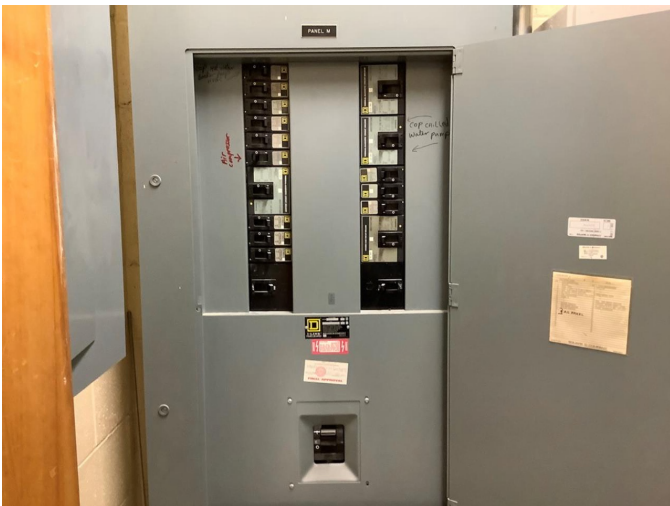
System: D5020 - Branch Wiring

Location: Throughout building
Distress: Beyond Expected Life
Category: Deferred Maintenance
Priority: 3 - Necessary (Years 2-5)
Correction: Renew System
Qty: 5,305.00
Unit of Measure: S.F.
Estimate: \$34,138.00
Assessor Name: Jejuan Hall
Date Created: 08/13/2014

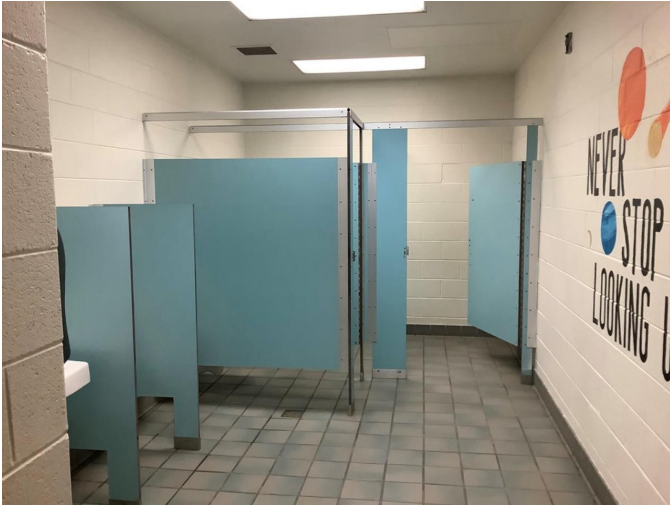
System: D5020 - Lighting

Location: Throughout building
Distress: Beyond Expected Life
Category: Deferred Maintenance
Priority: 3 - Necessary (Years 2-5)
Correction: Renew System
Qty: 5,305.00
Unit of Measure: S.F.
Estimate: \$51,236.00
Assessor Name: Jejuan Hall
Date Created: 10/16/2019

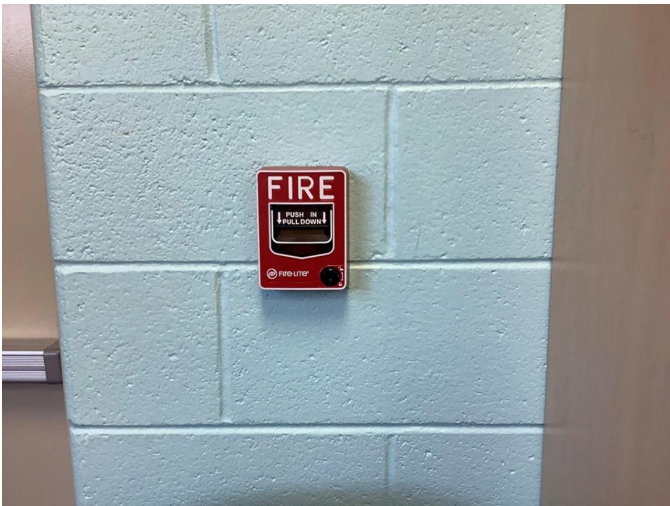
System: D5030910 - Fire Alarm Systems

Location: Throughout building
Distress: Beyond Expected Life
Category: Deferred Maintenance
Priority: 3 - Necessary (Years 2-5)
Correction: Renew System
Qty: 5,305.00
Unit of Measure: S.F.
Estimate: \$13,538.00
Assessor Name: Jejuan Hall
Date Created: 10/16/2019

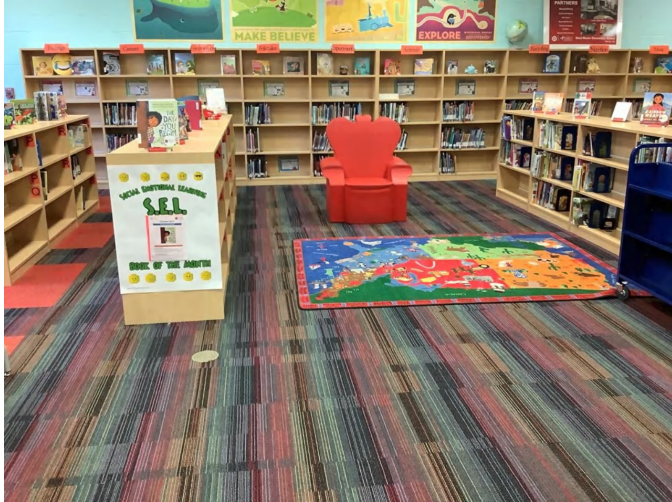
System: C3020901 - Carpet

Location: Throughout building
Distress: Beyond Expected Life
Category: Deferred Maintenance
Priority: 4 - Recommended (Years 6-10)
Correction: Renew System
Qty: 800.00
Unit of Measure: S.F.
Estimate: \$6,600.00
Assessor Name: Jejuan Hall
Date Created: 10/16/2019

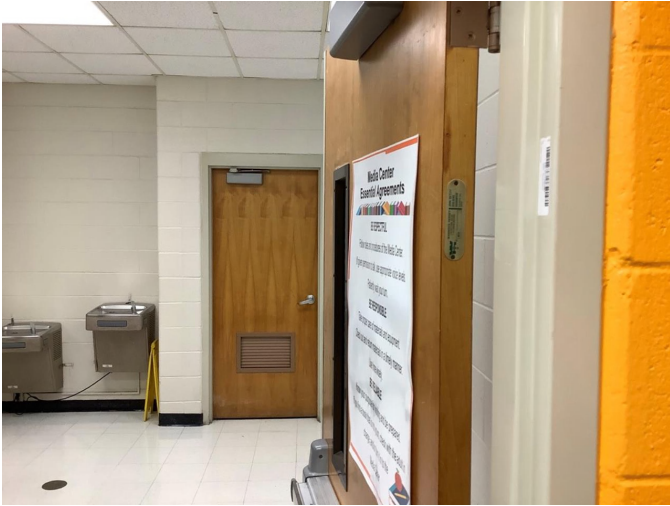
System: C3020903 - VCT

Location: Throughout building
Distress: Beyond Expected Life
Category: Deferred Maintenance
Priority: 4 - Recommended (Years 6-10)
Correction: Renew System
Qty: 4,105.00
Unit of Measure: S.F.
Estimate: \$22,142.00
Assessor Name: Jejuan Hall
Date Created: 10/16/2019

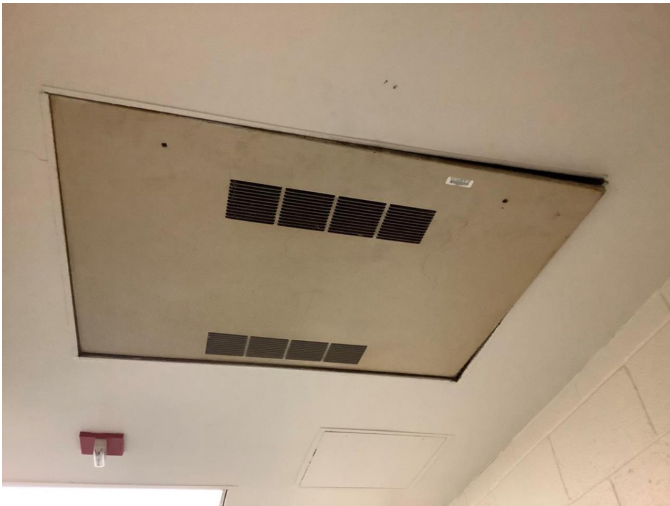
System: D3040 - Distribution Systems

Location: Throughout building
Distress: Beyond Expected Life
Category: Deferred Maintenance
Priority: 4 - Recommended (Years 6-10)
Correction: Renew System
Qty: 5,305.00
Unit of Measure: S.F.
Estimate: \$136,201.00
Assessor Name: Jejuan Hall
Date Created: 08/13/2014

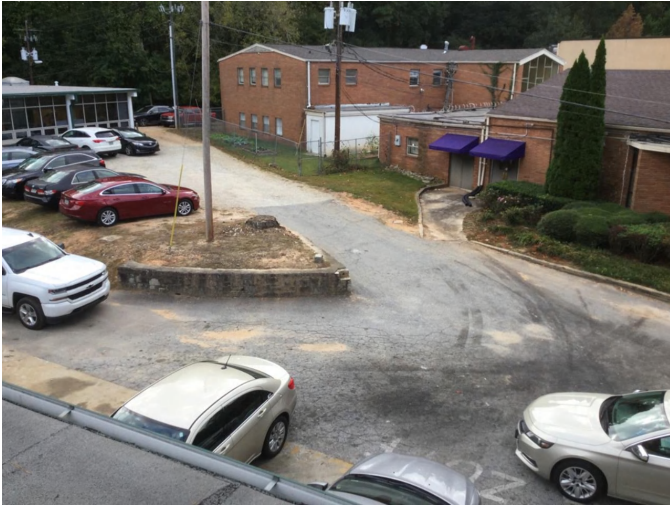
System: G2010 - Roadways

Location: Roadways
Distress: Failing
Category: Deferred Maintenance
Priority: 3 - Necessary (Years 2-5)
Correction: Renew System
Qty: 37,150.00
Unit of Measure: S.F.
Estimate: \$96,850.00
Assessor Name: Hayden Collins
Date Created: 08/05/2013

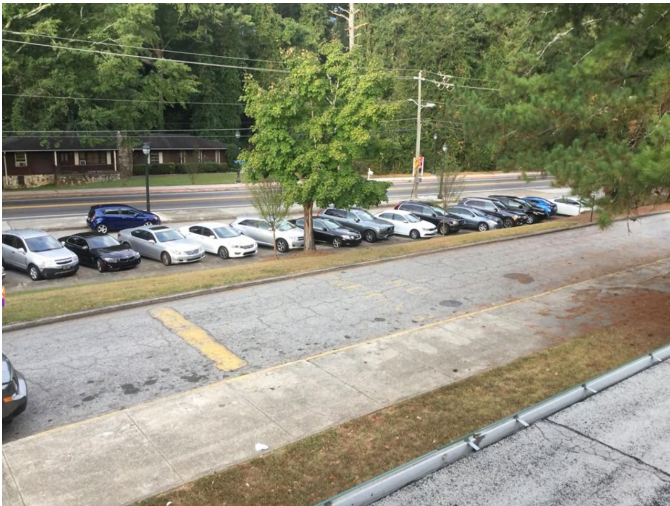
System: G2020 - Parking Lots

Location: Parking lot
Distress: Failing
Category: ADA Compliance
Priority: 3 - Necessary (Years 2-5)
Correction: Resurface asphalt paving and restripe.
Qty: 8,000.00
Unit of Measure: S.Y.
Estimate: \$18,421.64
Assessor Name: Hayden Collins
Date Created: 08/05/2013

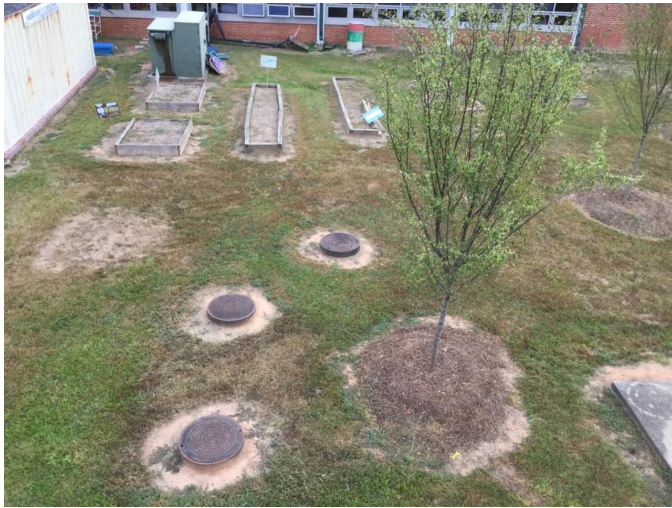
System: G3030 - Storm Sewer

Location: Site
Distress: Beyond Expected Life
Category: Deferred Maintenance
Priority: 3 - Necessary (Years 2-5)
Correction: Renew System
Qty: 37,150.00
Unit of Measure: S.F.
Estimate: \$51,081.00
Assessor Name: Hayden Collins
Date Created: 08/05/2013
