Atlanta Public Schools/Relocation Sites

# White Elementary School

## School Assessment Report

November 10, 2020

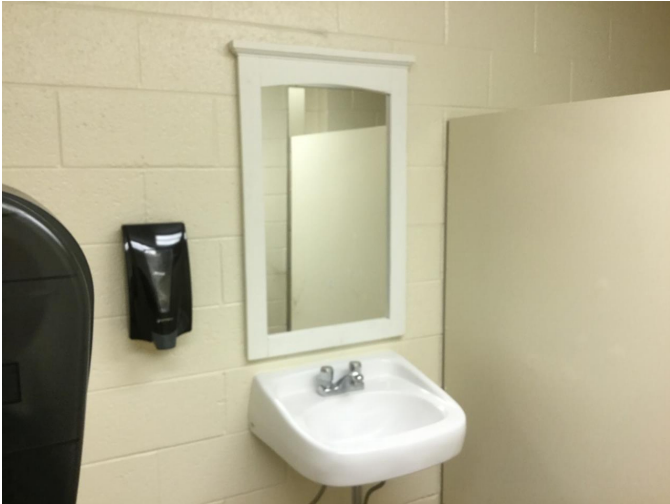
#### System: D2010 - Plumbing Fixtures

**Location:** Restrooms  
**Distress:** Beyond Expected Life  
**Category:** ADA Compliance  
**Priority:** 1 - Critical Immediate Need  
**Correction:** Renew System  
**Qty:** 46,808.00  
**Unit of Measure:** S.F.  
**Estimate:** \$325,924.00  
**Assessor Name:** Jejuan Hall  
**Date Created:** 09/30/2019

**Notes:** Plumbing fixtures are beyond their expected service life and should be replaced and upgraded for ADA compliance. This deficiency provides a budgetary consideration for repairs and modifications that should take place in conjunction with other recommended renovations.

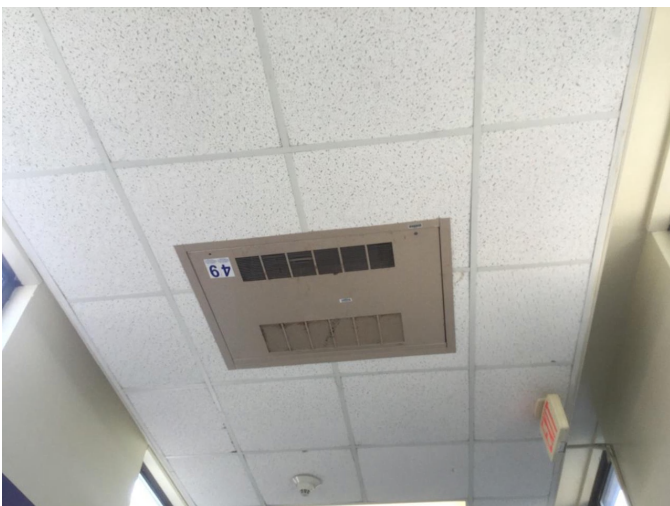
#### System: D3040 - Distribution Systems

**Location:** Throughout building  
**Distress:** Beyond Expected Life  
**Category:** Deferred Maintenance  
**Priority:** 1 - Critical Immediate Need  
**Correction:** Renew System  
**Qty:** 46,808.00  
**Unit of Measure:** S.F.  
**Estimate:** \$875,824.00  
**Assessor Name:** Hayden Collins  
**Date Created:** 09/30/2019

**Notes:** Most of the exhaust fans are out of service or not functioning as designed. Fan Coil units are no longer functioning and several sections of ducting have been out of service and will require either cleaning or replacement. Considering the current status of the school this deficiency provides a budgetary consideration for a general distribution system renewal prior to the school reopening.

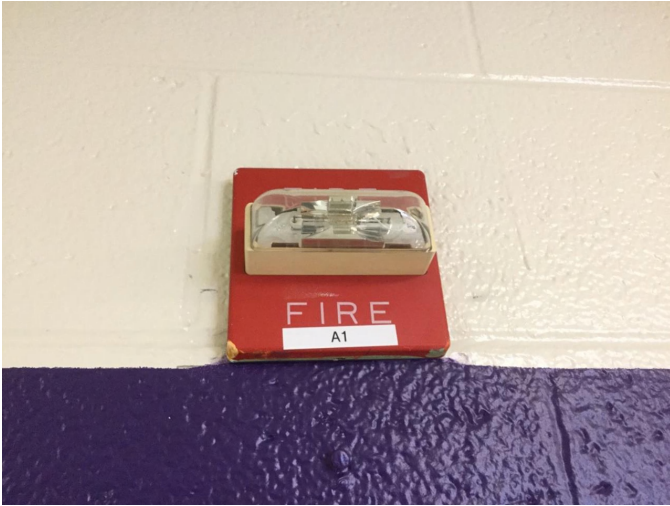
**System: D5030910 - Fire Alarm Systems**

**Location:** Throughout building  
**Distress:** Beyond Expected Life  
**Category:** Deferred Maintenance  
**Priority:** 1 - Critical Immediate Need  
**Correction:** Renew System  
**Qty:** 46,808.00  
**Unit of Measure:** S.F.  
**Estimate:** \$141,079.00  
**Assessor Name:** Hayden Collins  
**Date Created:** 12/15/2019

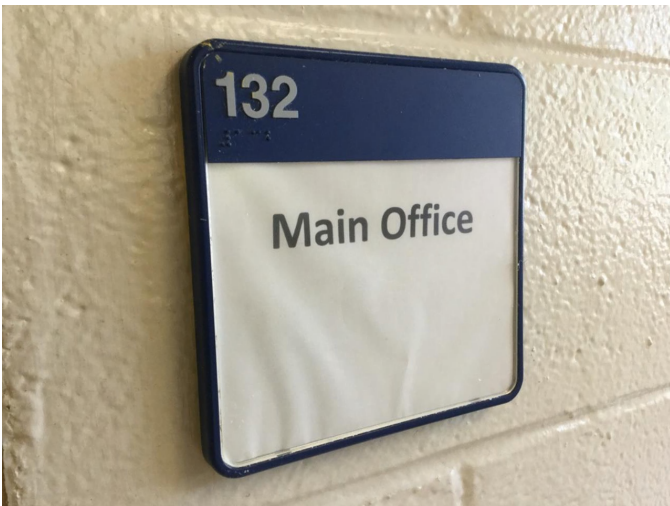
**System: C1030 - Fittings**

**Location:** Throughout building  
**Distress:** Beyond Expected Life  
**Category:** ADA Compliance  
**Priority:** 2 - Trending Critical (Year 1)  
**Correction:** Renew System  
**Qty:** 46,808.00  
**Unit of Measure:** S.F.  
**Estimate:** \$135,930.00  
**Assessor Name:** Jejuan Hall  
**Date Created:** 09/30/2019

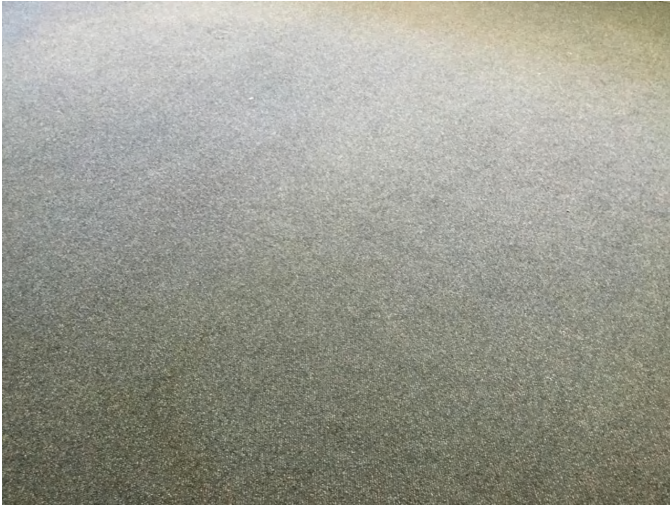
**System: C3020901 - Carpet**

**Location:** Administration Area  
**Distress:** Beyond Expected Life  
**Category:** Deferred Maintenance  
**Priority:** 2 - Trending Critical (Year 1)  
**Correction:** Renew System  
**Qty:** 2,808.00  
**Unit of Measure:** S.F.  
**Estimate:** \$23,166.00  
**Assessor Name:** Hayden Collins  
**Date Created:** 12/15/2019

**Notes:** The carpet finish is damaged and has exceeded its expected life cycle and is recommended for replacement in conjunction with other recommended renovations.

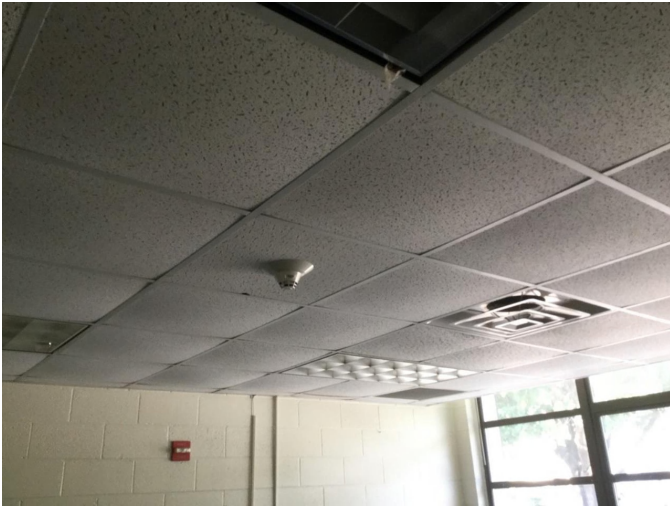
**System: C3030 - Ceiling Finishes**

**Location:** Throughout building  
**Distress:** Beyond Expected Life  
**Category:** Deferred Maintenance  
**Priority:** 2 - Trending Critical (Year 1)  
**Correction:** Renew System  
**Qty:** 46,808.00  
**Unit of Measure:** S.F.  
**Estimate:** \$462,369.00  
**Assessor Name:** Hayden Collins  
**Date Created:** 09/30/2019

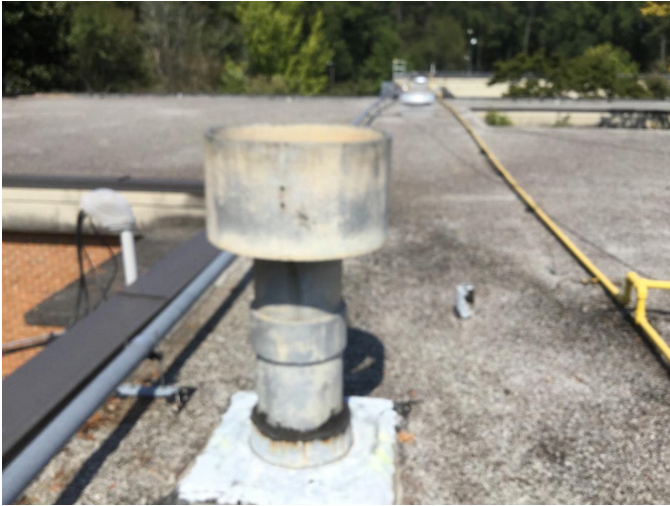
**System: B3010105 - Built-Up**

**Location:** Roof  
**Distress:** Beyond Expected Life  
**Category:** Deferred Maintenance  
**Priority:** 3 - Necessary (Years 2-5)  
**Correction:** Renew System  
**Qty:** 46,808.00  
**Unit of Measure:** S.F.  
**Estimate:** \$525,443.00  
**Assessor Name:** Hayden Collins  
**Date Created:** 12/15/2019

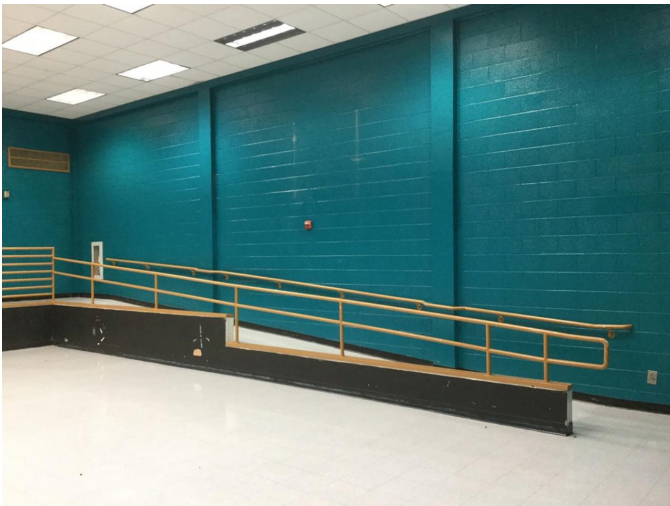
**System: C3010230 - Paint & Covering**

**Location:** Throughout building  
**Distress:** Beyond Expected Life  
**Category:** Deferred Maintenance  
**Priority:** 3 - Necessary (Years 2-5)  
**Correction:** Renew System  
**Qty:** 46,808.00  
**Unit of Measure:** S.F.  
**Estimate:** \$75,689.00  
**Assessor Name:** Hayden Collins  
**Date Created:** 12/15/2019

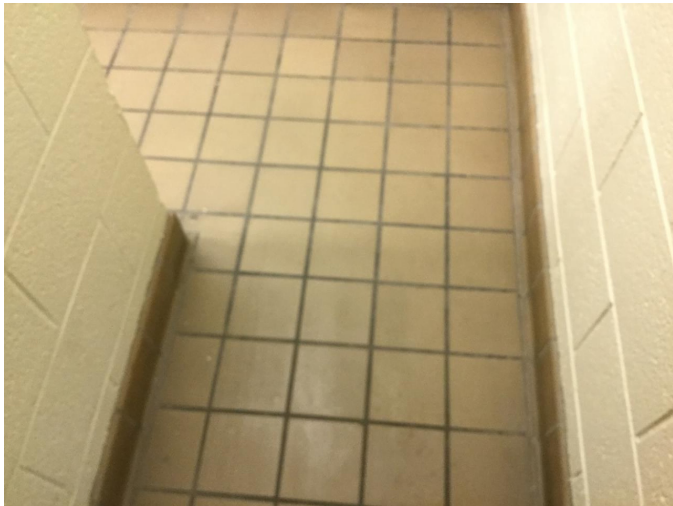
**System: C3020420 - Ceramic Tile**

**Location:** Restrooms  
**Distress:** Beyond Expected Life  
**Category:** Deferred Maintenance  
**Priority:** 3 - Necessary (Years 2-5)  
**Correction:** Renew System  
**Qty:** 8,000.00  
**Unit of Measure:** S.F.  
**Estimate:** \$200,880.00  
**Assessor Name:** Hayden Collins  
**Date Created:** 12/15/2019

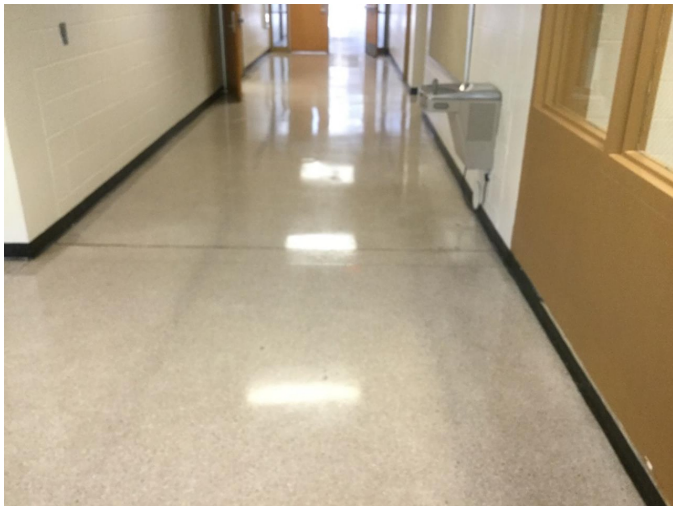
**System: C3020430 - Terrazzo**

**Location:** Throughout building  
**Distress:** Beyond Expected Life  
**Category:** Deferred Maintenance  
**Priority:** 3 - Necessary (Years 2-5)  
**Correction:** Renew System  
**Qty:** 14,000.00  
**Unit of Measure:** S.F.  
**Estimate:** \$378,350.00  
**Assessor Name:** Hayden Collins  
**Date Created:** 01/31/2020

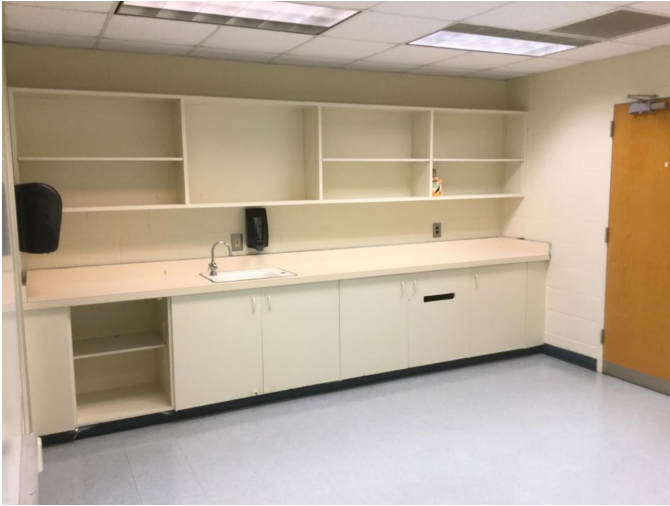
**System: C3020903 - VCT**

**Location:** Throughout building  
**Distress:** Beyond Expected Life  
**Category:** Deferred Maintenance  
**Priority:** 3 - Necessary (Years 2-5)  
**Correction:** Renew System  
**Qty:** 20,000.00  
**Unit of Measure:** S.F.  
**Estimate:** \$107,880.00  
**Assessor Name:** Hayden Collins  
**Date Created:** 12/15/2019

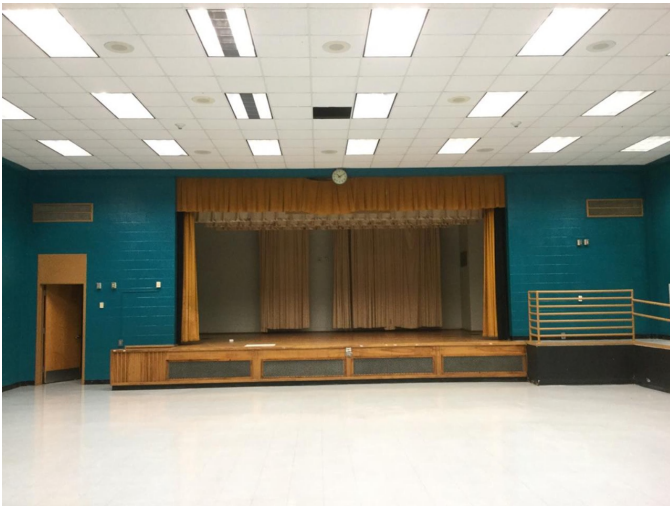
**System: C3020999 - Other - Wood**

**Location:** Stage  
**Distress:** Beyond Expected Life  
**Category:** Deferred Maintenance  
**Priority:** 3 - Necessary (Years 2-5)  
**Correction:** Renew System  
**Qty:** 2,000.00  
**Unit of Measure:** S.F.  
**Estimate:** \$37,785.00  
**Assessor Name:** Hayden Collins  
**Date Created:** 12/15/2019

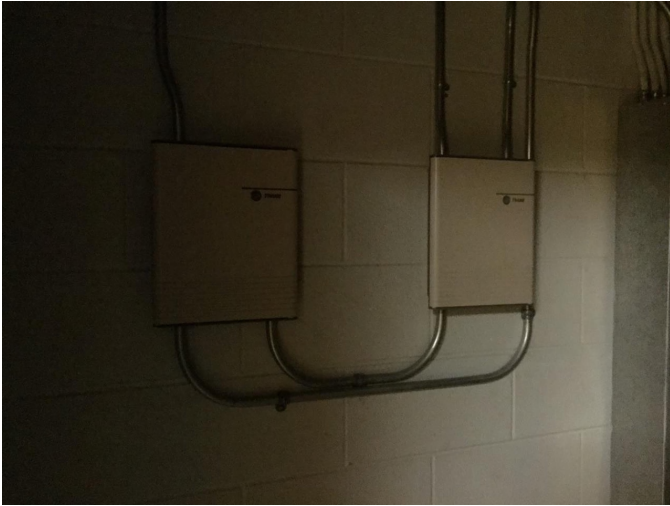
**System: D3060 - Controls & Instrumentation**

**Location:** Throughout building  
**Distress:** Beyond Expected Life  
**Category:** Deferred Maintenance  
**Priority:** 3 - Necessary (Years 2-5)  
**Correction:** Renew System  
**Qty:** 46,808.00  
**Unit of Measure:** S.F.  
**Estimate:** \$180,726.00  
**Assessor Name:** Hayden Collins  
**Date Created:** 08/13/2014

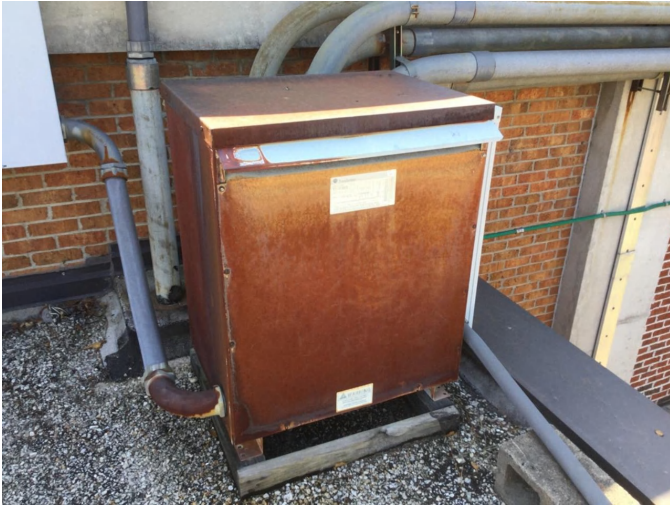
**System: D5010 - Electrical Service/Distribution**

**Location:** Throughout building  
**Distress:** Beyond Expected Life  
**Category:** Deferred Maintenance  
**Priority:** 3 - Necessary (Years 2-5)  
**Correction:** Renew System  
**Qty:** 46,808.00  
**Unit of Measure:** S.F.  
**Estimate:** \$110,701.00  
**Assessor Name:** Hayden Collins  
**Date Created:** 02/22/2020

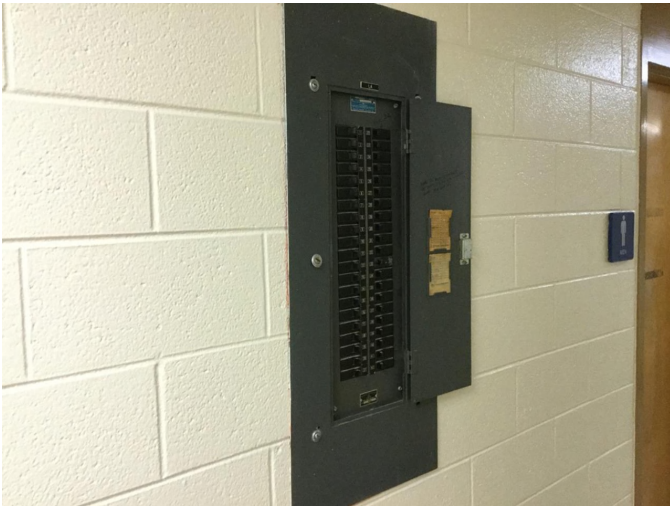
**System: D5020 - Branch Wiring**

**Location:** Throughout building  
**Distress:** Beyond Expected Life  
**Category:** Deferred Maintenance  
**Priority:** 3 - Necessary (Years 2-5)  
**Correction:** Renew System  
**Qty:** 46,808.00  
**Unit of Measure:** S.F.  
**Estimate:** \$225,006.00  
**Assessor Name:** Hayden Collins  
**Date Created:** 12/15/2019

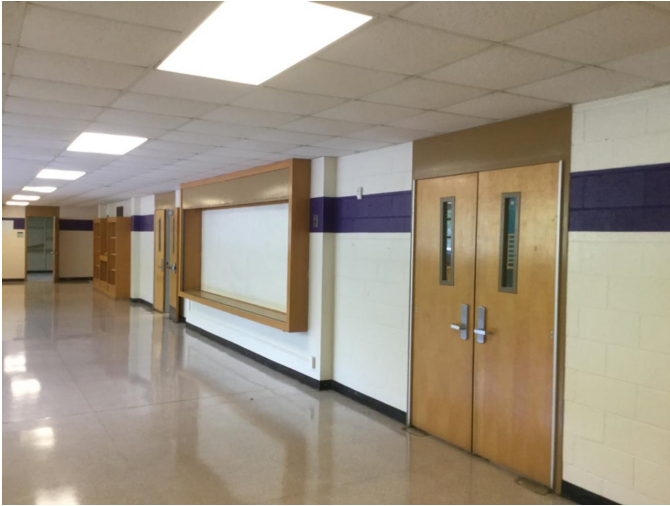
**System: D5020 - Lighting**

**Location:** Throughout building  
**Distress:** Beyond Expected Life  
**Category:** Deferred Maintenance  
**Priority:** 3 - Necessary (Years 2-5)  
**Correction:** Renew System  
**Qty:** 46,808.00  
**Unit of Measure:** S.F.  
**Estimate:** \$351,669.00  
**Assessor Name:** Hayden Collins  
**Date Created:** 09/30/2019

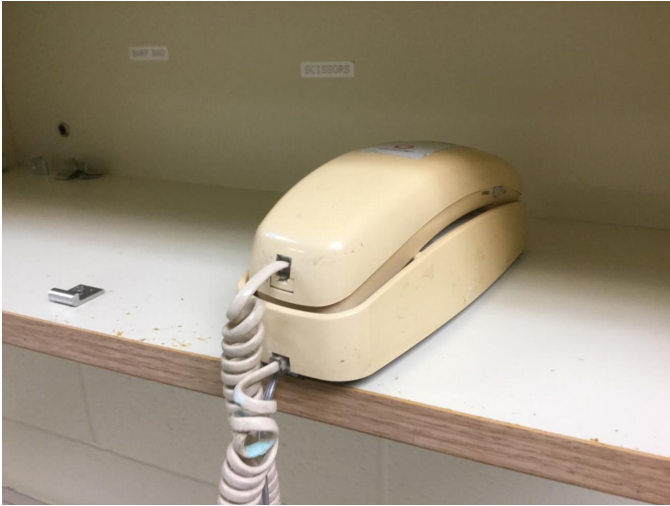
**System: E1090 - Other Equipment**

**Location:** Throughout building  
**Distress:** Beyond Expected Life  
**Category:** Deferred Maintenance  
**Priority:** 3 - Necessary (Years 2-5)  
**Correction:** Renew System  
**Qty:** 46,808.00  
**Unit of Measure:** S.F.  
**Estimate:** \$40,676.00  
**Assessor Name:** Hayden Collins  
**Date Created:** 09/30/2019

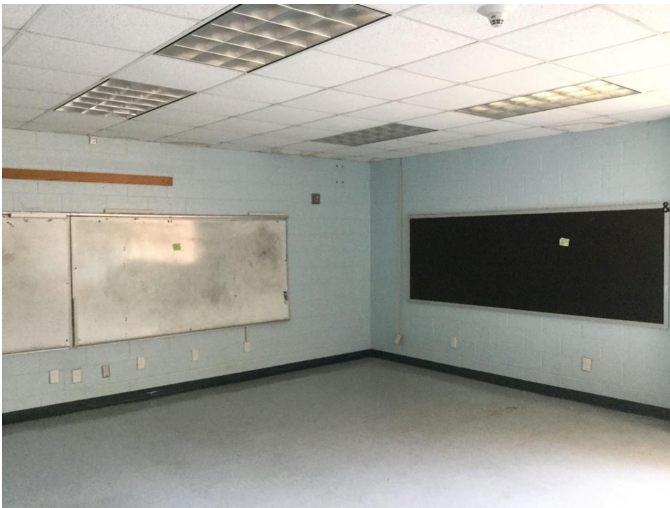
**System: C3020903 - VCT**

**Location:** Throughout building  
**Distress:** Beyond Expected Life  
**Category:** Deferred Maintenance  
**Priority:** 3 - Necessary (Years 2-5)  
**Correction:** Renew System  
**Qty:** 20,000.00  
**Unit of Measure:** S.F.  
**Estimate:** \$107,880.00  
**Assessor Name:** Homero Guerrero  
**Date Created:** 12/15/2019

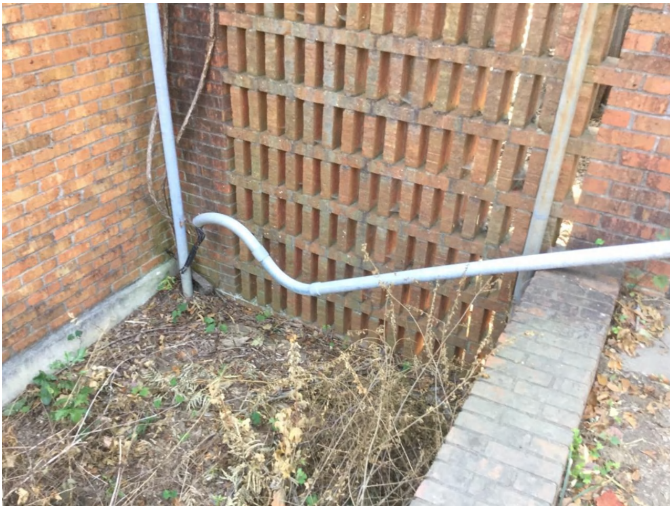
**System: D5020 - Branch Wiring**

**Location:** Throughout building  
**Distress:** Beyond Expected Life  
**Category:** Deferred Maintenance  
**Priority:** 3 - Necessary (Years 2-5)  
**Correction:** Renew System  
**Qty:** 23,308.00  
**Unit of Measure:** S.F.  
**Estimate:** \$112,042.00  
**Assessor Name:** Homero Guerrero  
**Date Created:** 09/30/2019

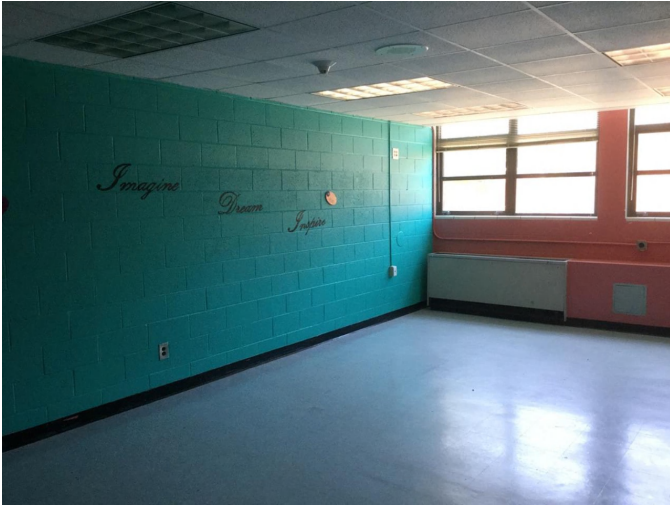
**Location:** Throughout building  
**Distress:** Beyond Expected Life  
**Category:** Deferred Maintenance  
**Priority:** 3 - Necessary (Years 2-5)  
**Correction:** Renew System  
**Qty:** 23,308.00  
**Unit of Measure:** S.F.  
**Estimate:** \$175,113.00  
**Assessor Name:** Homero Guerrero  
**Date Created:** 12/15/2019

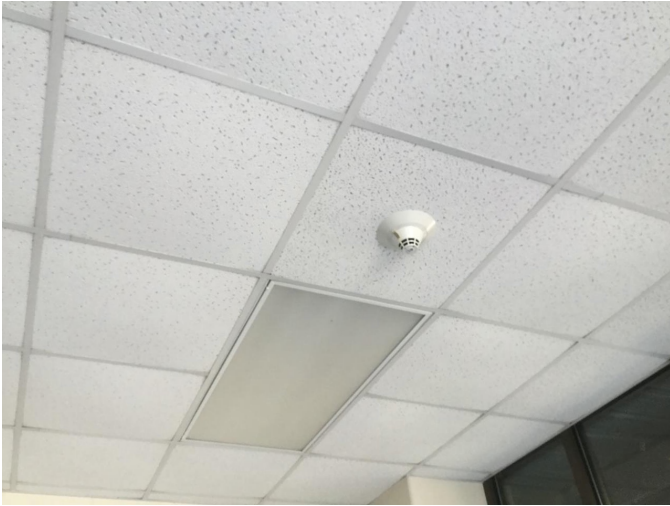
**Location:** Throughout building  
**Distress:** Beyond Expected Life  
**Category:** Deferred Maintenance  
**Priority:** 2 - Trending Critical (Year 1)  
**Correction:** Renew System  
**Qty:** 8,308.00  
**Unit of Measure:** S.F.  
**Estimate:** \$91,388.00  
**Assessor Name:** Homero Guerrero  
**Date Created:** 09/30/2019

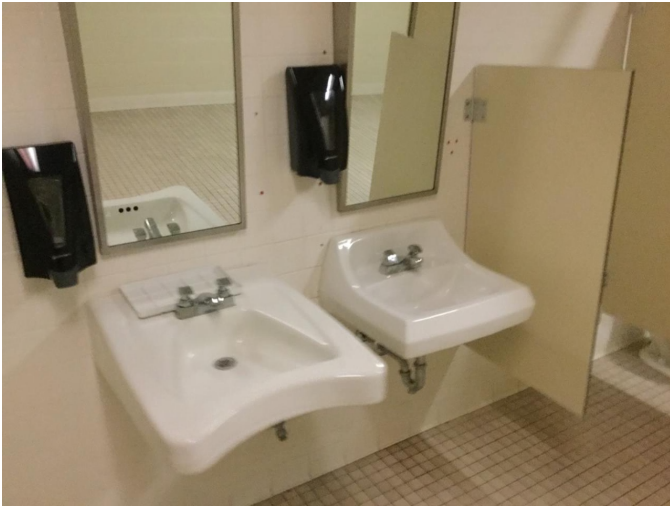
**Location:** Restrooms  
**Distress:** Beyond Expected Life  
**Category:** ADA Compliance  
**Priority:** 2 - Trending Critical (Year 1)  
**Correction:** Renew System  
**Qty:** 8,308.00  
**Unit of Measure:** S.F.  
**Estimate:** \$64,520.00  
**Assessor Name:** Jejuan Hall  
**Date Created:** 09/30/2019

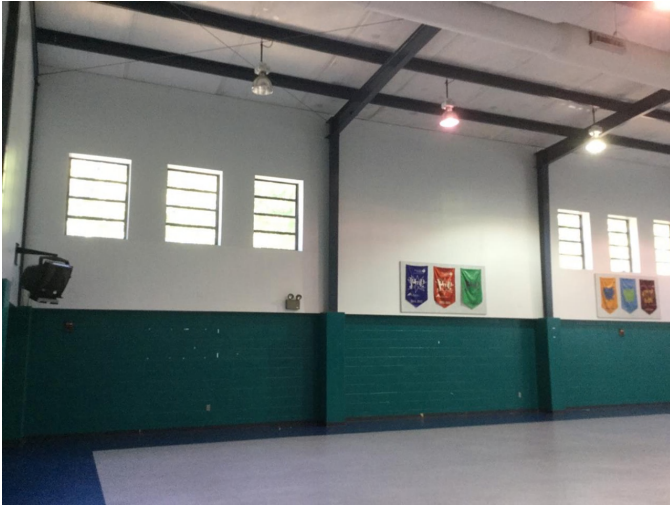
**Location:** Throughout building  
**Distress:** Beyond Expected Life  
**Category:** Deferred Maintenance  
**Priority:** 3 - Necessary (Years 2-5)  
**Correction:** Renew System  
**Qty:** 8,308.00  
**Unit of Measure:** S.F.  
**Estimate:** \$13,434.00  
**Assessor Name:** Homero Guerrero  
**Date Created:** 12/14/2019

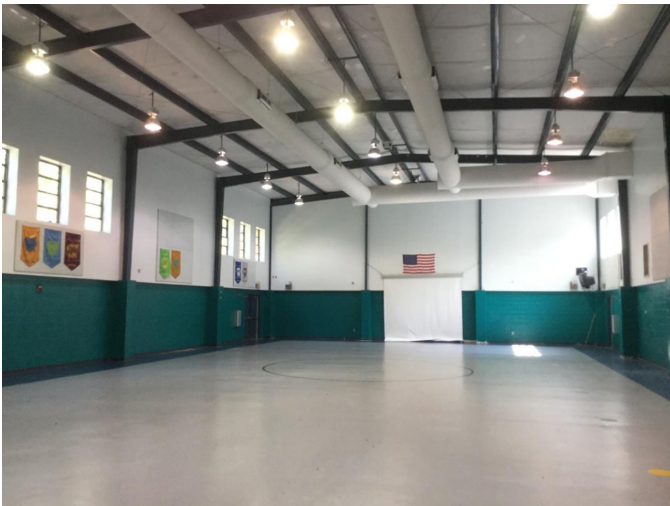
**Location:** Throughout building  
**Distress:** Beyond Expected Life  
**Category:** Deferred Maintenance  
**Priority:** 3 - Necessary (Years 2-5)  
**Correction:** Renew System  
**Qty:** 8,308.00  
**Unit of Measure:** S.F.  
**Estimate:** \$44,813.00  
**Assessor Name:** Homero Guerrero  
**Date Created:** 12/14/2019

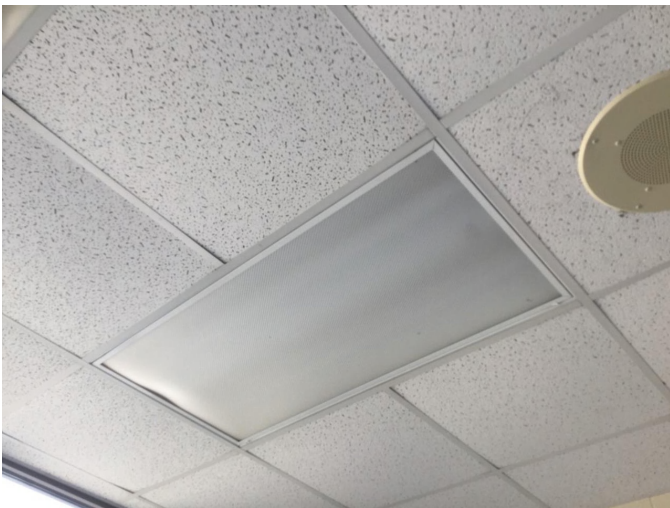
**Location:** Throughout building  
**Distress:** Beyond Expected Life  
**Category:** Deferred Maintenance  
**Priority:** 3 - Necessary (Years 2-5)  
**Correction:** Renew System  
**Qty:** 8,308.00  
**Unit of Measure:** S.F.  
**Estimate:** \$74,298.00  
**Assessor Name:** Homero Guerrero  
**Date Created:** 12/14/2019

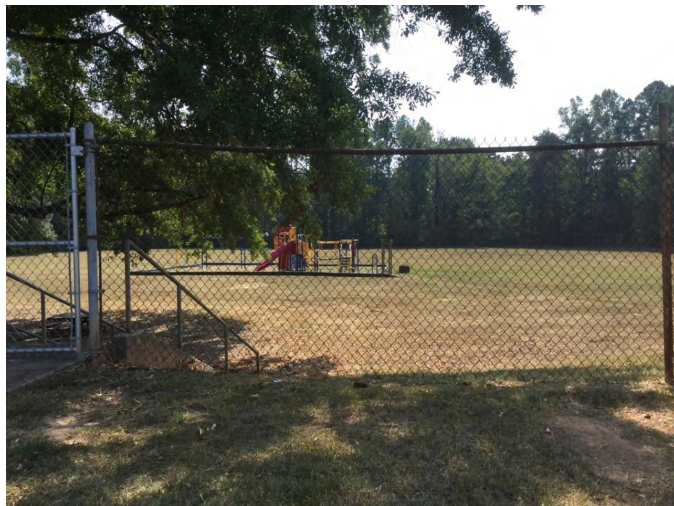
**Location:** Site  
**Distress:** Beyond Expected Life  
**Category:** Deferred Maintenance  
**Priority:** 3 - Necessary (Years 2-5)  
**Correction:** Renew System  
**Qty:** 78,524.00  
**Unit of Measure:** S.F.  
**Estimate:** \$474,206.00  
**Assessor Name:** Hayden Collins  
**Date Created:** 12/14/2019

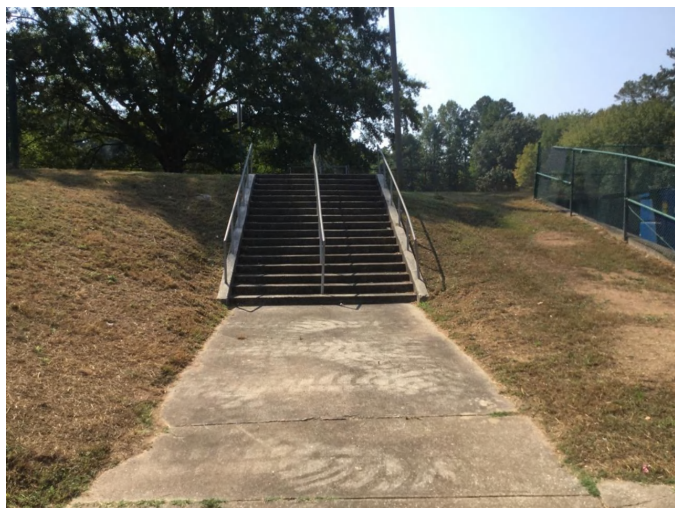
**Location:** Site  
**Distress:** Beyond Expected Life  
**Category:** Deferred Maintenance  
**Priority:** 4 - Recommended (Years 6-10)  
**Correction:** Renew System  
**Qty:** 78,524.00  
**Unit of Measure:** S.F.  
**Estimate:** \$99,333.00  
**Assessor Name:** Hayden Collins  
**Date Created:** 12/15/2019
