Atlanta Public Schools/ Douglass Cluster

BEST Academy/C.S. King

School Assessment Report

November 10, 2020

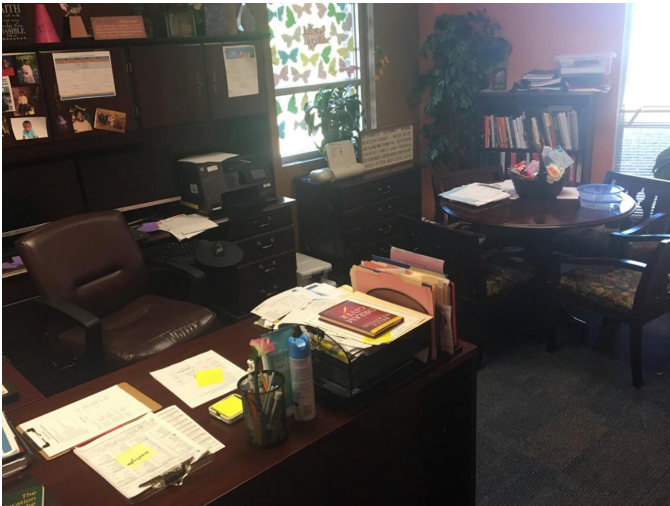
System: C3020901 - Carpet

Location: Throughout Building

Distress: Beyond Expected Life

Notes: The carpet is aged beyond its expected life, and should be replaced.
