Atlanta Public Schools/ Mays Cluster

Beecher Hills Elementary School

School Assessment Report

November 10, 2020

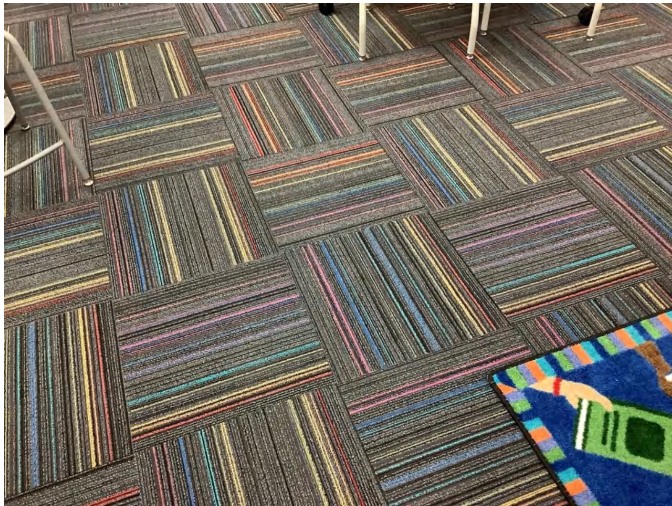
System: C3020901 - Carpet

Location: Media Center
Distress: Beyond Expected Life
Category: Deferred Maintenance
Priority: 3 - Necessary (Years 2-5)
Correction: Renew System
Qty: 2,000.00
Unit of Measure: S.F.
Estimate: \$16,500.00
Assessor Name: Jejuan Hall
Date Created: 12/13/2019

Notes: The Carpet floor finish is beyond its expected service life, worn and damaged, and is recommended for replacement.

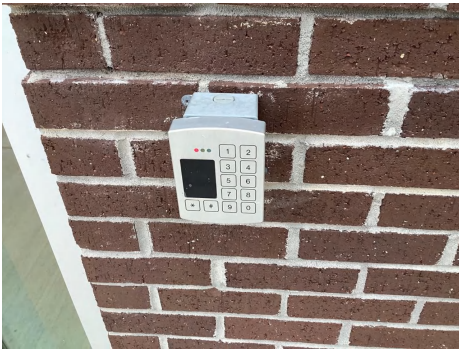
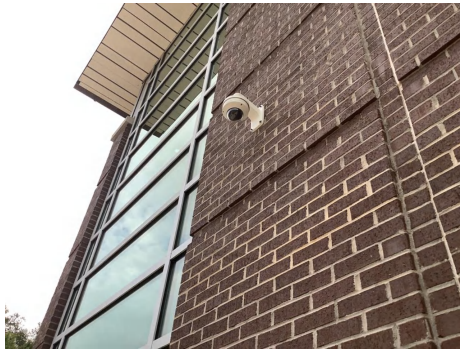
System: G4030 - Site Communication and Security

Note: Site security appears much newer than 1999 renovation date. Confirming with APS as to when security cameras were installed.
