Atlanta Public Schools/ N. Atlanta Cluster

# Bolton Academy

## School Assessment Report

November 10, 2020

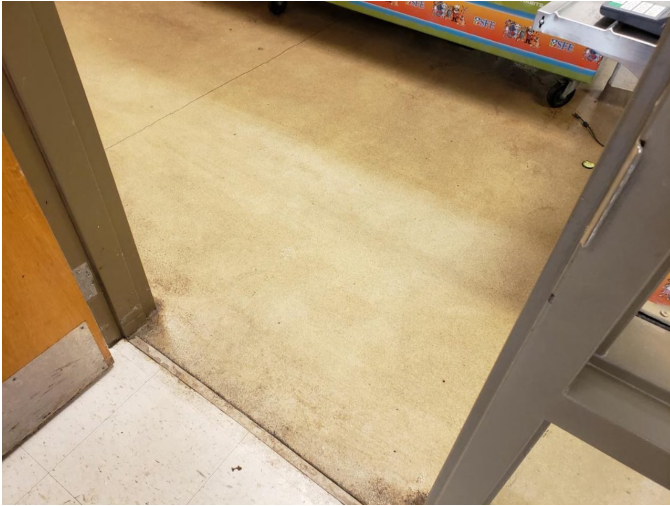
#### System: C3020405 - Epoxy

**Location:** Restrooms  
**Distress:** Beyond Expected Life  
**Category:** Deferred Maintenance  
**Priority:** 3 - Necessary (Years 2-5)  
**Correction:** Renew System  
**Qty:** 2,235.00  
**Unit of Measure:** S.F.  
**Estimate:** \$45,625.00  
**Assessor Name:** Jejuan Hall  
**Date Created:** 11/18/2019

**Notes:** The epoxy floor finish is beyond its expected service life, worn and damaged, and is recommended for replacement.

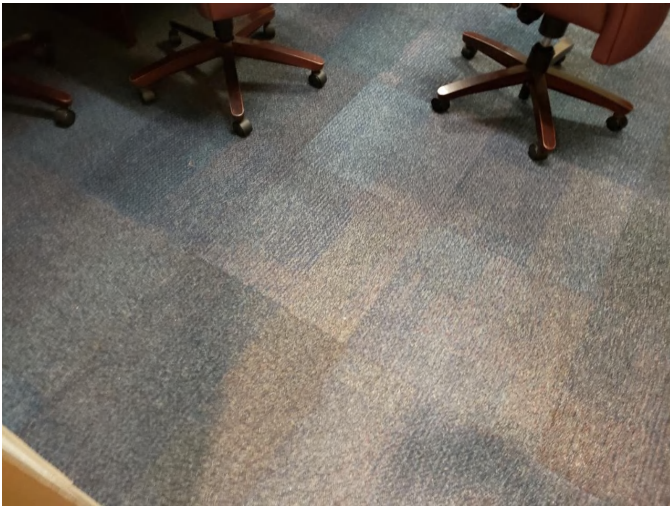
#### System: C3020901 - Carpet

**Location:** Media Center  
**Distress:** Beyond Expected Life  
**Category:** Deferred Maintenance  
**Priority:** 3 - Necessary (Years 2-5)  
**Correction:** Renew System  
**Qty:** 5,412.00  
**Unit of Measure:** S.F.  
**Estimate:** \$44,649.00  
**Assessor Name:** Jejuan Hall  
**Date Created:** 11/18/2019

**Notes:** The carpet floor finish is beyond its expected service life, worn and damaged, and is recommended for replacement.

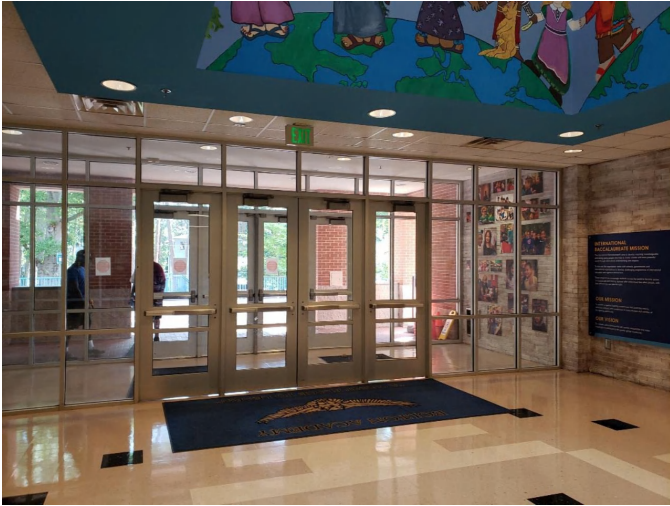
**System: C3020903 - VCT**

**Location:** Throughout Building  
**Distress:** Beyond Expected Life  
**Category:** Deferred Maintenance  
**Priority:** 3 - Necessary (Years 2-5)  
**Correction:** Renew System  
**Qty:** 68,700.00  
**Unit of Measure:** S.F.  
**Estimate:** \$370,568.00  
**Assessor Name:** Jejuan Hall  
**Date Created:** 11/18/2019

**Notes:** The VCT floor finish is beyond its expected service life, worn and damaged, and is recommended for replacement.

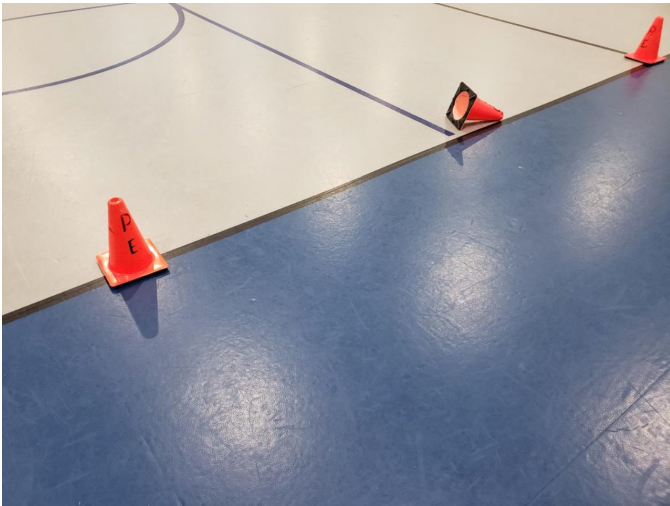
**System: C3020999 - Other - Rubber or Neoprene**

**Location:** Throughout Building  
**Distress:** Beyond Expected Life  
**Category:** Deferred Maintenance  
**Priority:** 3 - Necessary (Years 2-5)  
**Correction:** Renew System  
**Qty:** 5,538.00  
**Unit of Measure:** S.F.  
**Estimate:** \$162,468.00  
**Assessor Name:** Jejuan Hall  
**Date Created:** 11/18/2019

**Notes:** The Rubber or Neoprene floor finish is beyond its expected service life, worn and damaged, and is recommended for replacement.

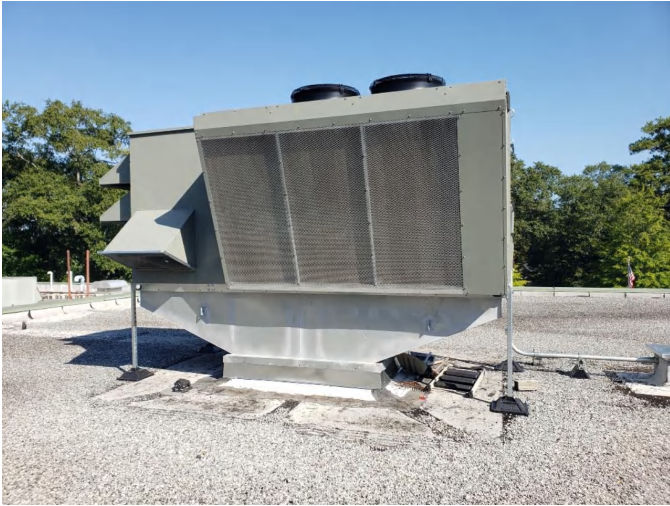
**System: D3050 - Terminal & Package Units**

**Location:** Roof  
**Distress:** Beyond Expected Life  
**Category:** Deferred Maintenance  
**Priority:** 3 - Necessary (Years 2-5)  
**Correction:** Renew System  
**Qty:** 83,653.00  
**Unit of Measure:** S.F.  
**Estimate:** \$611,922.00  
**Assessor Name:** Jejuan Hall  
**Date Created:** 09/30/2019

**Notes:** The terminal and package units are at the end of their useful life. The system is functional however upgrades are warranted.

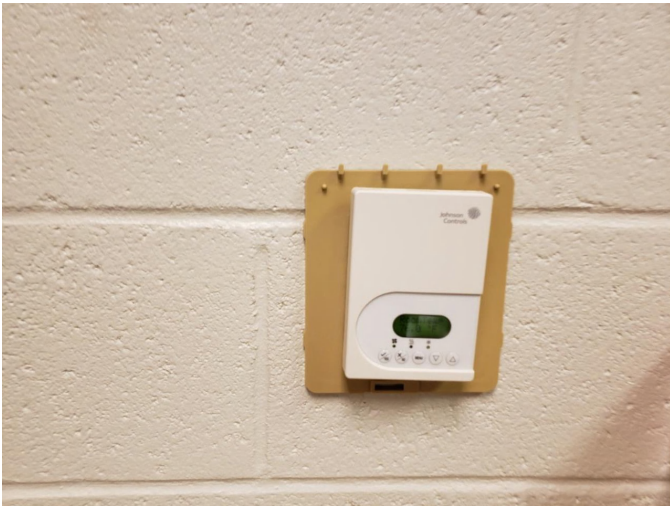
**System: D3060 - Controls & Instrumentation**

**Location:** Kitchen  
**Distress:** Beyond Expected Life  
**Category:** Deferred Maintenance  
**Priority:** 3 - Necessary (Years 2-5)  
**Correction:** Renew System  
**Qty:** 83,653.00  
**Unit of Measure:** S.F.  
**Estimate:** \$202,440.00  
**Assessor Name:** Jejuan Hall  
**Date Created:** 09/30/2019

**Notes:** The Controls Instrumentation are original. Several issues have surfaced over recent years and isolated upgrades have taken place to support the systems. This deficiency provides a budgetary consideration for a universal upgrade.

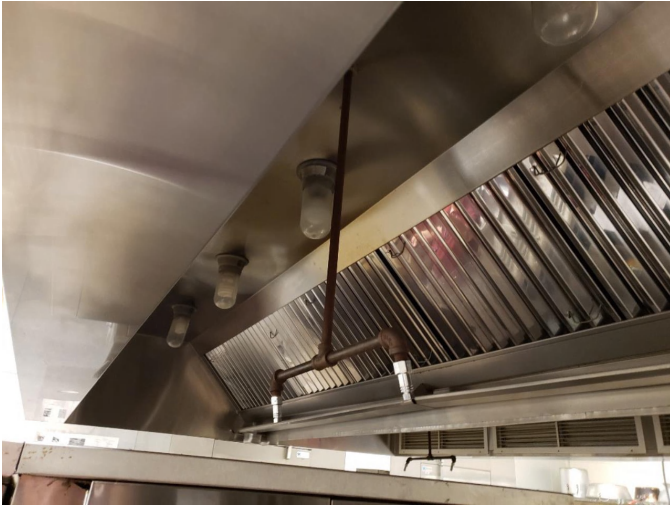
**System: D4090 - Other Fire Protection Systems**

**Location:** Kitchen  
**Distress:** Beyond Expected Life  
**Category:** Deferred Maintenance  
**Priority:** 3 - Necessary (Years 2-5)  
**Correction:** Renew System  
**Qty:** 83,653.00  
**Unit of Measure:** S.F.  
**Estimate:** \$55,211.00  
**Assessor Name:** Jejuan Hall  
**Date Created:** 09/30/2019

**Notes:** The exhaust hood system is original. This building high traffic use warrants upgrades to this system based on usage and age. This deficiency provides a budgetary consideration for universal upgrades to the system.
