Atlanta Public Schools/ N. Atlanta Cluster

Brandon Primary

School Assessment Report

November 10, 2020

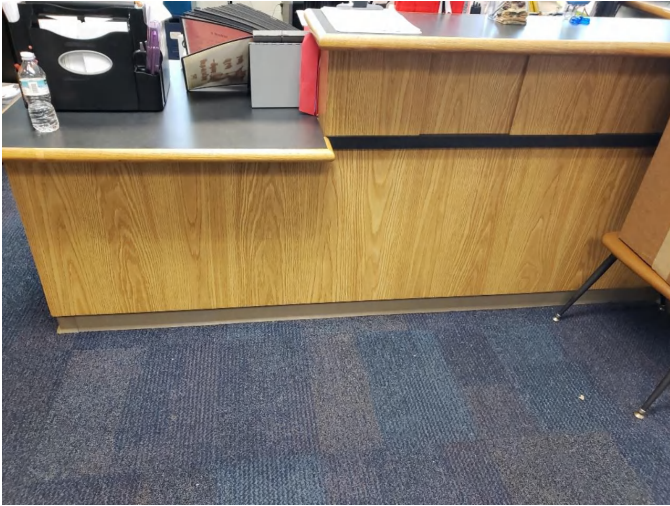
System: C3020901 - Carpet

Location: Throughout Building
Distress: Beyond Expected Life
Category: Deferred Maintenance
Priority: 3 - Necessary (Years 2-5)
Correction: Renew System
Qty: 1,000.00
Unit of Measure: S.F.
Estimate: \$8,250.00
Assessor Name: Jejuan Hall
Date Created: 01/27/2020

Notes: The carpet floor finish is beyond its expected service life, worn and damaged, and is recommended for replacement.

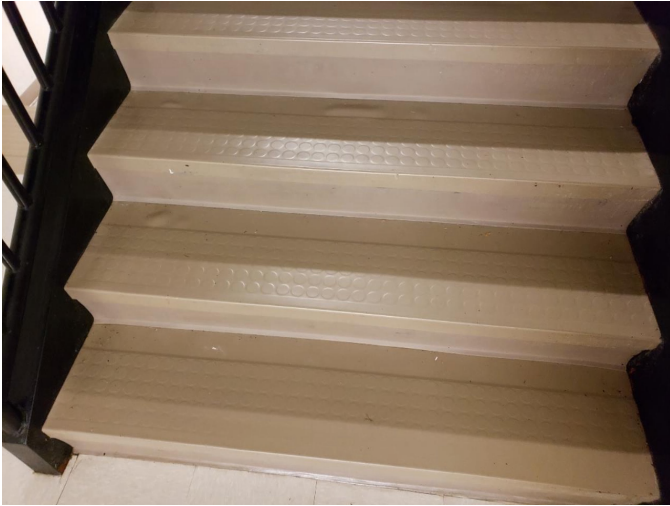
System: C3020999 - Other - Rubber or Neoprene

Location: Stairs
Distress: Beyond Expected Life
Category: Deferred Maintenance
Priority: 3 - Necessary (Years 2-5)
Correction: Renew System
Qty: 1,000.00
Unit of Measure: S.F.
Estimate: \$29,337.00
Assessor Name: Hayden Collins
Date Created: 01/27/2020

Notes: The Rubber or Neoprene floor finish is beyond its expected service life, worn and damaged, and is recommended for replacement.

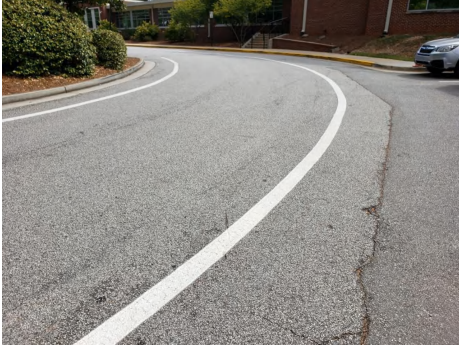
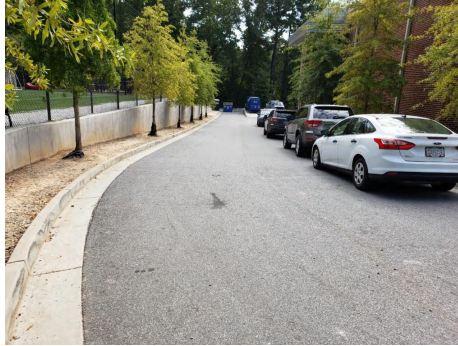
System: G2010 - Roadways

Note: Added a new road around the new addition to access the new dumpster, small parking area and facilitate access to kitchen for deliveries. Does not exceed 75% needed to update to 2015.

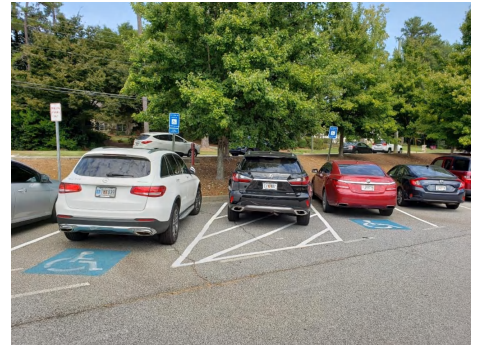
System: G2020 - Parking Lots

Note: added a nine (9) space parking area on the backside of the new addition
