Atlanta Public Schools/ Therrell Cluster

Bunche Middle School

School Assessment Report

November 10, 2020

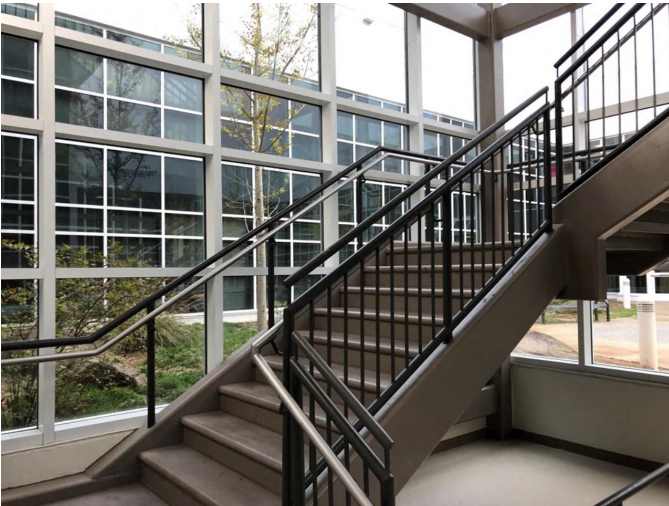
System: C3020999 - Other - Concrete Finish w/Sealer

Location: 1979 Bldg 401.1
Distress: Beyond Expected Life
Category: Deferred Maintenance
Priority: 3 - Necessary (Years 2-5)
Correction: Renew System
Qty: 114.00
Unit of Measure: S.F.
Estimate: \$862.00
Assessor Name: Eduardo Lopez
Date Created: 10/08/2020

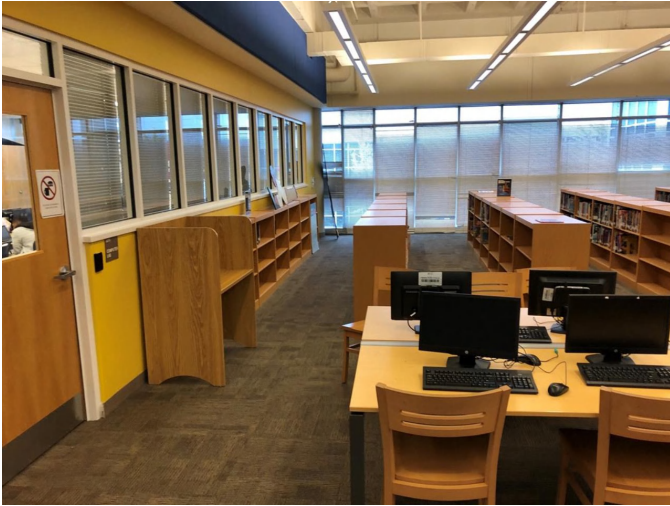
System: C3020901 - Carpet

Location: 2014 Bldg 4010
Distress: Beyond Expected Life
Category: Deferred Maintenance
Priority: 3 - Necessary (Years 2-5)
Correction: Renew System
Qty: 2,000.00
Unit of Measure: S.F.
Estimate: \$16,500.00
Assessor Name: Eduardo Lopez
Date Created: 10/08/2020

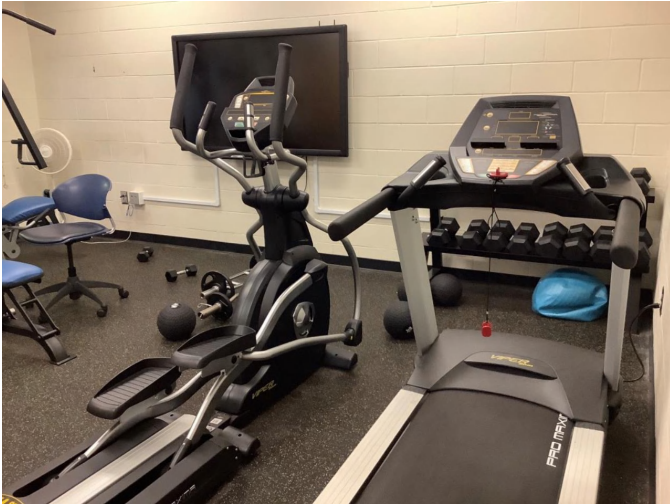
System: C3020999 - Other - Rubber or Neoprene

Location: 2014 Bldg 4010
Distress: Beyond Expected Life
Category: Deferred Maintenance
Priority: 3 - Necessary (Years 2-5)
Correction: Renew System
Qty: 1,000.00
Unit of Measure: S.F.
Estimate: \$29,337.00
Assessor Name: Eduardo Lopez
Date Created: 10/08/2020
