Atlanta Public Schools/ Carver Cluster

Carver High School

School Assessment Report

November 10, 2020

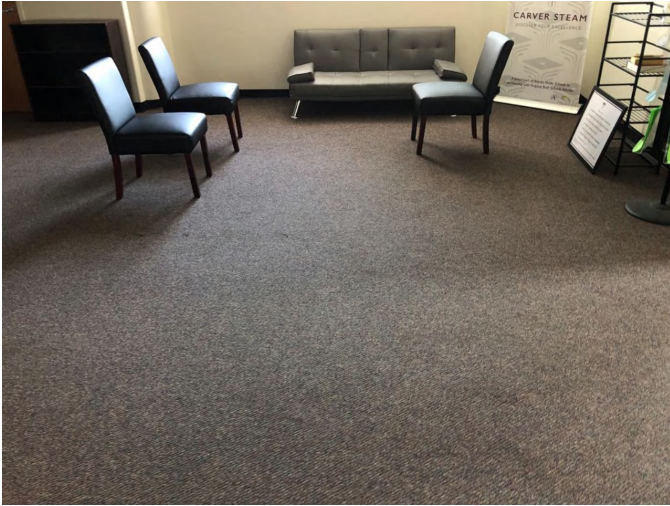
System: C3020901 - Carpet

Location: Throughout Building
Distress: Beyond Expected Life
Category: Deferred Maintenance
Priority: 3 - Necessary (Years 2-5)
Correction: Renew System
Qty: 6,837.00
Unit of Measure: S.F.
Estimate: \$56,405.00
Assessor Name: Eduardo Lopez
Date Created: 12/31/2019

Notes: The carpeted floor finish in the administrative sections of the building are warn and recommended for upgrade.

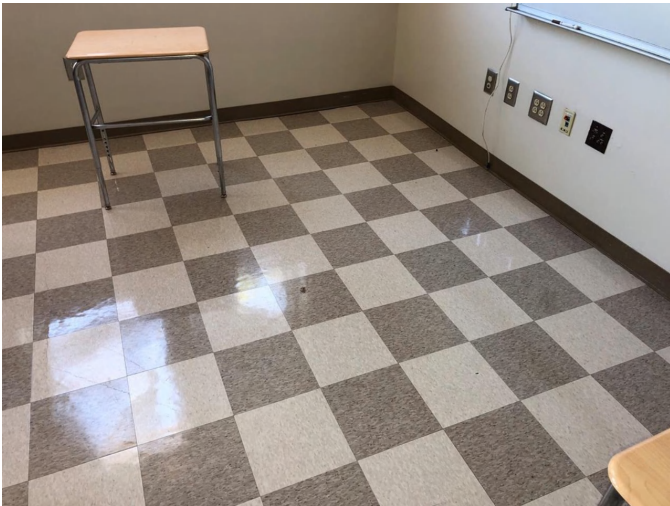
System: C3020903 - VCT

Location: 1920 Bldg 5010
Distress: Beyond Expected Life
Category: Deferred Maintenance
Priority: 3 - Necessary (Years 2-5)
Correction: Renew System
Qty: 23,952.00
Unit of Measure: S.F.
Estimate: \$129,197.00
Assessor Name: Eduardo Lopez
Date Created: 10/08/2020

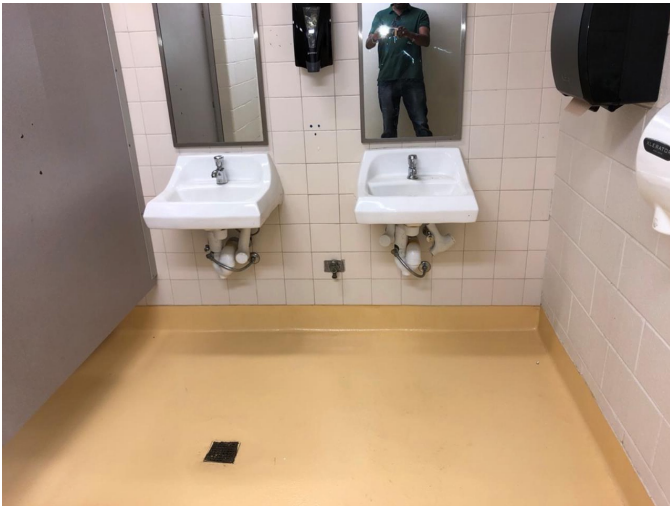
System: C3020999 - Other - Vinyl Sheet

Location: 1920 Bldg 5010
Distress: Beyond Expected Life
Category: Deferred Maintenance
Priority: 3 - Necessary (Years 2-5)
Correction: Renew System
Qty: 813.00
Unit of Measure: S.F.
Estimate: \$6,341.00
Assessor Name: Eduardo Lopez
Date Created: 10/08/2020

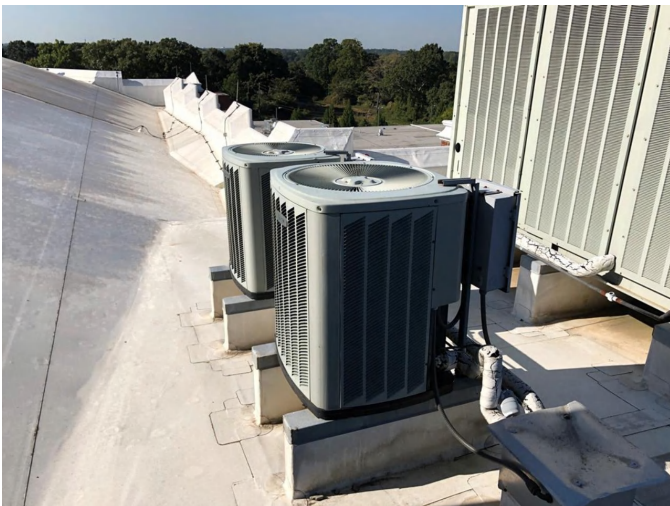
System: D3050 - Terminal & Package Units

Location: 1920 Bldg 5010
Distress: Beyond Expected Life
Category: Deferred Maintenance
Priority: 3 - Necessary (Years 2-5)
Correction: Renew System
Qty: 34,216.00
Unit of Measure: S.F.
Estimate: \$630,053.00
Assessor Name: Eduardo Lopez
Date Created: 10/08/2020

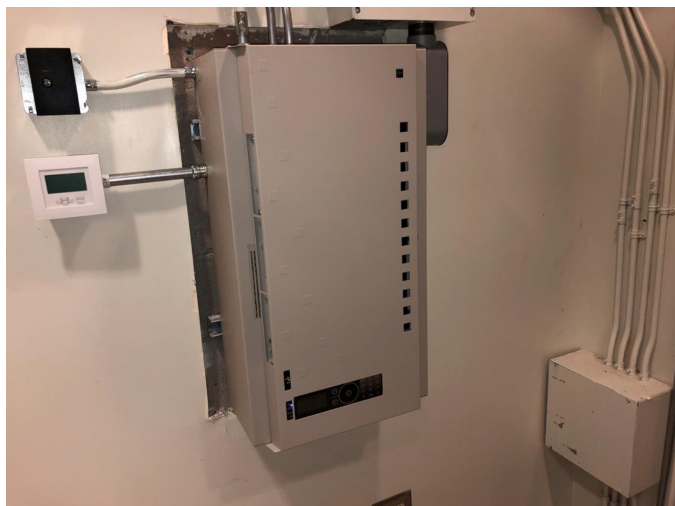
System: D3060 - Controls & Instrumentation

Location: 1920 Bldg 5010
Distress: Beyond Expected Life
Category: Deferred Maintenance
Priority: 3 - Necessary (Years 2-5)
Correction: Renew System
Qty: 34,216.00
Unit of Measure: S.F.
Estimate: \$85,814.00
Assessor Name: Eduardo Lopez
Date Created: 10/08/2020

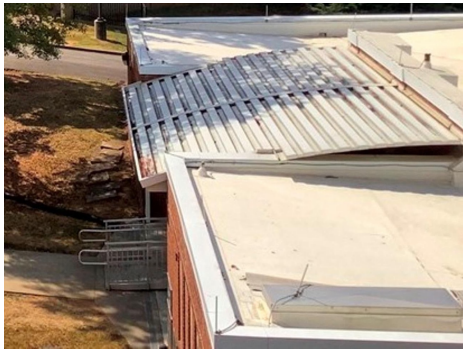
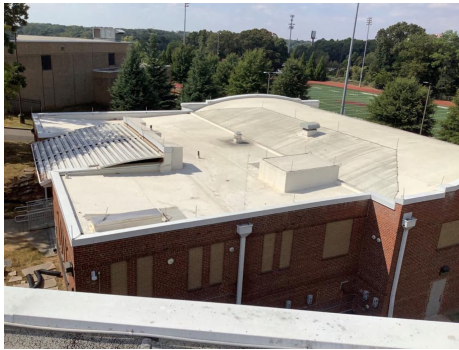
System: B3020 - Roof Openings

Note: Pics were taken from another building because they did not have access to the roof at the time of the inspection

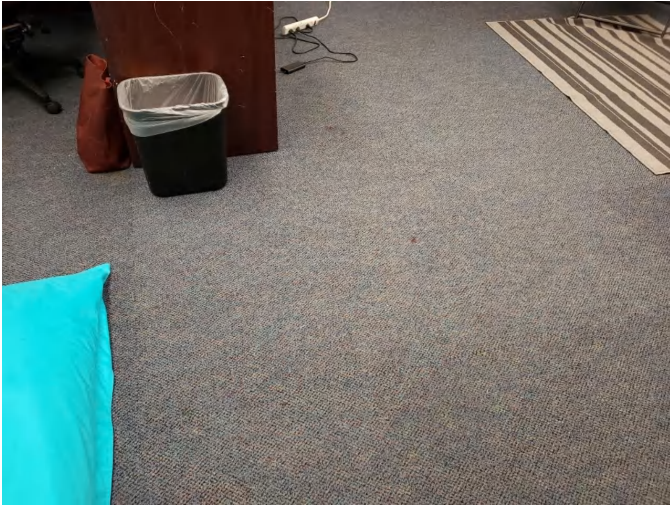
System: C3020901 - Carpet

Location: Different office areas throughout building
Distress: Beyond Expected Life
Category: Deferred Maintenance
Priority: 3 - Necessary (Years 2-5)
Correction: Renew System
Qty: 2,602.00
Unit of Measure: S.F.
Estimate: \$21,467.00
Assessor Name: Eduardo Lopez
Date Created: 01/03/2020

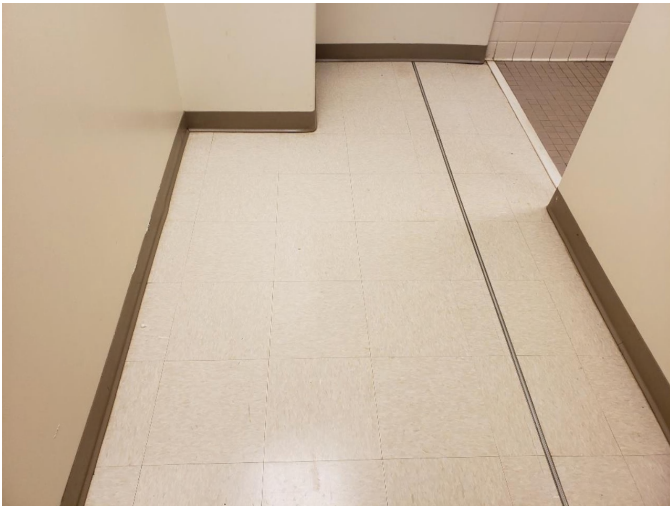
System: C3020903 - VCT

Location: 1947 Bldg 503.1
Distress: Beyond Expected Life
Category: Deferred Maintenance
Priority: 3 - Necessary (Years 2-5)
Correction: Renew System
Qty: 9,358.00
Unit of Measure: S.F.
Estimate: \$50,477.00
Assessor Name: Eduardo Lopez
Date Created: 10/08/2020

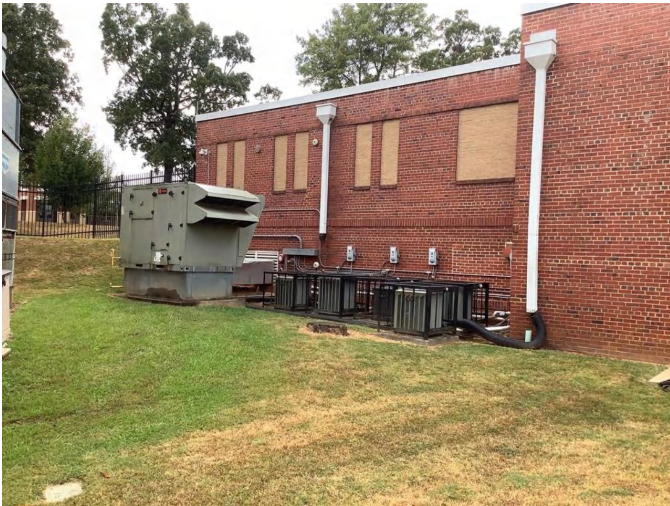
System: D3050 - Terminal & Package Units

Location: 1947 Bldg 503.1
Distress: Beyond Expected Life
Category: Deferred Maintenance
Priority: 3 - Necessary (Years 2-5)
Correction: Renew System
Qty: 13,498.00
Unit of Measure: S.F.
Estimate: \$250,631.00
Assessor Name: Eduardo Lopez
Date Created: 10/08/2020

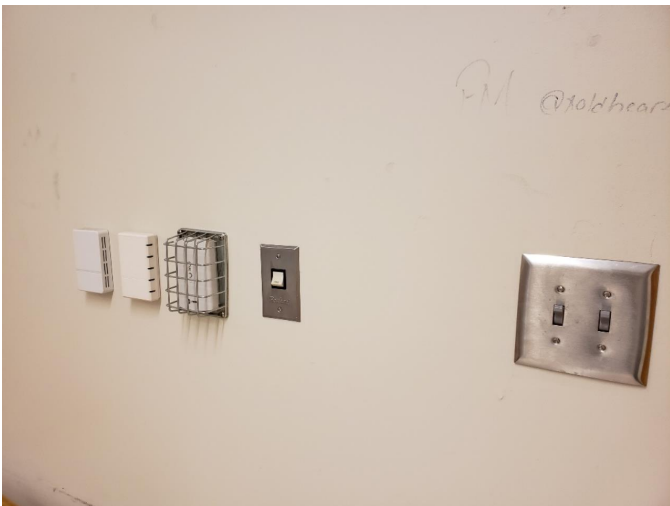
System: D3060 - Controls & Instrumentation

Location: 1947 Bldg 503.1
Distress: Beyond Expected Life
Category: Deferred Maintenance
Priority: 3 - Necessary (Years 2-5)
Correction: Renew System
Qty: 13,498.00
Unit of Measure: S.F.
Estimate: \$34,001.00
Assessor Name: Eduardo Lopez
Date Created: 10/08/2020

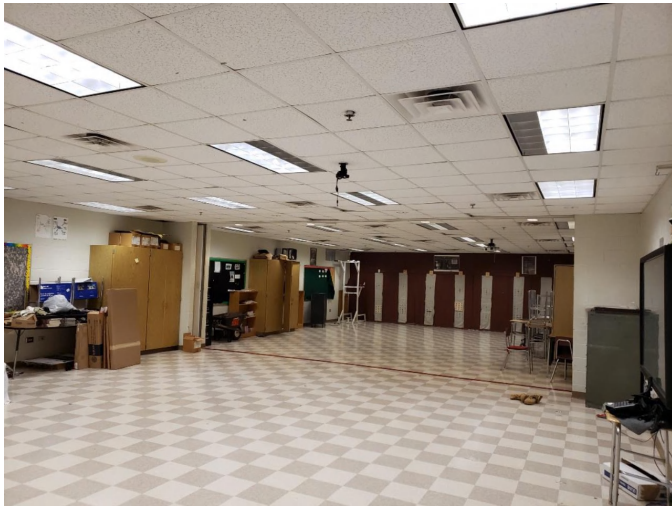
System: C3020903 - VCT

Location: 1970_2005 Bldg 507.6_5070
Distress: Beyond Expected Life
Category: Deferred Maintenance
Priority: 3 - Necessary (Years 2-5)
Correction: Renew System
Qty: 28,583.00
Unit of Measure: S.F.
Estimate: \$154,177.00
Assessor Name: Eduardo Lopez
Date Created: 10/08/2020

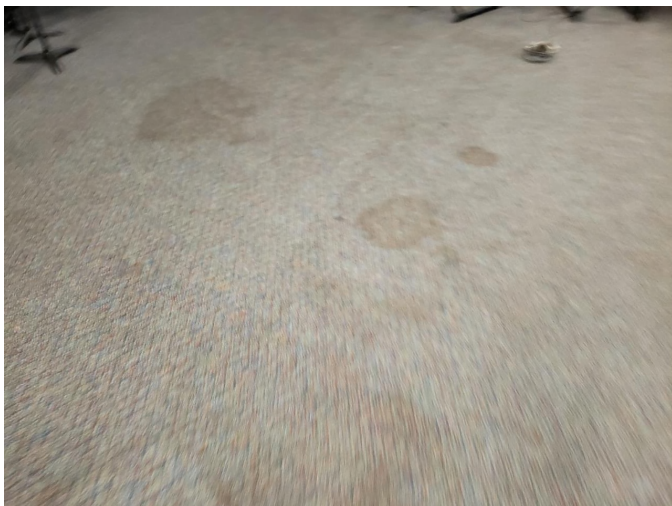
System: C3020999 - Other - Carpet

Location: Chorus room and throughout different areas in the building
Distress: Beyond Expected Life
Category: Deferred Maintenance
Priority: 3 - Necessary (Years 2-5)
Correction: Renew System
Qty: 3,210.00
Unit of Measure: S.F.
Estimate: \$26,483.00
Assessor Name: Eduardo Lopez
Date Created: 01/03/2020

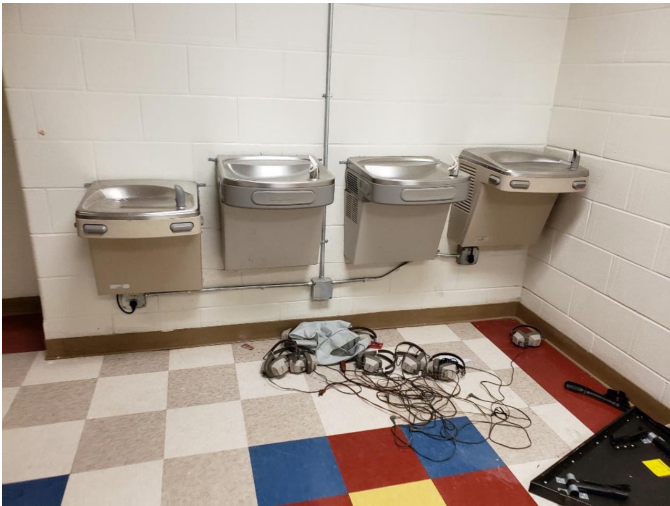
System: D2020 - Domestic Water Distribution

Location: Gym
Distress: Beyond Expected Life
Category: Deferred Maintenance
Priority: 3 - Necessary (Years 2-5)
Correction: Renew System
Qty: 52,059.00
Unit of Measure: S.F.
Estimate: \$43,521.00
Assessor Name: Eduardo Lopez
Date Created: 08/27/2013

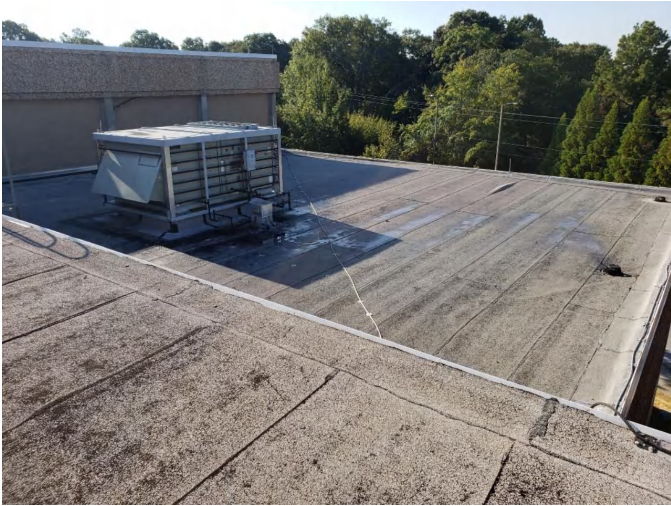
System: D3050 - Terminal & Package Units

Location: 1970_2005 Bldg 507.6_5070
Distress: Beyond Expected Life
Category: Deferred Maintenance
Priority: 3 - Necessary (Years 2-5)
Correction: Renew System
Qty: 52,059.00
Unit of Measure: S.F.
Estimate: \$768,495.00
Assessor Name: Eduardo Lopez
Date Created: 10/08/2020

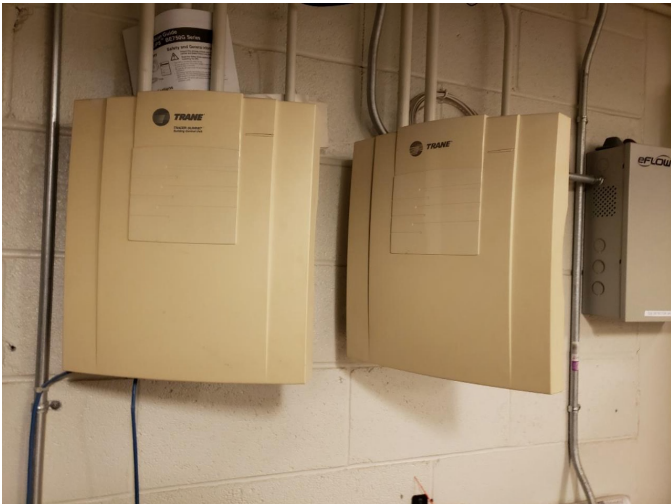
System: D3060 - Controls & Instrumentation

Location: 1970_2005 Bldg 507.6_5070
Distress: Beyond Expected Life
Category: Deferred Maintenance
Priority: 3 - Necessary (Years 2-5)
Correction: Renew System
Qty: 52,059.00
Unit of Measure: S.F.
Estimate: \$132,855.00
Assessor Name: Eduardo Lopez
Date Created: 10/08/2020

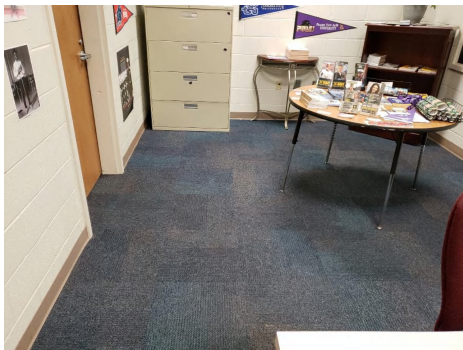
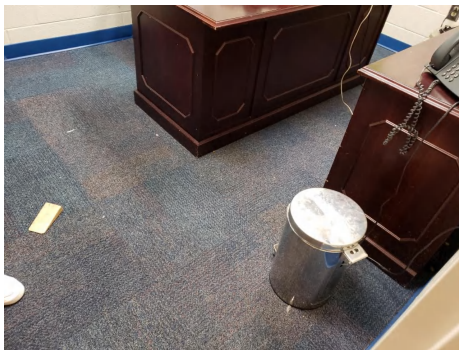
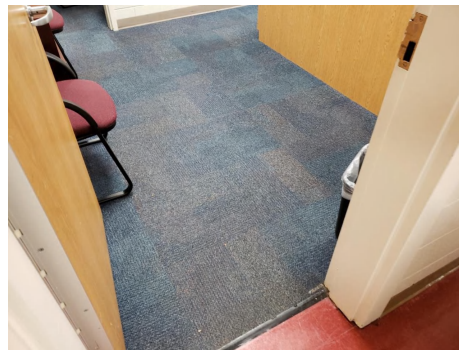
System: C3020901 - Carpet

Notes: The carpet is aged, worn and stained, and should be replaced.

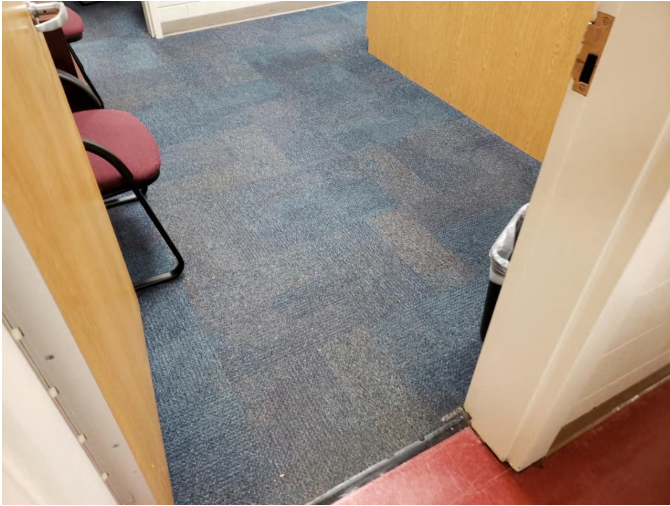
System: C3020901 - Carpet

Location: Different office areas throughout building
Distress: Beyond Expected Life
Category: Deferred Maintenance
Priority: 3 - Necessary (Years 2-5)
Correction: Renew System
Qty: 9,766.00
Unit of Measure: S.F.
Estimate: \$80,570.00
Assessor Name: Eduardo Lopez
Date Created: 01/06/2020

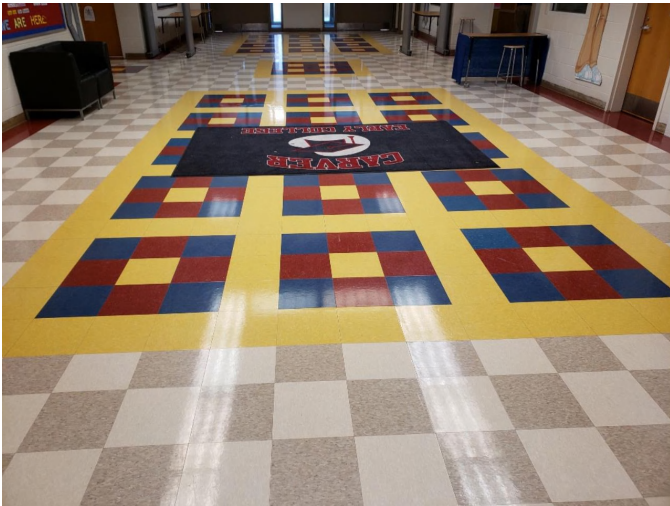
System: C3020903 - VCT

Location: 2005 Bldg 5040
Distress: Beyond Expected Life
Category: Deferred Maintenance
Priority: 3 - Necessary (Years 2-5)
Correction: Renew System
Qty: 60,360.00
Unit of Measure: S.F.
Estimate: \$325,582.00
Assessor Name: Eduardo Lopez
Date Created: 10/08/2020

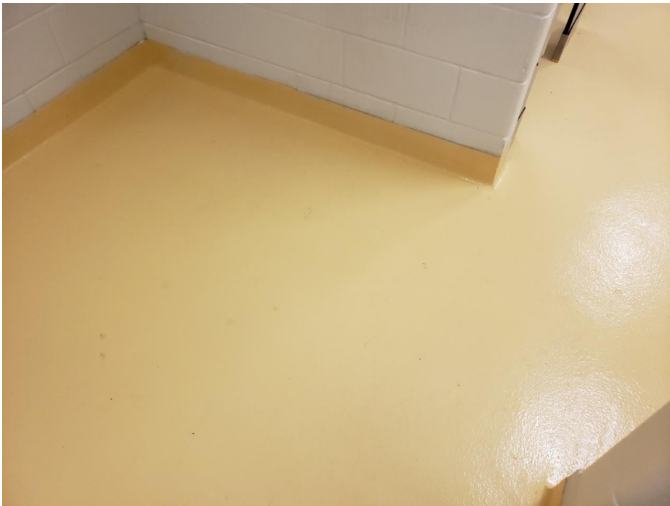
System: C3020999 - Other - Vinyl Sheet

Location: 2005 Bldg 5040
Distress: Beyond Expected Life
Category: Deferred Maintenance
Priority: 3 - Necessary (Years 2-5)
Correction: Renew System
Qty: 2,168.00
Unit of Measure: S.F.
Estimate: \$16,908.00
Assessor Name: Eduardo Lopez
Date Created: 10/08/2020

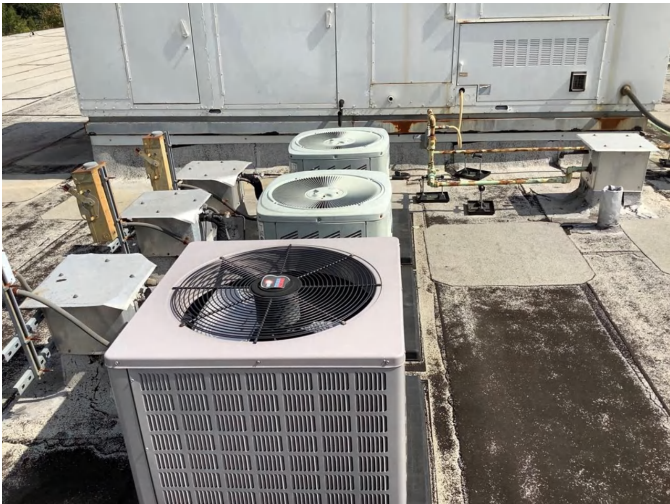
System: D3050 - Terminal & Package Units

Location: 2005 Bldg 5040
Distress: Beyond Expected Life
Category: Deferred Maintenance
Priority: 3 - Necessary (Years 2-5)
Correction: Renew System
Qty: 73,974.00
Unit of Measure: S.F.
Estimate: \$540,306.00
Assessor Name: Eduardo Lopez
Date Created: 10/08/2020

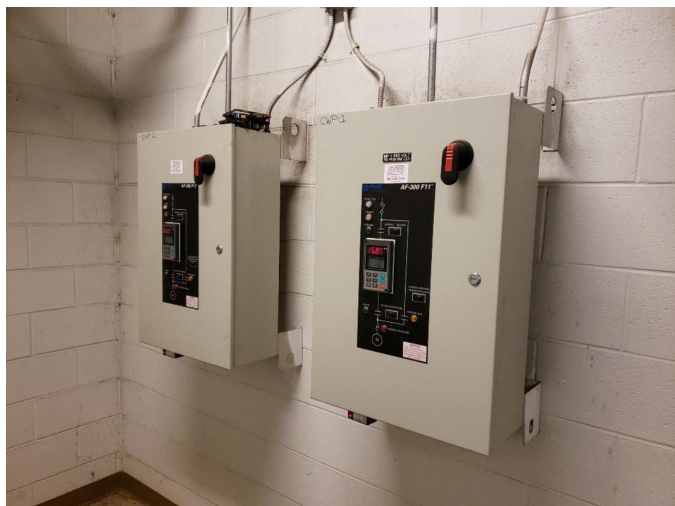
System: D3060 - Controls & Instrumentation

Location: 2005 Bldg 5040

Distress: Beyond Expected Life

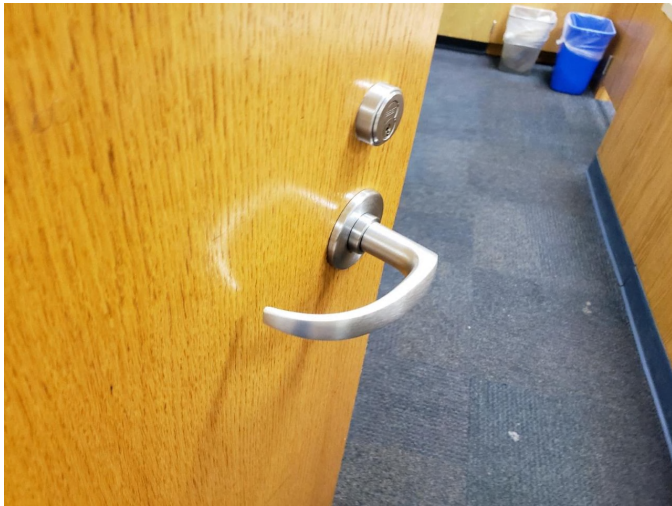
Location: Throughout Building
Distress: Beyond Expected Life
Category: Deferred Maintenance
Priority: 3 - Necessary (Years 2-5)
Correction: Renew System
Qty: 1,881.00
Unit of Measure: S.F.
Estimate: \$15,518.00
Assessor Name: Eduardo Lopez
Date Created: 01/06/2020

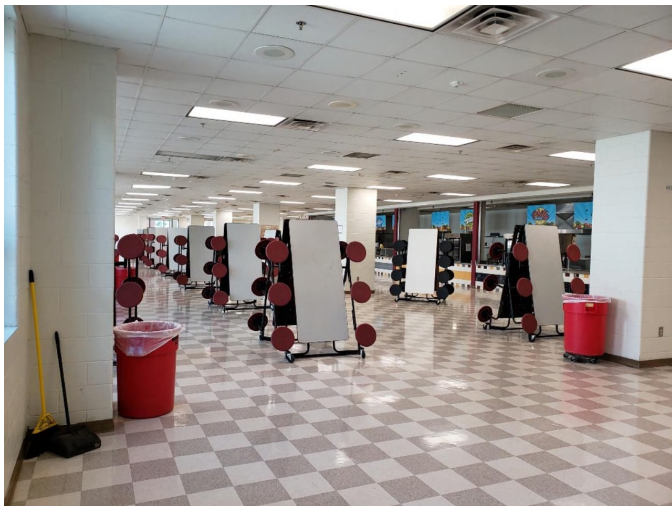
Location: 2005 Bldg 5050
Distress: Beyond Expected Life
Category: Deferred Maintenance
Priority: 3 - Necessary (Years 2-5)
Correction: Renew System
Qty: 80,015.00
Unit of Measure: S.F.
Estimate: \$431,601.00
Assessor Name: Eduardo Lopez
Date Created: 10/08/2020

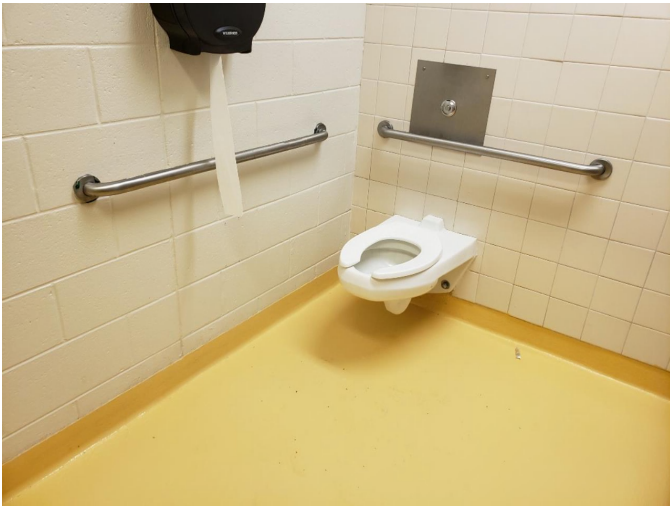
System: C3020999 - Other - Vinyl Sheet

Location: 2005 Bldg 5050
Distress: Beyond Expected Life
Category: Deferred Maintenance
Priority: 3 - Necessary (Years 2-5)
Correction: Renew System
Qty: 6,936.00
Unit of Measure: S.F.
Estimate: \$54,094.00
Assessor Name: Eduardo Lopez
Date Created: 10/08/2020

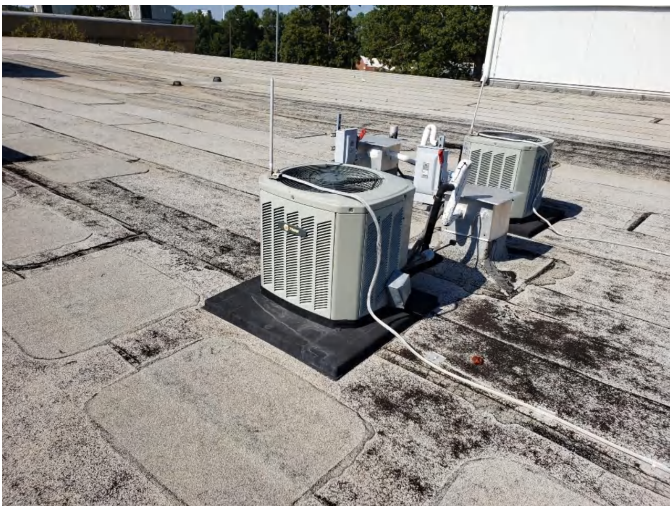
System: D3050 - Terminal & Package Units

Location: 2005 Bldg 5050
Distress: Beyond Expected Life
Category: Deferred Maintenance
Priority: 3 - Necessary (Years 2-5)
Correction: Renew System
Qty: 94,989.00
Unit of Measure: S.F.
Estimate: \$695,889.00
Assessor Name: Eduardo Lopez
Date Created: 10/08/2020

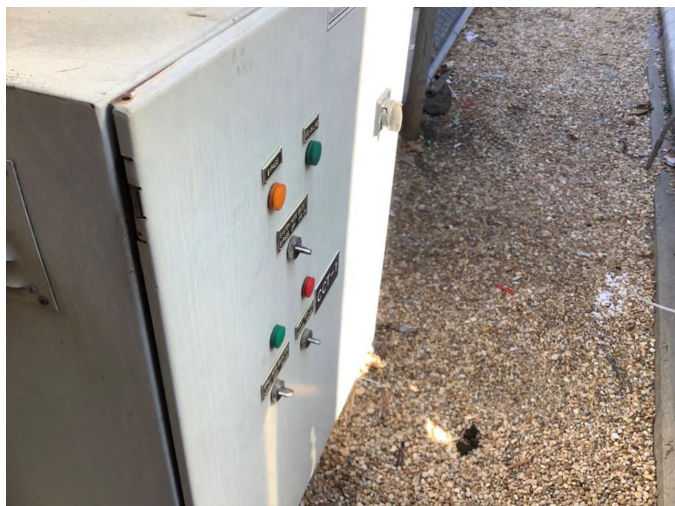
System: D3060 - Controls & Instrumentation

Location: 2005 Bldg 5050
Distress: Beyond Expected Life
Category: Deferred Maintenance
Priority: 3 - Necessary (Years 2-5)
Correction: Renew System
Qty: 94,989.00
Unit of Measure: S.F.
Estimate: \$229,873.00
Assessor Name: Eduardo Lopez
Date Created: 10/08/2020

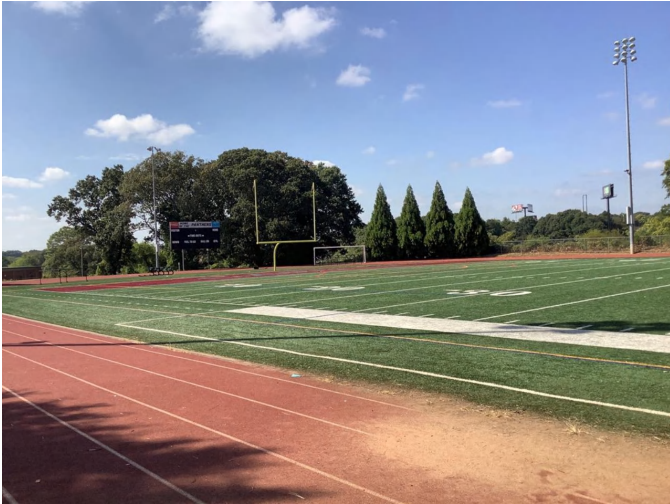
Location: outside around the football/soccer field
Distress: Beyond Expected Life
Category: Deferred Maintenance
Priority: 3 - Necessary (Years 2-5)
Correction: Renew System
Qty: 271,429.00
Unit of Measure: S.F.
Estimate: \$501,601.00
Assessor Name: Jejuan Hall
Date Created: 01/08/2020
