Atlanta Public Schools/Charter Schools

# Centennial Place ES (Centennial Place Academy)

## School Assessment Report

November 10, 2020

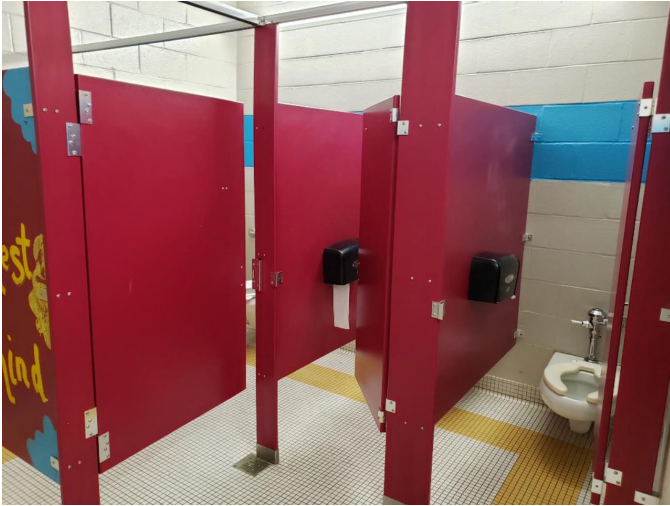
#### System: C1030 - Fittings

**Location:** Throughout Building  
**Distress:** Beyond Expected Life  
**Category:** Deferred Maintenance  
**Priority:** 3 - Necessary (Years 2-5)  
**Correction:** Renew System  
**Qty:** 63,806.00  
**Unit of Measure:** S.F.  
**Estimate:** \$209,156.00  
**Assessor Name:** Eduardo Lopez  
**Date Created:** 10/09/2020

**Notes:** The fittings throughout the building are aged, in marginal condition, and should be replaced to include room signage with Braille per ADA standards.

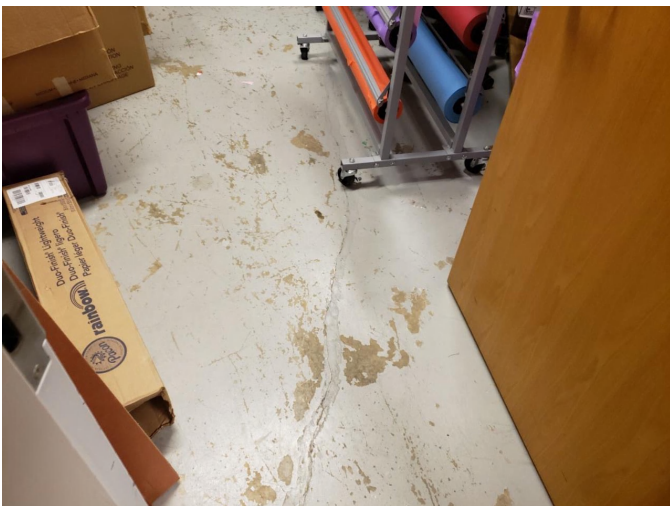
#### System: C3020405 - Epoxy

**Location:** Throughout Building  
**Distress:** Beyond Expected Life  
**Category:** Deferred Maintenance  
**Priority:** 3 - Necessary (Years 2-5)  
**Correction:** Renew System  
**Qty:** 2,470.00  
**Unit of Measure:** S.F.  
**Estimate:** \$50,423.00  
**Assessor Name:** Eduardo Lopez  
**Date Created:** 01/30/2020

**Notes:** The epoxy flooring system is beyond its expected service life and should be scheduled for replacement.
