Atlanta Public Schools/Relocation Sites

Connally Elementary School

School Assessment Report

November 10, 2020

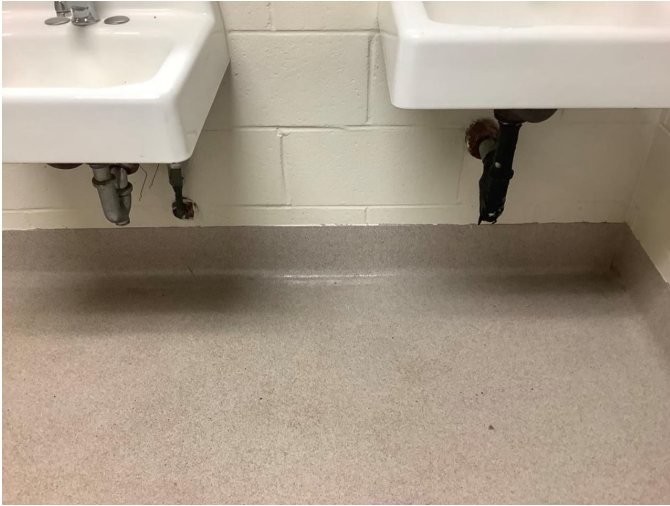
System: C3020405 - Epoxy

Location: Restrooms
Distress: Beyond Expected Life
Category: Deferred Maintenance
Priority: 3 - Necessary (Years 2-5)
Correction: Renew System
Qty: 2,000.00
Unit of Measure: S.F.
Estimate: \$40,828.00
Assessor Name: Eduardo Lopez
Date Created: 01/10/2020

Notes: The Epoxy floor finish is beyond its expected service life, worn and damaged, and is recommended for replacement.

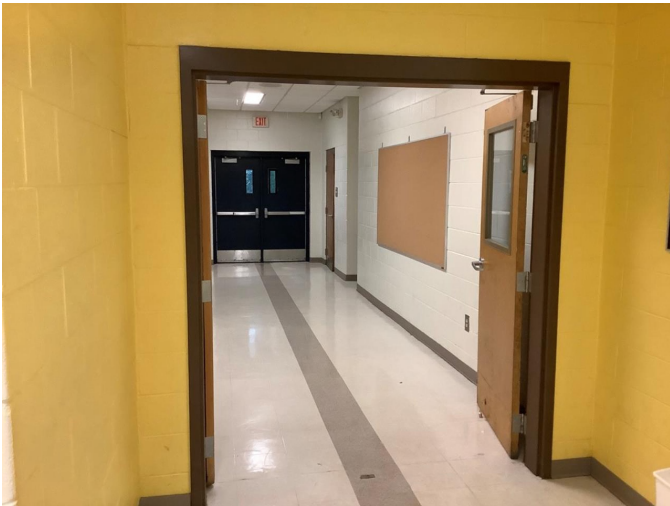
System: C3020903 - VCT

Location: Throughout building
Distress: Beyond Expected Life
Category: Deferred Maintenance
Priority: 3 - Necessary (Years 2-5)
Correction: Renew System
Qty: 65,215.00
Unit of Measure: S.F.
Estimate: \$351,770.00
Assessor Name: Eduardo Lopez
Date Created: 01/10/2020

Notes: The VCT floor finish is beyond its expected service life, worn and damaged, and is recommended for replacement.

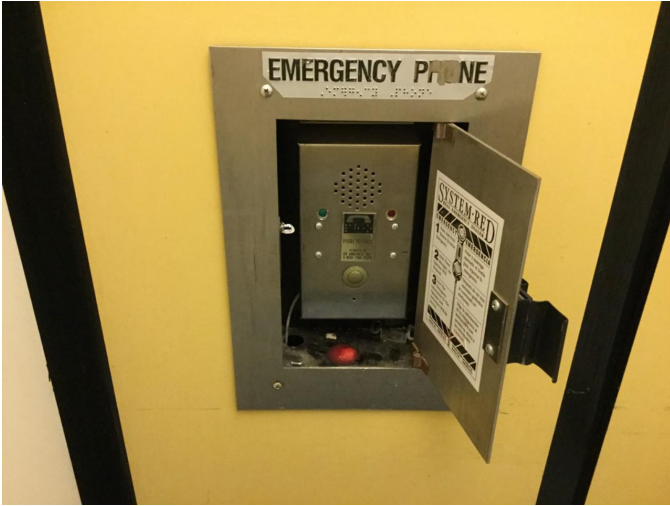
System: D1010 - Elevators and Lifts

Location: Elevator
Distress: Beyond Expected Life
Category: Deferred Maintenance
Priority: 3 - Necessary (Years 2-5)
Correction: Renew System
Qty: 67,215.00
Unit of Measure: S.F.
Estimate: \$97,596.00
Assessor Name: Eduardo Lopez
Date Created: 09/17/2015

Notes: The elevator system is from original construction. The design was prior to any consideration for ADA standards. The elevator system has exceeded its life cycle and recommended for upgrade. All aspects of the current ADA standards are expected to be included in the new installation.

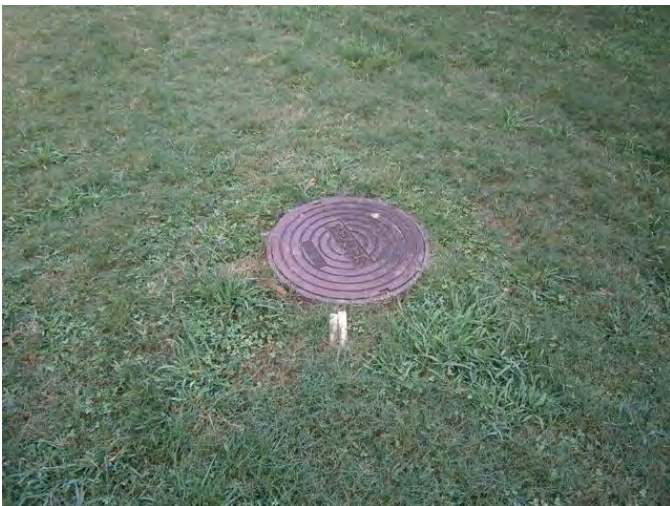
System: D2030 - Sanitary Waste

Location: Throughout Building
Distress: Beyond Expected Life
Category: Deferred Maintenance
Priority: 3 - Necessary (Years 2-5)
Correction: Renew System
Qty: 67,215.00
Unit of Measure: S.F.
Estimate: \$133,086.00
Assessor Name: Eduardo Lopez
Date Created: 08/30/2013

Notes: The sanitary waste piping is original to the building's construction. There were no reported issues during the time of the inspection; however, this system is recommended for upgrade based on age.

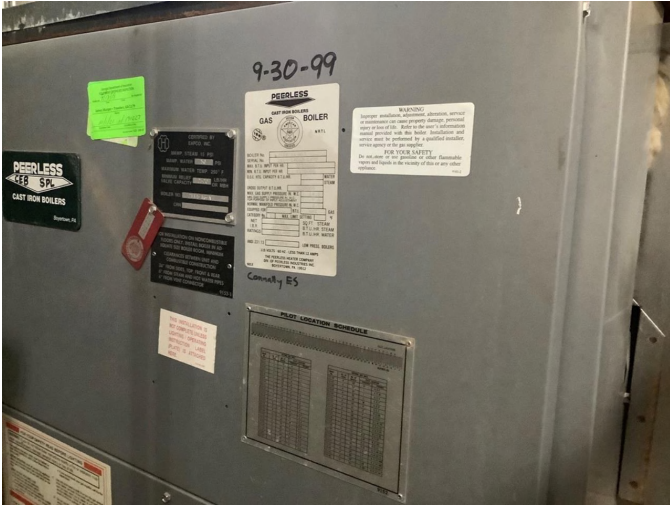
System: D3020 - Heat Generating Systems

Location: Throughout Building
Distress: Beyond Expected Life
Category: Deferred Maintenance
Priority: 3 - Necessary (Years 2-5)
Correction: Renew System
Qty: 67,215.00
Unit of Measure: S.F.
Estimate: \$280,959.00
Assessor Name: Eduardo Lopez
Date Created: 10/06/2020

Notes: The heat generating system is beyond its expected service life and should be scheduled for replacement.

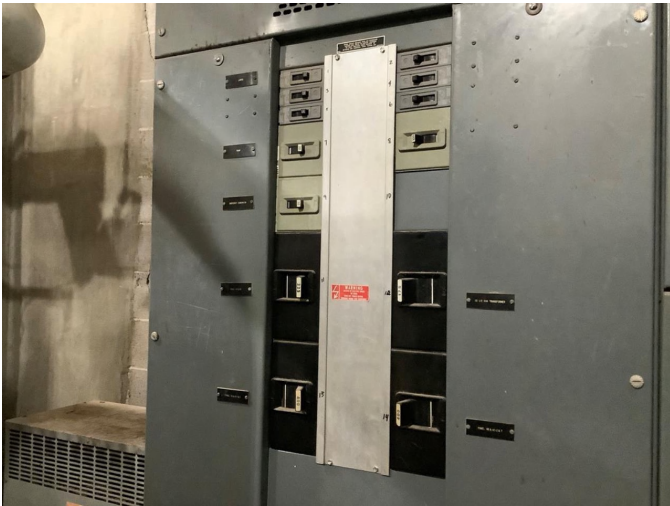
System: D5010 - Electrical Service/Distribution

Location: Throughout building
Distress: Beyond Expected Life
Category: Deferred Maintenance
Priority: 3 - Necessary (Years 2-5)
Correction: Renew System
Qty: 67,215.00
Unit of Measure: S.F.
Estimate: \$178,926.00
Assessor Name: Eduardo Lopez
Date Created: 02/22/2020

The Federal Pacific electrical service and distribution system consist of a service disconnect, primary main rated at 2000 amps, breaker system, (This system is under recall) and switch box, and conduit and wiring to equipment, interior and exterior lights. This system is a mix of the old and new. Some of the system was recently upgraded; however, a majority of the system is original. This system should be scheduled for replacement and upgrade in conjunction with other recommended renovations.

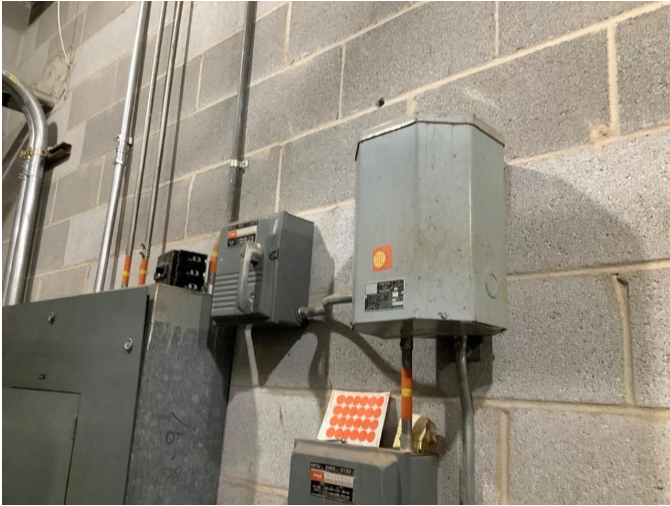
System: D5020 - Branch Wiring

Location: Throughout Building
Distress: Beyond Expected Life
Category: Deferred Maintenance
Priority: 3 - Necessary (Years 2-5)
Correction: Renew System
Qty: 67,215.00
Unit of Measure: S.F.
Estimate: \$348,241.00
Assessor Name: Eduardo Lopez
Date Created: 01/13/2020

Notes: Most of the branch wiring system appears to be from the original construction. The system is showing signs of age and environmental damage and should be scheduled for replacement and upgrade in conjunction with other recommended renovations.

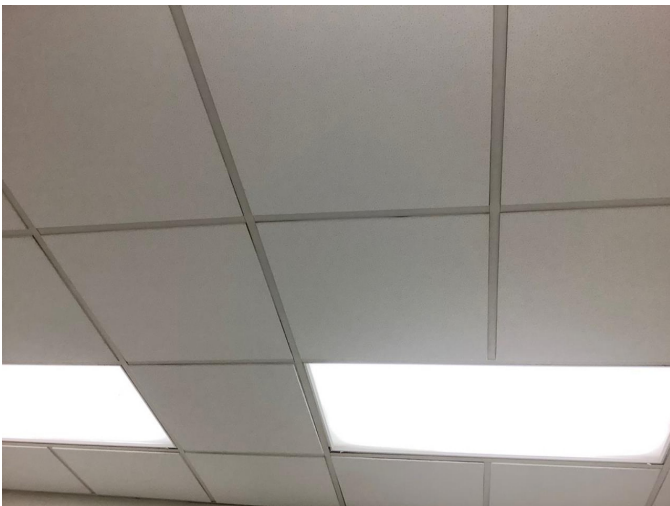
System: D5020 - Lighting

Location: Throughout building
Distress: Beyond Expected Life
Category: Deferred Maintenance
Priority: 3 - Necessary (Years 2-5)
Correction: Renew System
Qty: 67,215.00
Unit of Measure: S.F.
Estimate: \$521,992.00
Assessor Name: Eduardo Lopez
Date Created: 01/14/2020

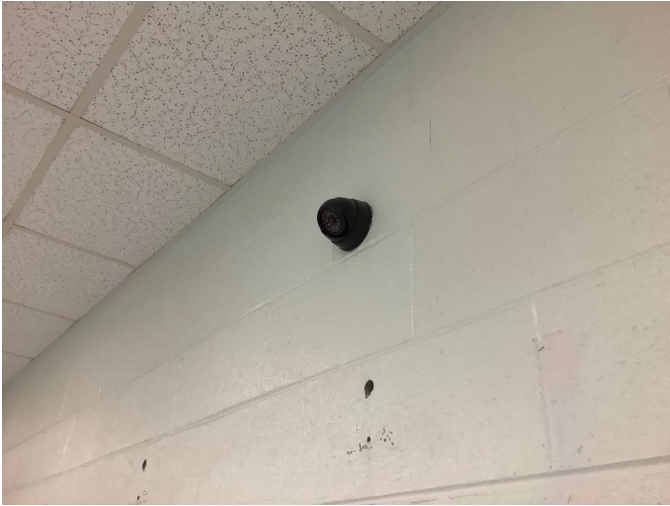
System: D5030810 - Security & Detection Systems

Location: Throughout building
Distress: Beyond Expected Life
Category: Deferred Maintenance
Priority: 3 - Necessary (Years 2-5)
Correction: Renew System
Qty: 67,215.00
Unit of Measure: S.F.
Estimate: \$111,644.00
Assessor Name: Eduardo Lopez
Date Created: 01/14/2020

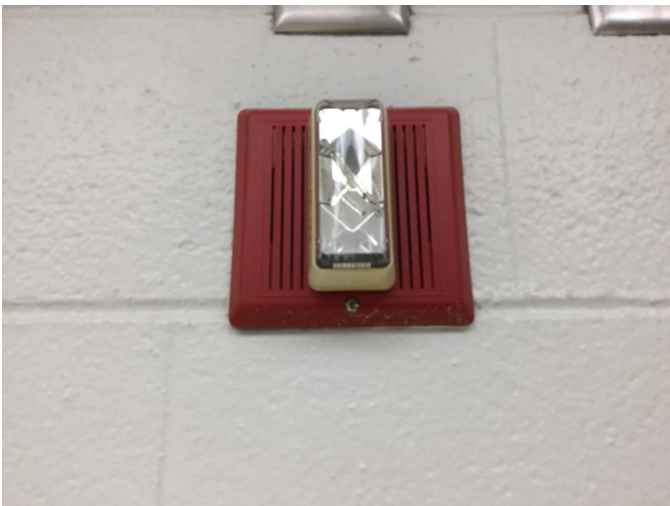
System: D5030910 - Fire Alarm Systems

Location: Throughout building
Distress: Beyond Expected Life
Category: Deferred Maintenance
Priority: 3 - Necessary (Years 2-5)
Correction: Renew System
Qty: 67,215.00
Unit of Measure: S.F.
Estimate: \$202,586.00
Assessor Name: Eduardo Lopez
Date Created: 01/14/2020

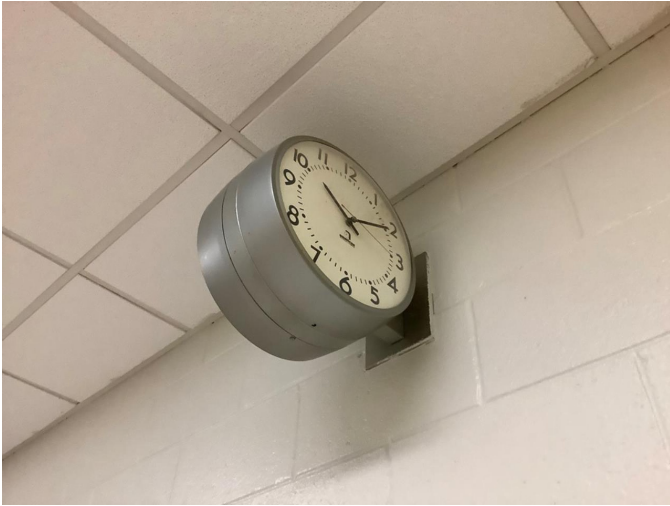
System: D5030920 - Data Communication

Location: Throughout building
Distress: Beyond Expected Life
Category: Deferred Maintenance
Priority: 3 - Necessary (Years 2-5)
Correction: Renew System
Qty: 67,215.00
Unit of Measure: S.F.
Estimate: \$263,214.00
Assessor Name: Eduardo Lopez
Date Created: 01/14/2020

This facility has a data communications system that provides access to the internet. The system is beyond its service life and a new data system is recommended.

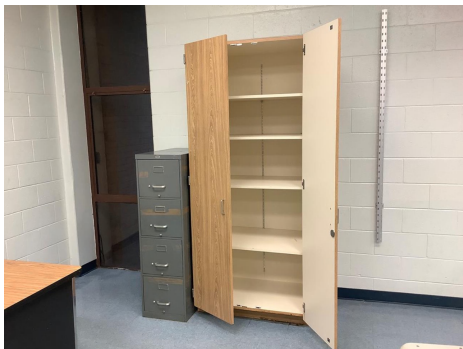
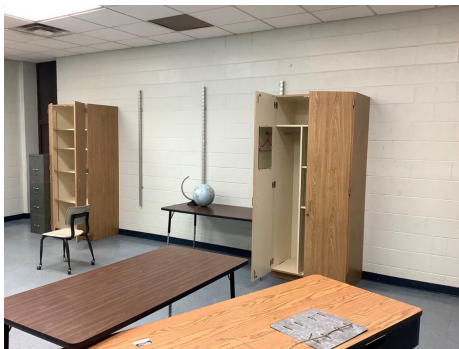
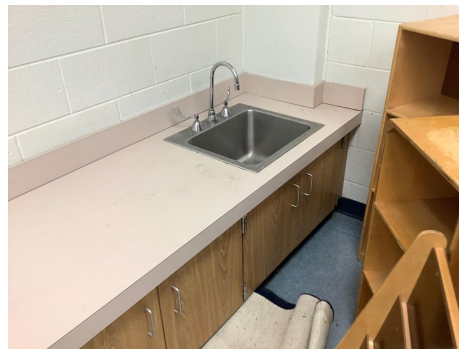
System: E2010 - Fixed Furnishings

Fixed furnishings are aged, worn and damaged, and should be scheduled for replacement.

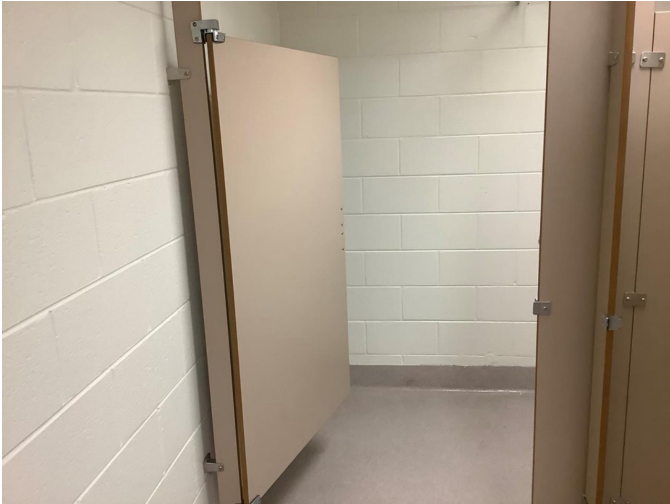
System: C1030 - Fittings

Location: Throughout building
Distress: Beyond Expected Life
Category: ADA Compliance
Priority: 3 - Necessary (Years 2-5)
Correction: Renew System
Qty: 2,607.00
Unit of Measure: S.F.
Estimate: \$7,599.00
Assessor Name: Eduardo Lopez
Date Created: 02/22/2020

Fittings, such as toilet partitions, signage and railing, are beyond their expected service life, worn and damaged in areas, and should be replaced and upgraded for compliance with ADA standards.

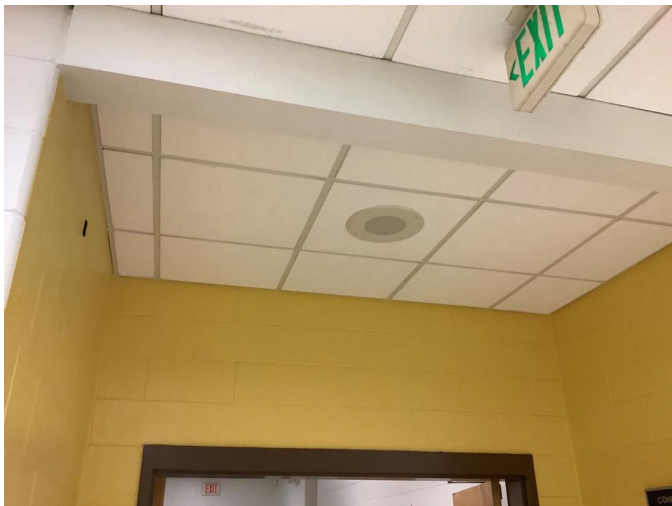
System: C3030 - Ceiling Finishes

Location: Throughout building
Distress: Beyond Expected Life
Category: Deferred Maintenance
Priority: 3 - Necessary (Years 2-5)
Correction: Renew System
Qty: 2,607.00
Unit of Measure: S.F.
Estimate: \$25,809.00
Assessor Name: Eduardo Lopez
Date Created: 02/22/2020

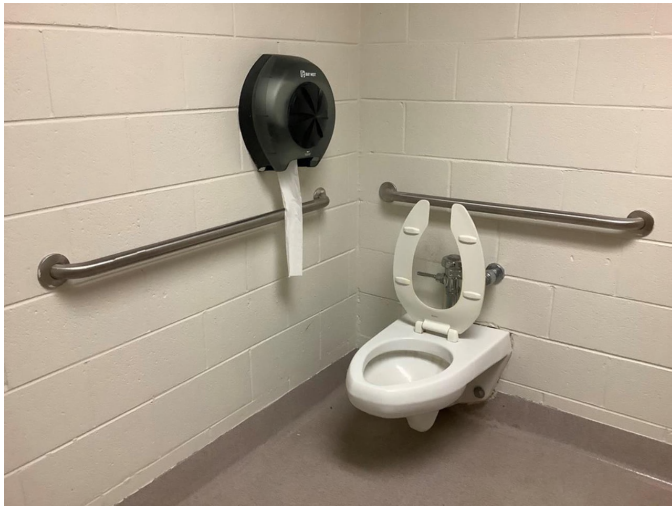
System: D2010 - Plumbing Fixtures

Location: Restrooms
Distress: Beyond Expected Life
Category: ADA Compliance
Priority: 3 - Necessary (Years 2-5)
Correction: Renew System
Qty: 2,607.00
Unit of Measure: S.F.
Estimate: \$18,267.00
Assessor Name: Eduardo Lopez
Date Created: 08/13/2014

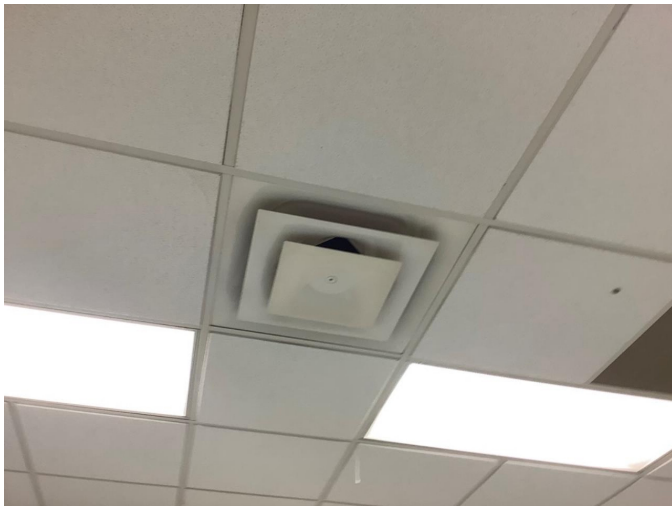
System: D3040 - Distribution Systems

Location: Throughout Building
Distress: Beyond Expected Life
Category: Deferred Maintenance
Priority: 3 - Necessary (Years 2-5)
Correction: Renew System
Qty: 2,607.00
Unit of Measure: S.F.
Estimate: \$30,455.00
Assessor Name: Eduardo Lopez
Date Created: 10/06/2020

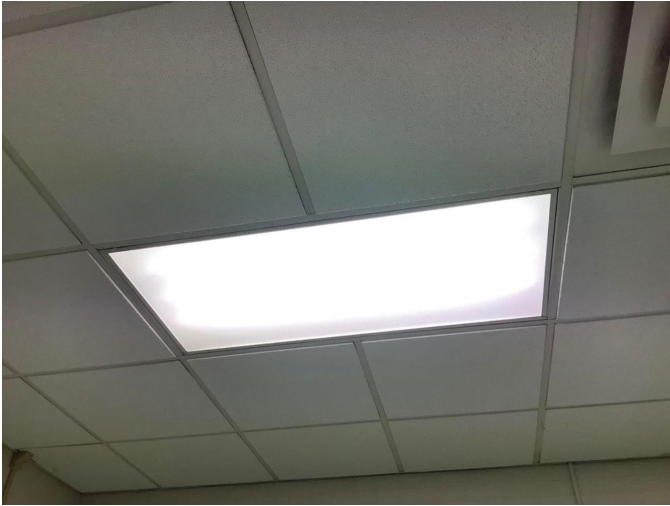
System: D5020 - Branch Wiring

Location: Throughout Building
Distress: Beyond Expected Life
Category: Deferred Maintenance
Priority: 3 - Necessary (Years 2-5)
Correction: Renew System
Qty: 2,607.00
Unit of Measure: S.F.
Estimate: \$12,847.00
Assessor Name: Eduardo Lopez
Date Created: 08/13/2014

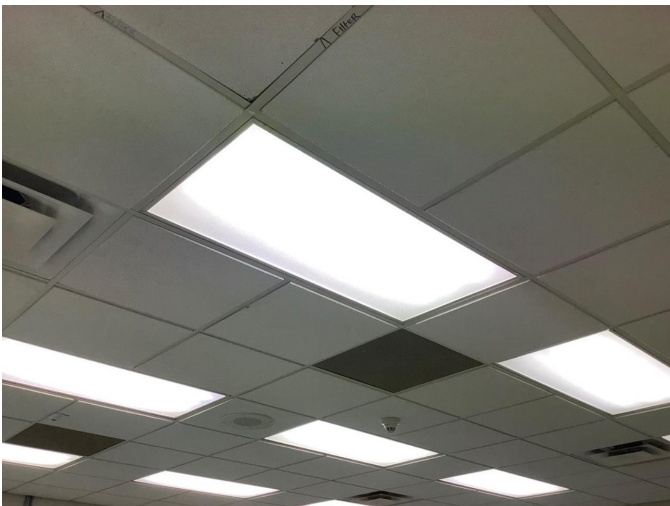
System: D5020 - Lighting

Location: Throughout Building
Distress: Beyond Expected Life
Category: Deferred Maintenance
Priority: 3 - Necessary (Years 2-5)
Correction: Renew System
Qty: 2,607.00
Unit of Measure: S.F.
Estimate: \$19,242.00
Assessor Name: Eduardo Lopez
Date Created: 01/13/2020

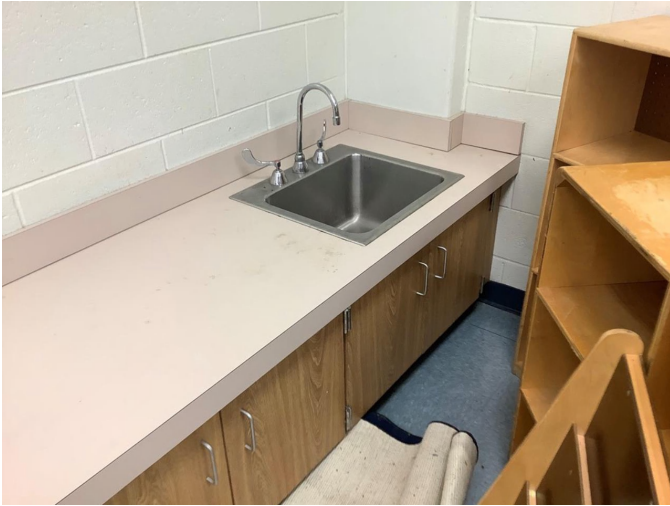
System: E2010 - Fixed Furnishings

Location: Throughout building
Distress: Beyond Expected Life
Category: Deferred Maintenance
Priority: 3 - Necessary (Years 2-5)
Correction: Renew System
Qty: 2,607.00
Unit of Measure: S.F.
Estimate: \$5,477.00
Assessor Name: Eduardo Lopez
Date Created: 02/22/2020

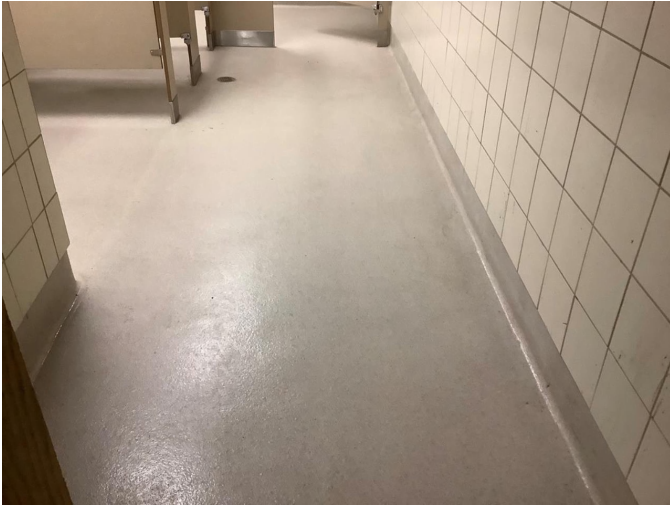
Location: Restrooms
Distress: Beyond Expected Life
Category: Deferred Maintenance
Priority: 3 - Necessary (Years 2-5)
Correction: Renew System
Qty: 1,595.00
Unit of Measure: S.F.
Estimate: \$32,560.00
Assessor Name: Eduardo Lopez
Date Created: 01/13/2020

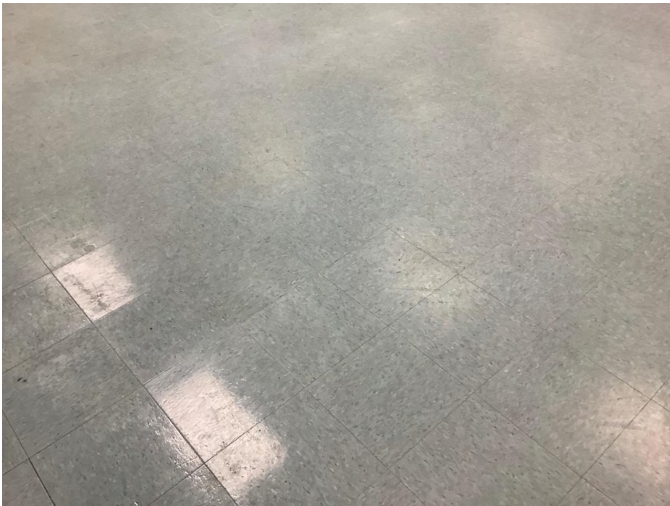
Location: Throughout Building
Distress: Beyond Expected Life
Category: Deferred Maintenance
Priority: 3 - Necessary (Years 2-5)
Correction: Renew System
Qty: 10,000.00
Unit of Measure: S.F.
Estimate: \$53,940.00
Assessor Name: Eduardo Lopez
Date Created: 01/13/2020

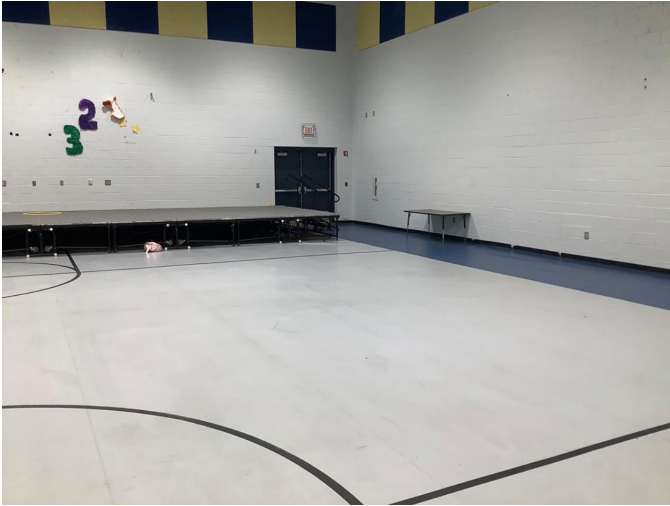
Location: GYM
Distress: Beyond Expected Life
Category: Deferred Maintenance
Priority: 3 - Necessary (Years 2-5)
Correction: Renew System
Qty: 7,000.00
Unit of Measure: S.F.
Estimate: \$205,359.00
Assessor Name: Eduardo Lopez
Date Created: 01/13/2020

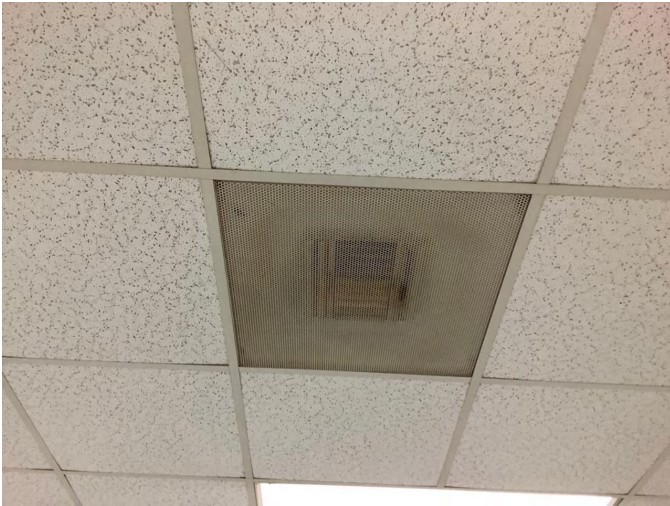
Location: Throughout Building
Distress: Beyond Expected Life
Category: Deferred Maintenance
Priority: 3 - Necessary (Years 2-5)
Correction: Renew System
Qty: 18,595.00
Unit of Measure: S.F.
Estimate: \$259,977.00
Assessor Name: Eduardo Lopez
Date Created: 10/06/2020

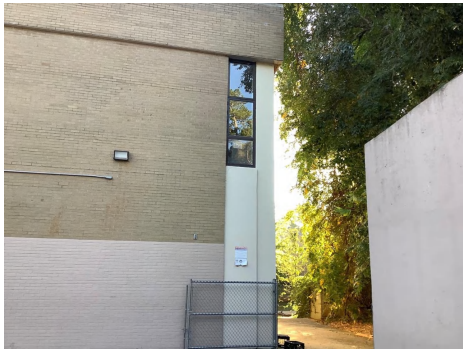
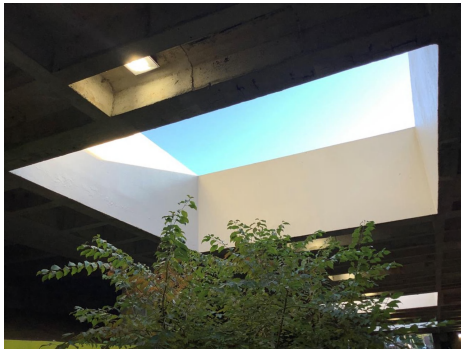
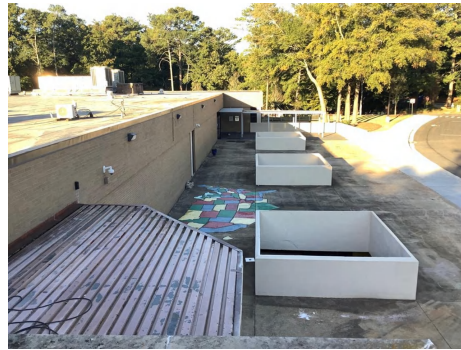
System: G4020 - Site Lighting

Notes: The existing site lighting system consists of a building mounted lighting program support by a few pole-mounted lights. Additional lighting is recommended. Replace the existing lights and add a new lighting program to provide for the entire site.

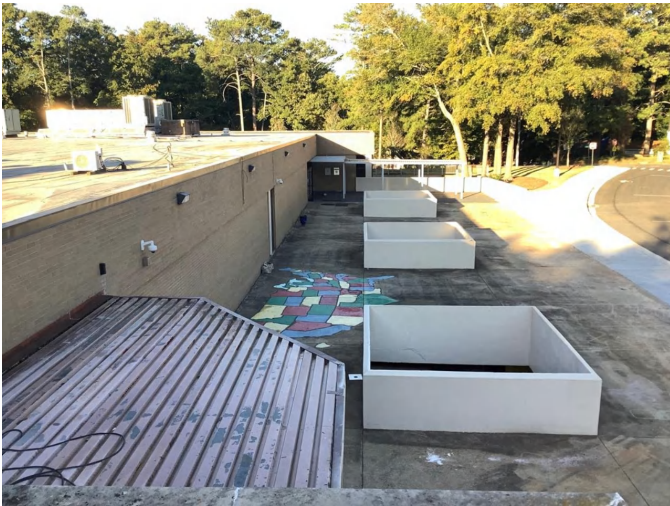
Location: Throughout building
Distress: Beyond Expected Life
Category: Deferred Maintenance
Priority: 3 - Necessary (Years 2-5)
Correction: Renew System
Qty: 88,417.00
Unit of Measure: S.F.
Estimate: \$289,831.00
Assessor Name: Hayden Collins
Date Created: 02/22/2020
