Atlanta Public Schools/Charter Schools

# Cook ES (Wesley International Academy)

## School Assessment Report

November 10, 2020

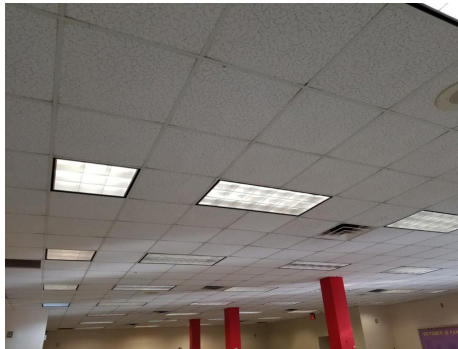
**System:** C3030 - Ceiling Finishes

**Notes:** The original ceiling finishes are aged, failing and should be replaced.

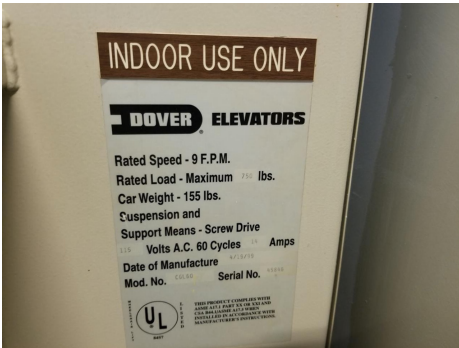
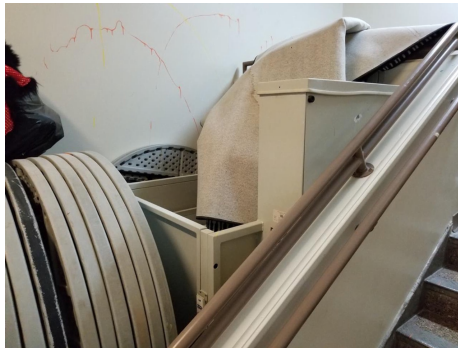
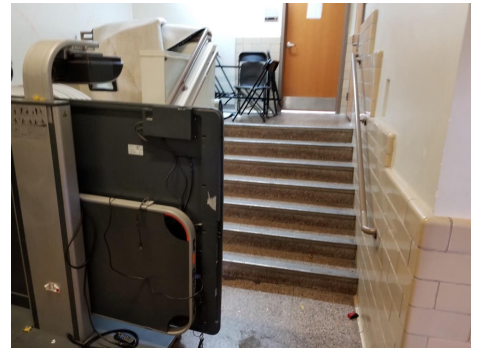
**System:** D1010 - Elevators and Lifts

**Notes:** The wheelchair lift is beyond its expected service life and should be scheduled for replacement.

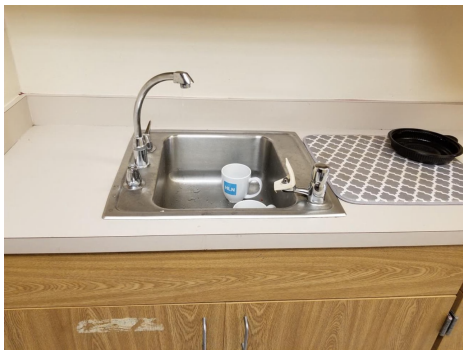
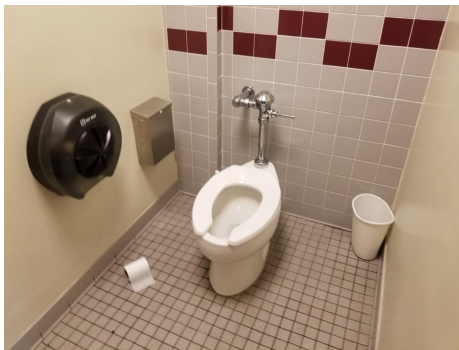
**System:** D2010 - Plumbing Fixtures

**Notes:** Plumbing fixtures are in operational conditions. However, they are aged and should be replaced.

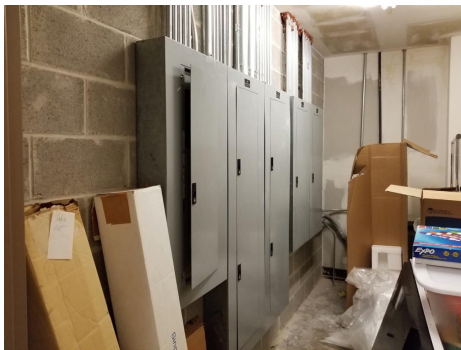
**System:** D5020 - Branch Wiring

**Notes:** The branch wiring system is operating, but is aged, in poor condition, and should be replaced.

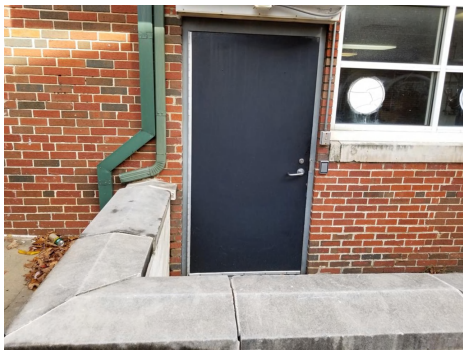
**System:** D5030810 - Security & Detection Systems

**Notes:** The security system is beyond its expected service life and should be scheduled for replacement.

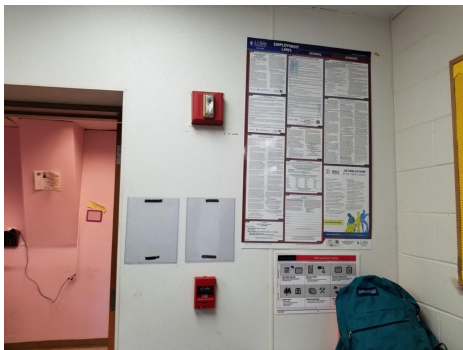
**System:** D5030910 - Fire & Alarm Systems

**Notes:** The fire system is beyond its expected service life and should be scheduled for replacement.

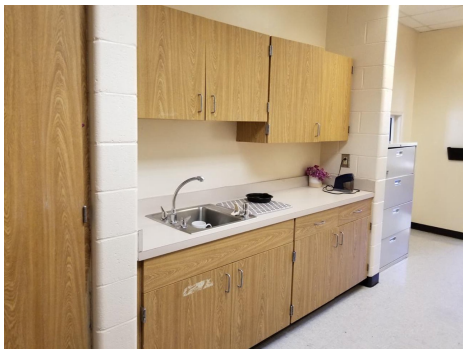
**System:** E2010 - Fixed Furnishings

**Notes:** The fixed furnishings are aged, in marginal condition, and should be replaced.

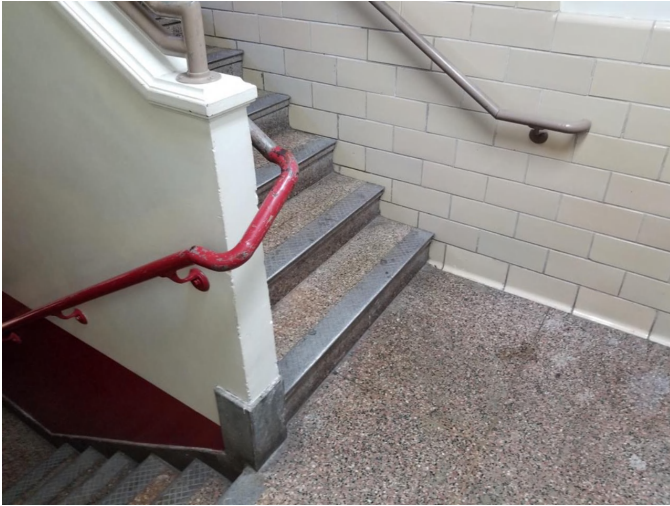
#### System: C1030 - Fittings

**Location:** Throughout Building  
**Distress:** Beyond Expected Life  
**Category:** ADA Compliance  
**Priority:** 3 - Necessary (Years 2-5)  
**Correction:** Renew System  
**Qty:** 15,238.00  
**Unit of Measure:** S.F.  
**Estimate:** \$25,646.00  
**Assessor Name:** Jejuan Hall  
**Date Created:** 10/01/2019

**Notes:** The fittings throughout the building are aged, in marginal condition, and should be replaced.

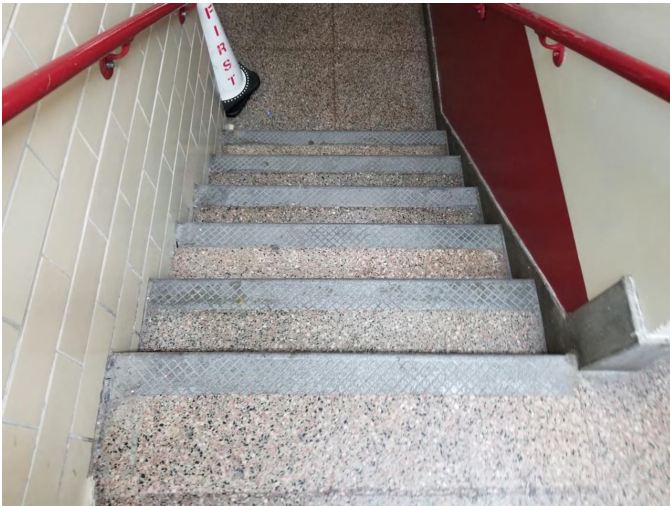
#### System: C3020430 - Terrazzo

**Location:** Throughout Building  
**Distress:** Beyond Expected Life  
**Category:** Deferred Maintenance  
**Priority:** 3 - Necessary (Years 2-5)  
**Correction:** Renew System  
**Qty:** 730.00  
**Unit of Measure:** S.F.  
**Estimate:** \$19,728.00  
**Assessor Name:** Homero Guerrero  
**Date Created:** 02/05/2020

**Notes:** The terrazzo flooring is beyond its expected service life and should be scheduled for replacement.

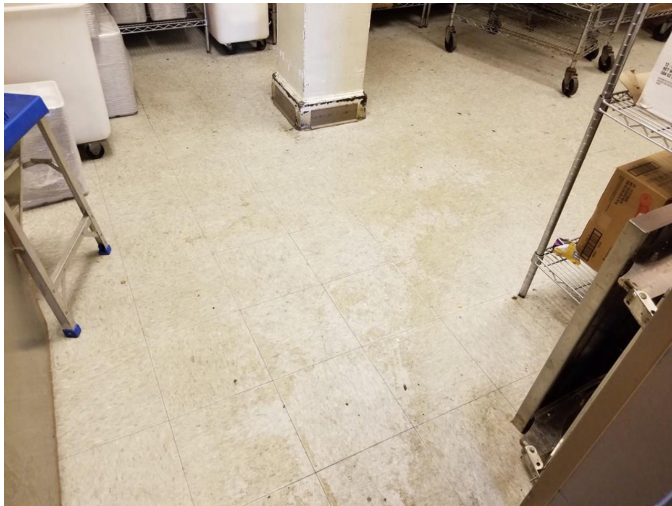
**System: C3020903 - VCT**

**Location:** Throughout Building  
**Distress:** Beyond Expected Life  
**Category:** Deferred Maintenance  
**Priority:** 3 - Necessary (Years 2-5)  
**Correction:** Renew System  
**Qty:** 11,963.00  
**Unit of Measure:** S.F.  
**Estimate:** \$64,528.00  
**Assessor Name:** Homero Guerrero  
**Date Created:** 02/05/2020

**Notes:** The VCT flooring is in poor conditions, and should be replaced.

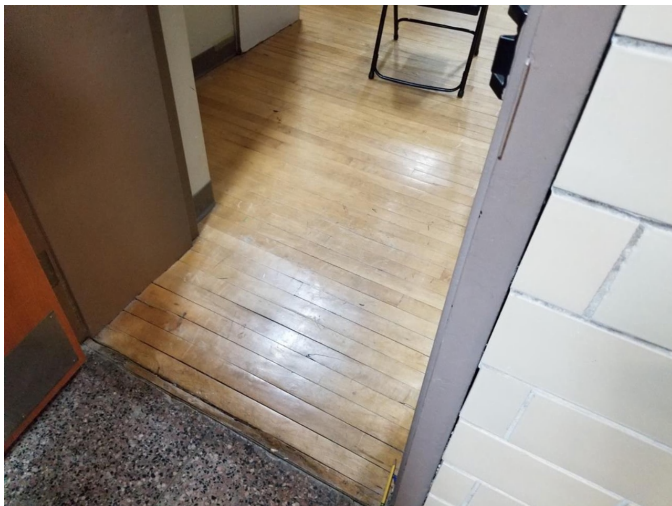
**System: C3020999 - Other - Wood**

**Location:** Throughout Building  
**Distress:** Beyond Expected Life  
**Category:** Deferred Maintenance  
**Priority:** 3 - Necessary (Years 2-5)  
**Correction:** Renew System  
**Qty:** 1,042.00  
**Unit of Measure:** S.F.  
**Estimate:** \$22,926.00  
**Assessor Name:** Homero Guerrero  
**Date Created:** 01/29/2020

**Notes:** The wood flooring system is beyond its expected service life and should be scheduled for replacement.

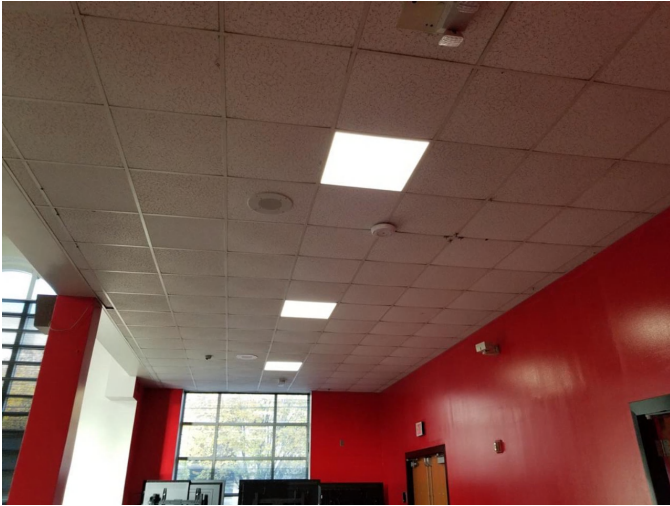
**System: C3030 - Ceiling Finishes**

**Location:** Throughout Building  
**Distress:** Beyond Expected Life  
**Category:** Deferred Maintenance  
**Priority:** 3 - Necessary (Years 2-5)  
**Correction:** Renew System  
**Qty:** 15,238.00  
**Unit of Measure:** S.F.  
**Estimate:** \$150,856.00  
**Assessor Name:** Homero Guerrero  
**Date Created:** 02/05/2020

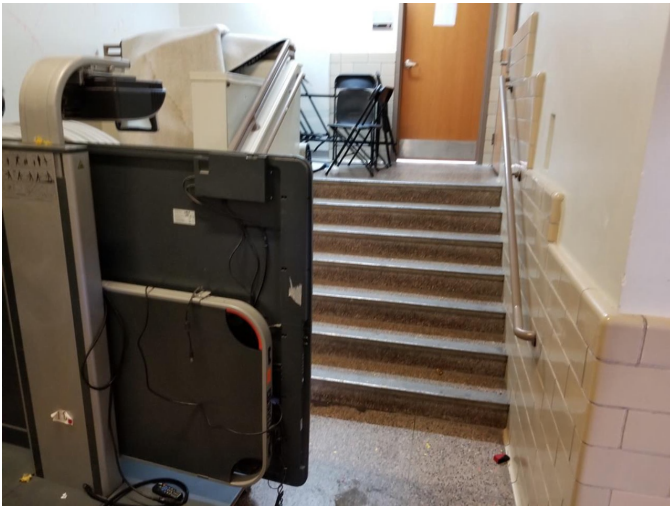
**System: D1010 - Elevators and Lifts**

**Location:** Throughout Building  
**Distress:** Beyond Expected Life  
**Category:** Deferred Maintenance  
**Priority:** 3 - Necessary (Years 2-5)  
**Correction:** Renew System  
**Qty:** 15,238.00  
**Unit of Measure:** S.F.  
**Estimate:** \$31,512.00  
**Assessor Name:** Homero Guerrero  
**Date Created:** 02/05/2020

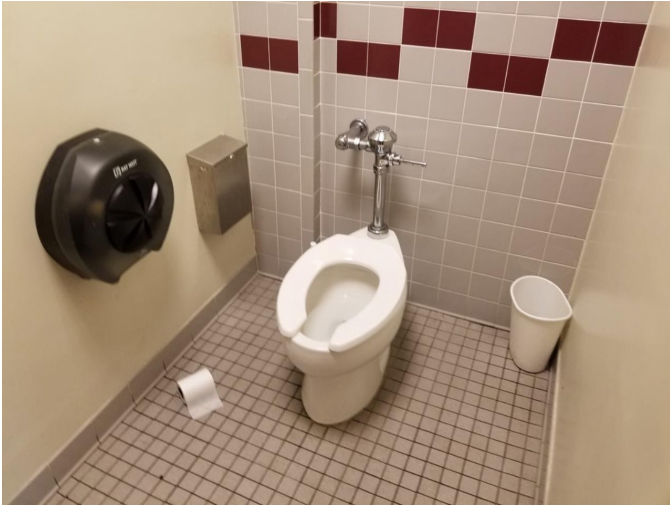
**System: D2010 - Plumbing Fixtures**

**Location:** Throughout Building  
**Distress:** Beyond Expected Life  
**Category:** ADA Compliance  
**Priority:** 3 - Necessary (Years 2-5)  
**Correction:** Renew System  
**Qty:** 15,238.00  
**Unit of Measure:** S.F.  
**Estimate:** \$10,560.00  
**Assessor Name:** Jejuan Hall  
**Date Created:** 10/01/2019

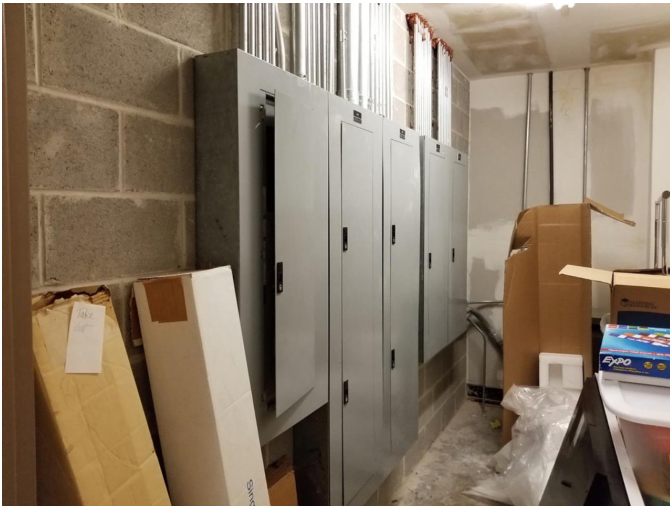
**System: D5020 - Branch Wiring**

**Location:** Throughout Building  
**Distress:** Beyond Expected Life  
**Category:** Deferred Maintenance  
**Priority:** 3 - Necessary (Years 2-5)  
**Correction:** Renew System  
**Qty:** 15,238.00  
**Unit of Measure:** S.F.  
**Estimate:** \$79,619.00  
**Assessor Name:** Homero Guerrero  
**Date Created:** 02/05/2020

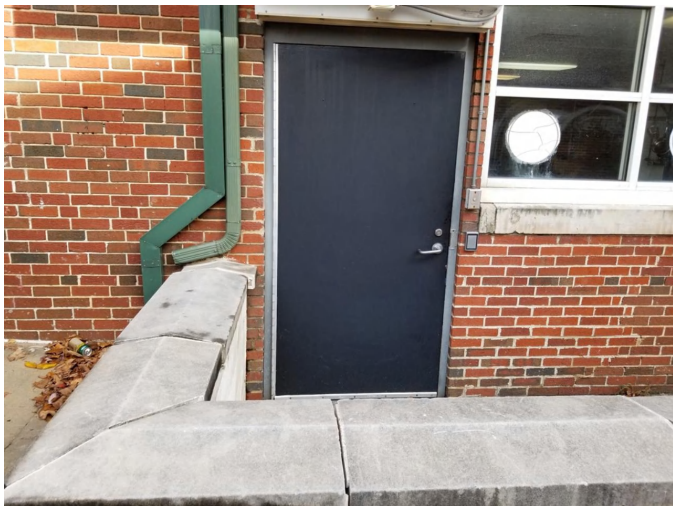
**System: D5030810 - Security & Detection Systems**

**Location:** Throughout Building  
**Distress:** Beyond Expected Life  
**Category:** Deferred Maintenance  
**Priority:** 3 - Necessary (Years 2-5)  
**Correction:** Renew System  
**Qty:** 15,238.00  
**Unit of Measure:** S.F.  
**Estimate:** \$25,310.00  
**Assessor Name:** Homero Guerrero  
**Date Created:** 02/03/2020

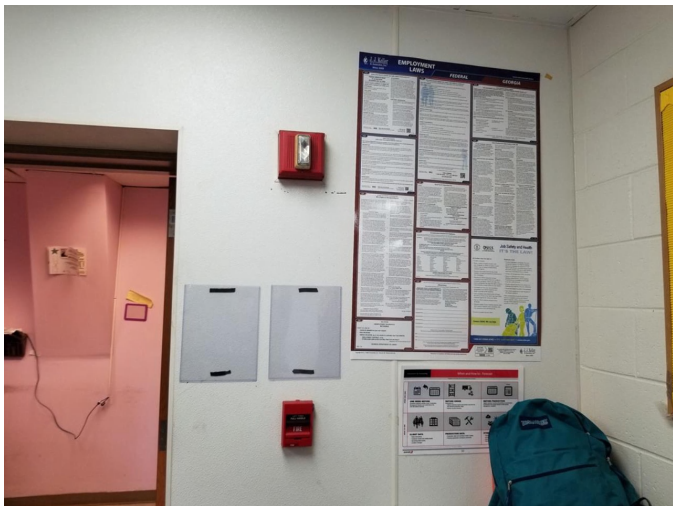
**System: D5030910 - Fire & Alarm Systems**

**Location:** Throughout Building  
**Distress:** Beyond Expected Life  
**Category:** Deferred Maintenance  
**Priority:** 3 - Necessary (Years 2-5)  
**Correction:** Renew System  
**Qty:** 15,238.00  
**Unit of Measure:** S.F.  
**Estimate:** \$45,927.00  
**Assessor Name:** Homero Guerrero  
**Date Created:** 02/05/2020

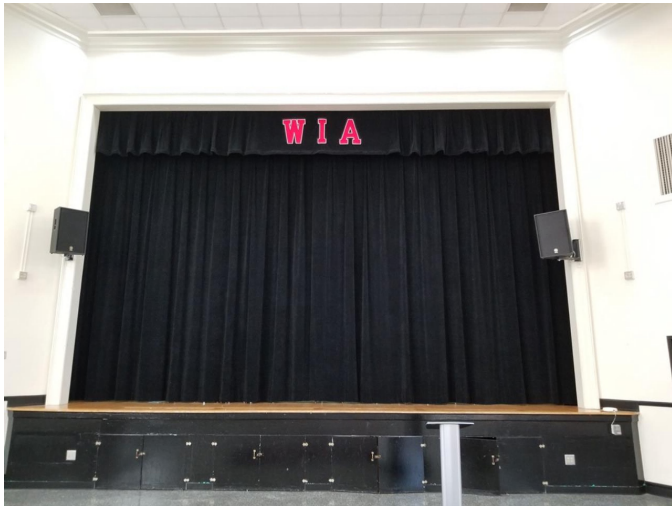
**System: E1020 - Institutional Equipment**

**Location:** Throughout Building  
**Distress:** Beyond Expected Life  
**Category:** Deferred Maintenance  
**Priority:** 3 - Necessary (Years 2-5)  
**Correction:** Renew System  
**Qty:** 15,238.00  
**Unit of Measure:** S.F.  
**Estimate:** \$44,251.00  
**Assessor Name:** Homero Guerrero  
**Date Created:** 02/05/2020

**Notes:** The system is beyond its expected service life and should be scheduled for replacement.

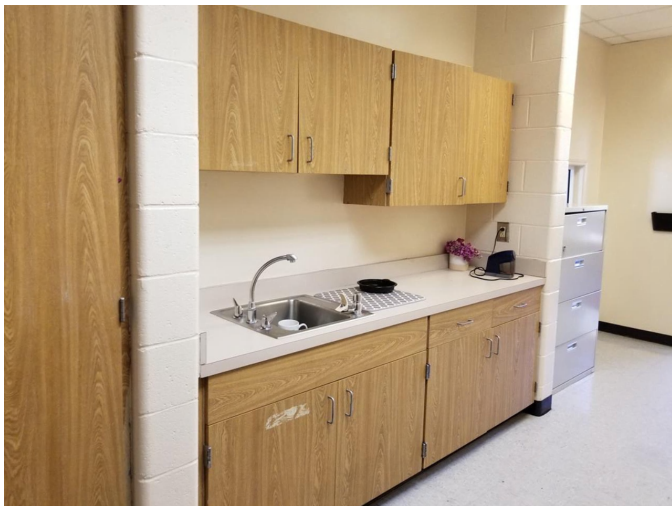
**System: E2010 - Fixed Furnishings**

**Location:** Throughout Building  
**Distress:** Beyond Expected Life  
**Category:** Deferred Maintenance  
**Priority:** 3 - Necessary (Years 2-5)  
**Correction:** Renew System  
**Qty:** 15,238.00  
**Unit of Measure:** S.F.  
**Estimate:** \$32,015.00  
**Assessor Name:** Homero Guerrero  
**Date Created:** 02/05/2020

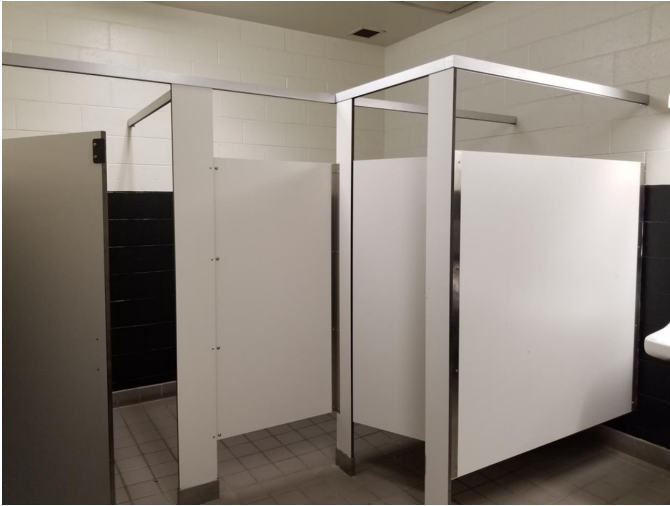
#### System: C1030 - Fittings

**Location:** Throughout Building  
**Distress:** Beyond Expected Life  
**Category:** ADA Compliance  
**Priority:** 3 - Necessary (Years 2-5)  
**Correction:** Renew System  
**Qty:** 18,927.00  
**Unit of Measure:** S.F.  
**Estimate:** \$62,043.00  
**Assessor Name:** Jejuan Hall  
**Date Created:** 09/17/2015

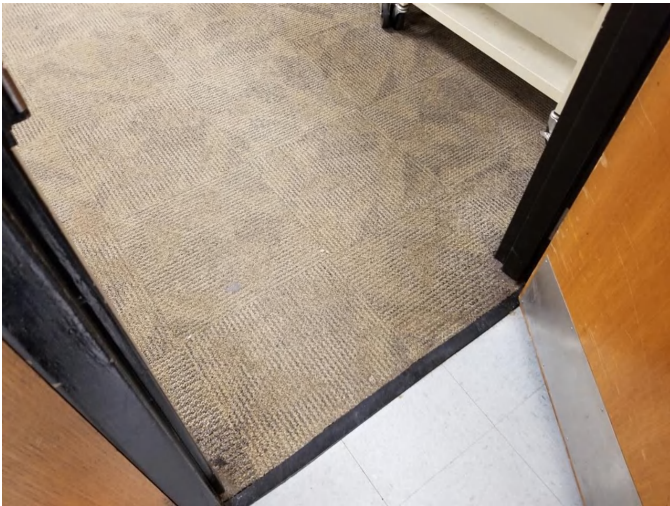
#### System: C3020901 - Carpet

**Location:** Throughout Building  
**Distress:** Beyond Expected Life  
**Category:** Deferred Maintenance  
**Priority:** 3 - Necessary (Years 2-5)  
**Correction:** Renew System  
**Qty:** 3,040.00  
**Unit of Measure:** S.F.  
**Estimate:** \$25,080.00  
**Assessor Name:** Eduardo Lopez  
**Date Created:** 01/29/2020

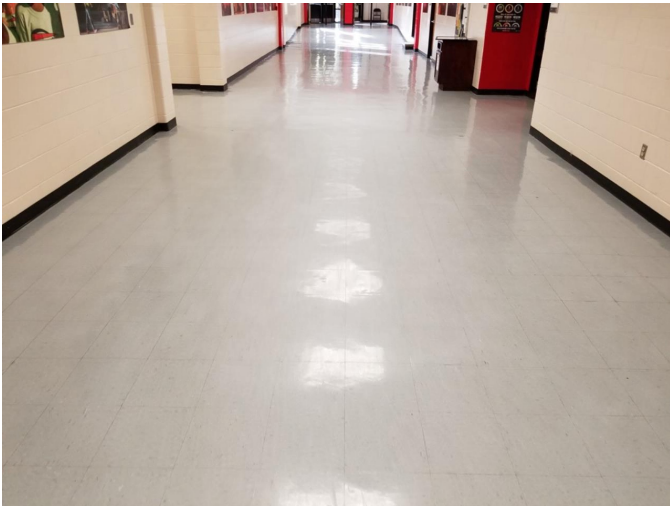
**Location:** Throughout Building  
**Distress:** Beyond Expected Life  
**Category:** Deferred Maintenance  
**Priority:** 3 - Necessary (Years 2-5)  
**Correction:** Renew System  
**Qty:** 14,847.00  
**Unit of Measure:** S.F.  
**Estimate:** \$80,085.00  
**Assessor Name:** Eduardo Lopez  
**Date Created:** 01/29/2020

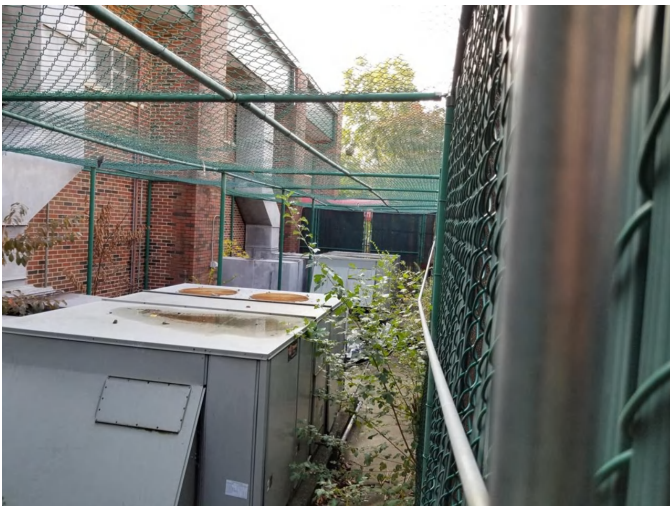
**Location:** Throughout Building  
**Distress:** Beyond Expected Life  
**Category:** Deferred Maintenance  
**Priority:** 3 - Necessary (Years 2-5)  
**Correction:** Renew System  
**Qty:** 18,927.00  
**Unit of Measure:** S.F.  
**Estimate:** \$378,086.00  
**Assessor Name:** Eduardo Lopez  
**Date Created:** 08/26/2013

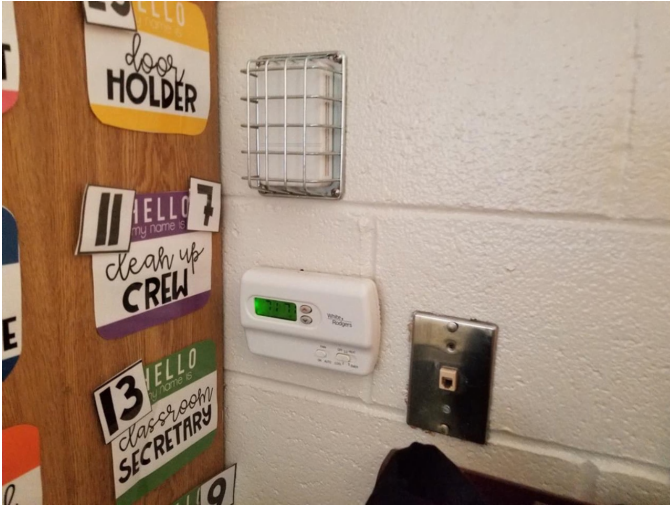
**Location:** Throughout Building  
**Distress:** Beyond Expected Life  
**Category:** Deferred Maintenance  
**Priority:** 3 - Necessary (Years 2-5)  
**Correction:** Renew System  
**Qty:** 18,927.00  
**Unit of Measure:** S.F.  
**Estimate:** \$51,216.00  
**Assessor Name:** Eduardo Lopez  
**Date Created:** 02/05/2020

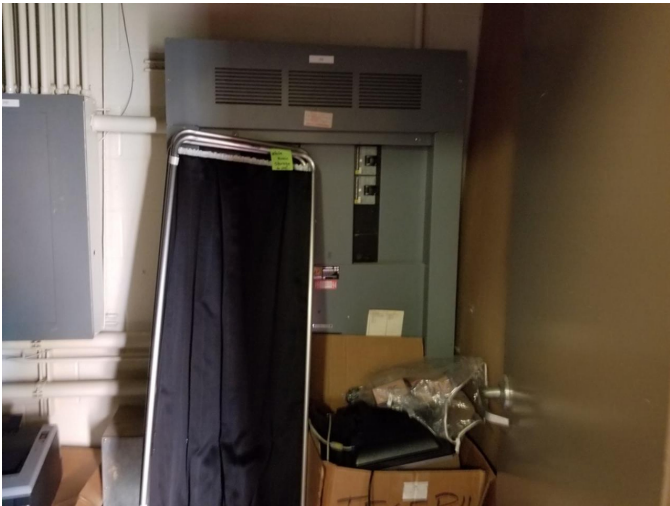
**Location:** Throughout Building  
**Distress:** Beyond Expected Life  
**Category:** Deferred Maintenance  
**Priority:** 3 - Necessary (Years 2-5)  
**Correction:** Renew System  
**Qty:** 18,927.00  
**Unit of Measure:** S.F.  
**Estimate:** \$53,090.00  
**Assessor Name:** Eduardo Lopez  
**Date Created:** 02/03/2020

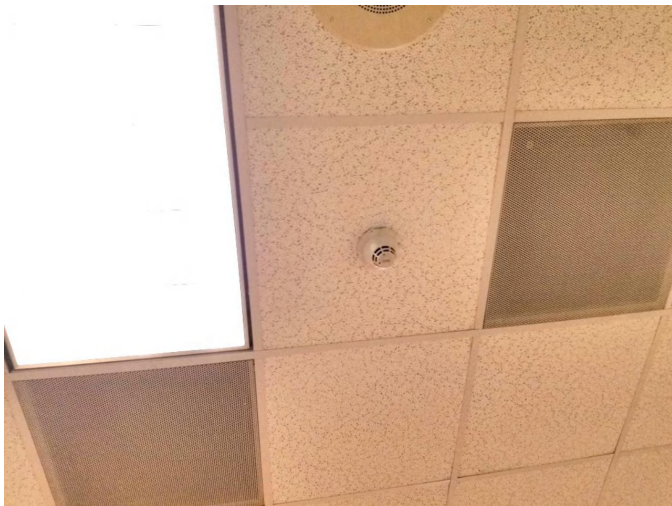
**Location:** Throughout Building  
**Distress:** Beyond Expected Life  
**Category:** Deferred Maintenance  
**Priority:** 3 - Necessary (Years 2-5)  
**Correction:** Renew System  
**Qty:** 18,927.00  
**Unit of Measure:** S.F.  
**Estimate:** \$57,046.00  
**Assessor Name:** Eduardo Lopez  
**Date Created:** 01/29/2020

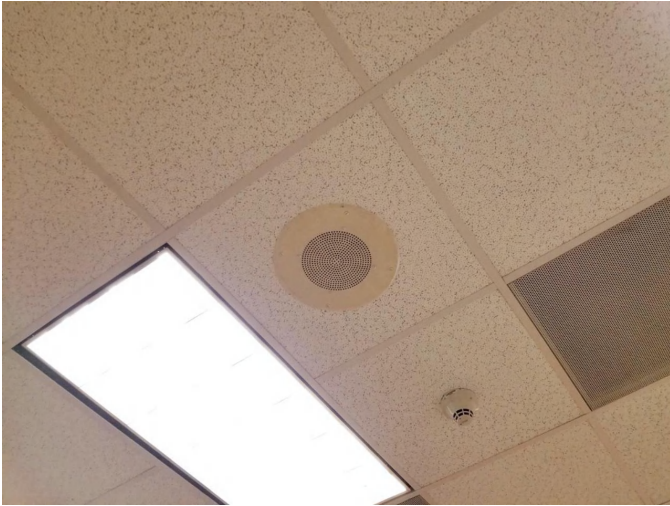
**Location:** Throughout Building  
**Distress:** Beyond Expected Life  
**Category:** Deferred Maintenance  
**Priority:** 3 - Necessary (Years 2-5)  
**Correction:** Renew System  
**Qty:** 18,927.00  
**Unit of Measure:** S.F.  
**Estimate:** \$74,118.00  
**Assessor Name:** Eduardo Lopez  
**Date Created:** 01/29/2020

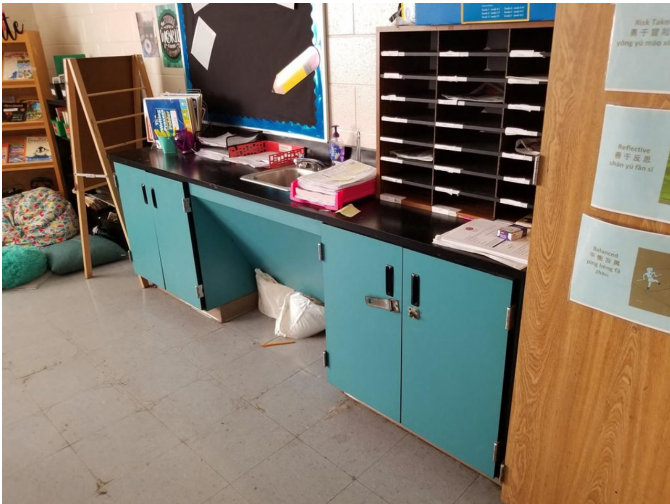
**System: E2010 - Fixed Furnishings**

**Location:** Throughout Building  
**Distress:** Beyond Expected Life  
**Category:** Deferred Maintenance  
**Priority:** 3 - Necessary (Years 2-5)  
**Correction:** Renew System  
**Qty:** 18,927.00  
**Unit of Measure:** S.F.  
**Estimate:** \$44,762.00  
**Assessor Name:** Eduardo Lopez  
**Date Created:** 09/17/2015

**Notes:** The fixed furnishings are aged, in marginal condition, and should be replaced.

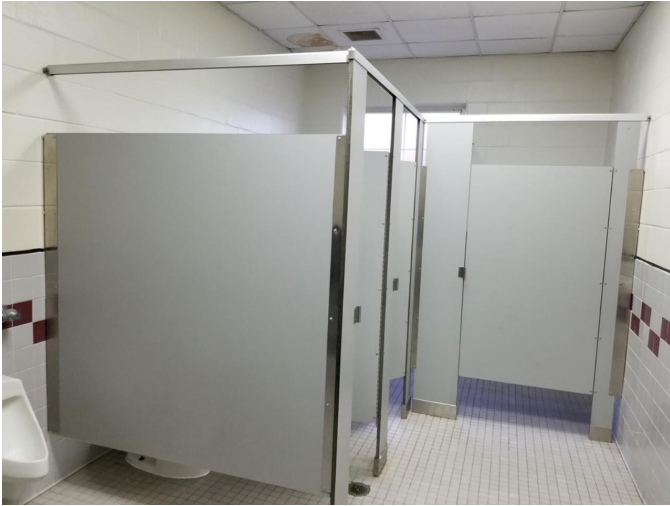
**Location:** Throughout Building  
**Distress:** Beyond Expected Life  
**Category:** ADA Compliance  
**Priority:** 3 - Necessary (Years 2-5)  
**Correction:** Renew System  
**Qty:** 41,668.00  
**Unit of Measure:** S.F.  
**Estimate:** \$121,462.00  
**Assessor Name:** Jejuan Hall  
**Date Created:** 10/01/2019

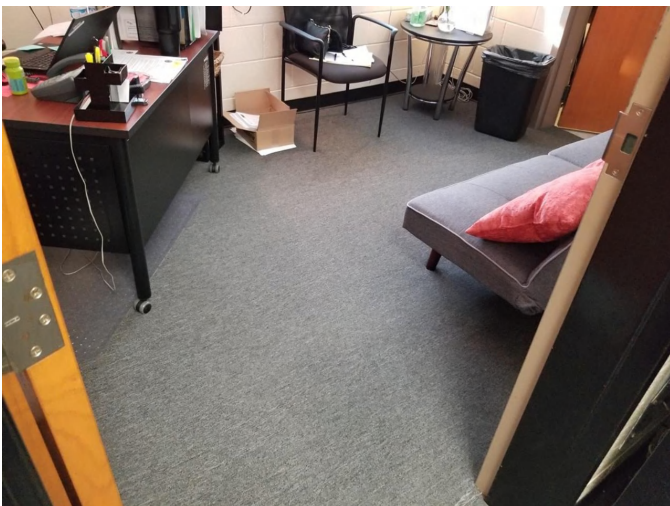
**Location:** Throughout Building  
**Distress:** Beyond Expected Life  
**Category:** Deferred Maintenance  
**Priority:** 3 - Necessary (Years 2-5)  
**Correction:** Renew System  
**Qty:** 1,020.00  
**Unit of Measure:** S.F.  
**Estimate:** \$8,415.00  
**Assessor Name:** Homero Guerrero  
**Date Created:** 01/29/2020

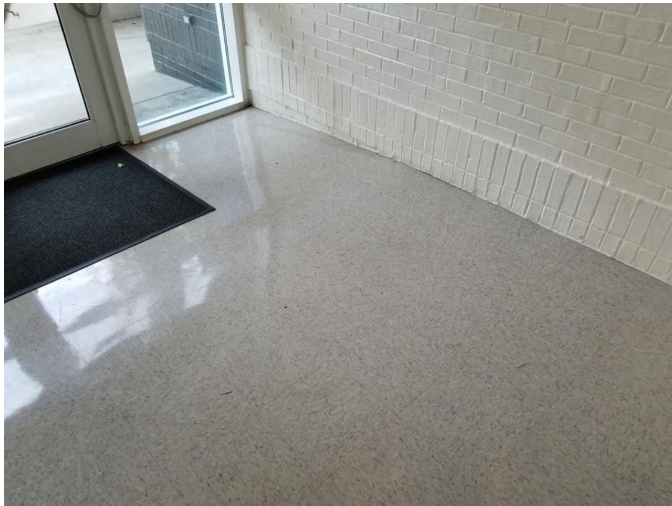
**Location:** Throughout Building  
**Distress:** Beyond Expected Life  
**Category:** Deferred Maintenance  
**Priority:** 3 - Necessary (Years 2-5)  
**Correction:** Renew System  
**Qty:** 37,806.00  
**Unit of Measure:** S.F.  
**Estimate:** \$203,926.00  
**Assessor Name:** Homero Guerrero  
**Date Created:** 01/29/2020

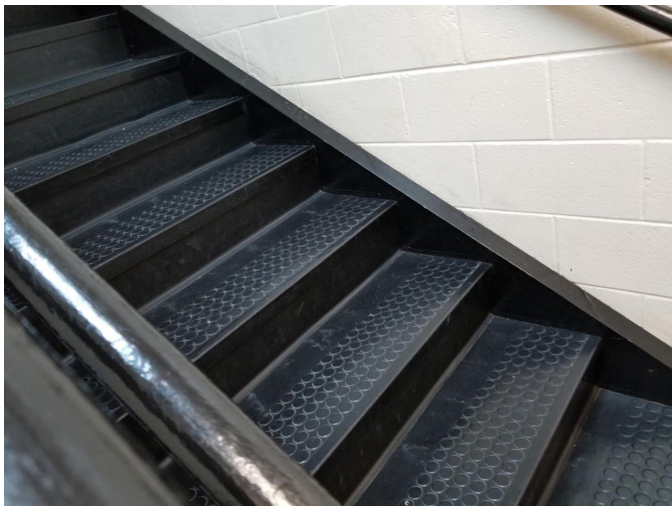
**Location:** Throughout Building  
**Distress:** Beyond Expected Life  
**Category:** Deferred Maintenance  
**Priority:** 3 - Necessary (Years 2-5)  
**Correction:** Renew System  
**Qty:** 295.00  
**Unit of Measure:** S.F.  
**Estimate:** \$8,654.00  
**Assessor Name:** Homero Guerrero  
**Date Created:** 01/29/2020

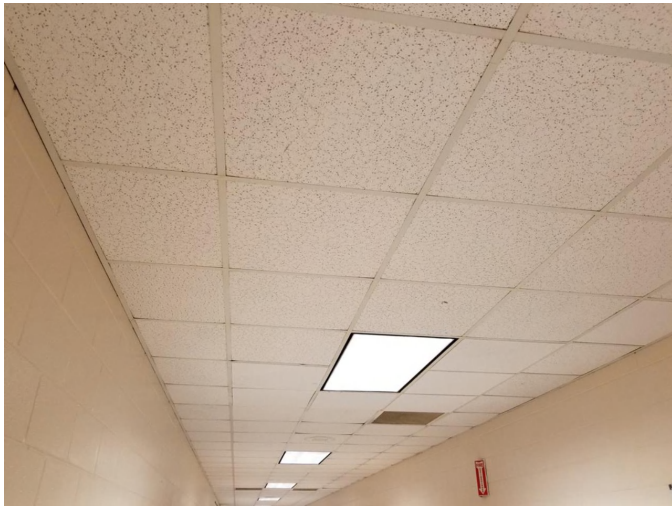
**Location:** Throughout Building  
**Distress:** Beyond Expected Life  
**Category:** Deferred Maintenance  
**Priority:** 3 - Necessary (Years 2-5)  
**Correction:** Renew System  
**Qty:** 41,668.00  
**Unit of Measure:** S.F.  
**Estimate:** \$412,513.00  
**Assessor Name:** Homero Guerrero  
**Date Created:** 10/01/2019

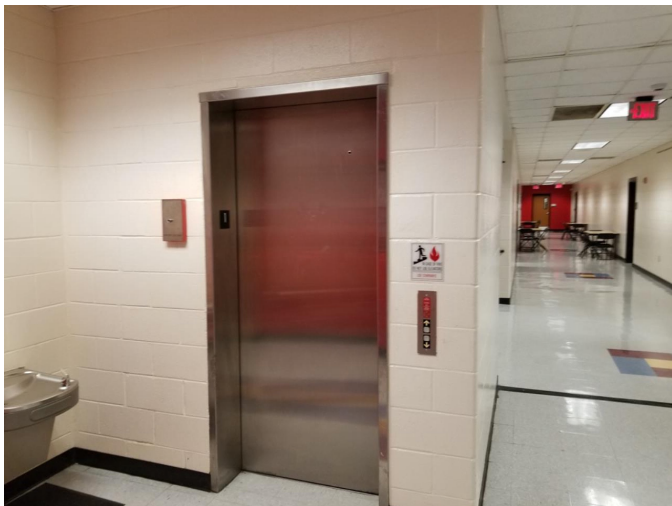
**Location:** Throughout Building  
**Distress:** Beyond Expected Life  
**Category:** Deferred Maintenance  
**Priority:** 3 - Necessary (Years 2-5)  
**Correction:** Renew System  
**Qty:** 41,668.00  
**Unit of Measure:** S.F.  
**Estimate:** \$57,294.00  
**Assessor Name:** Homero Guerrero  
**Date Created:** 10/01/2019

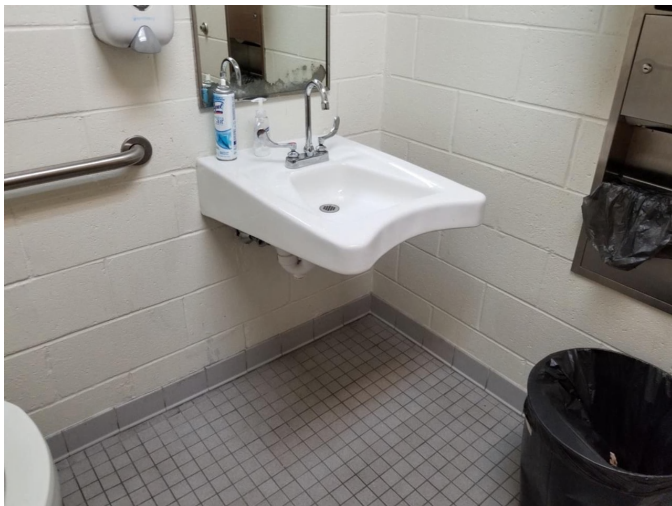
**Location:** Throughout Building  
**Distress:** Beyond Expected Life  
**Category:** ADA Compliance  
**Priority:** 3 - Necessary (Years 2-5)  
**Correction:** Renew System  
**Qty:** 41,668.00  
**Unit of Measure:** S.F.  
**Estimate:** \$291,968.00  
**Assessor Name:** Jejuan Hall  
**Date Created:** 10/01/2019

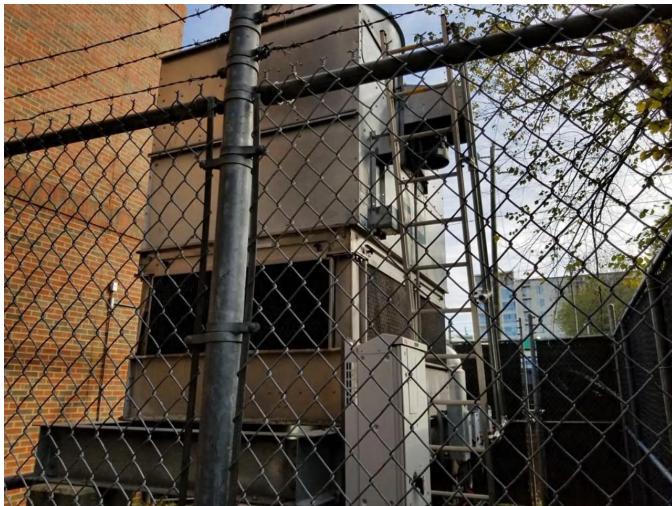
**Location:** Site  
**Distress:** Beyond Expected Life  
**Category:** Deferred Maintenance  
**Priority:** 3 - Necessary (Years 2-5)  
**Correction:** Renew System  
**Qty:** 41,668.00  
**Unit of Measure:** S.F.  
**Estimate:** \$279,134.00  
**Assessor Name:** Homero Guerrero  
**Date Created:** 10/01/2019

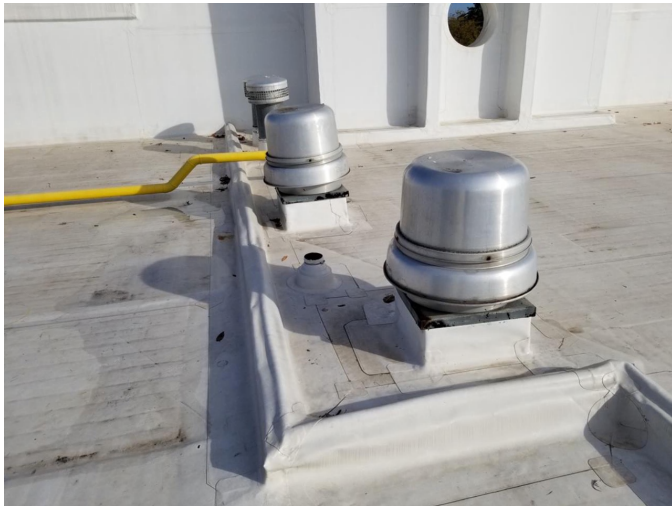
**Location:** Throughout Building  
**Distress:** Beyond Expected Life  
**Category:** Deferred Maintenance  
**Priority:** 3 - Necessary (Years 2-5)  
**Correction:** Renew System  
**Qty:** 41,668.00  
**Unit of Measure:** S.F.  
**Estimate:** \$486,766.00  
**Assessor Name:** Homero Guerrero  
**Date Created:** 10/01/2019

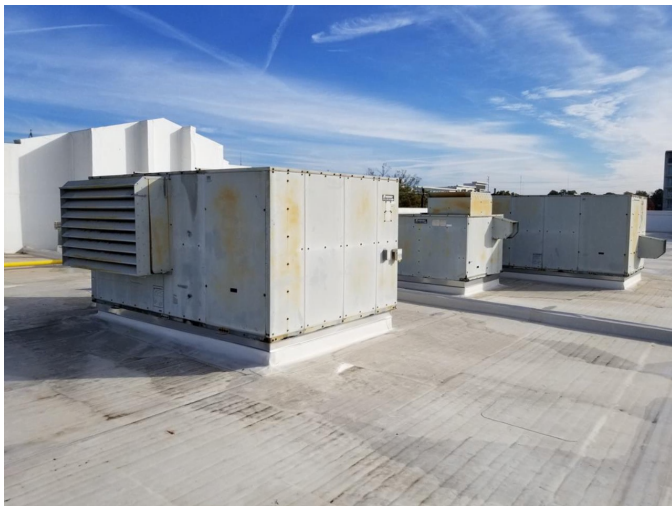
**Location:** Throughout Building  
**Distress:** Beyond Expected Life  
**Category:** Deferred Maintenance  
**Priority:** 3 - Necessary (Years 2-5)  
**Correction:** Renew System  
**Qty:** 41,668.00  
**Unit of Measure:** S.F.  
**Estimate:** \$304,801.00  
**Assessor Name:** Homero Guerrero  
**Date Created:** 09/17/2015

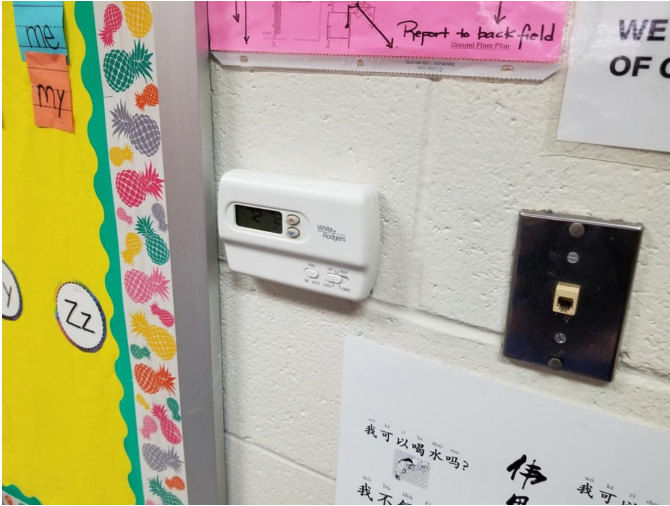
**Location:** Throughout Building  
**Distress:** Beyond Expected Life  
**Category:** Deferred Maintenance  
**Priority:** 3 - Necessary (Years 2-5)  
**Correction:** Renew System  
**Qty:** 41,668.00  
**Unit of Measure:** S.F.  
**Estimate:** \$100,837.00  
**Assessor Name:** Homero Guerrero  
**Date Created:** 09/17/2015

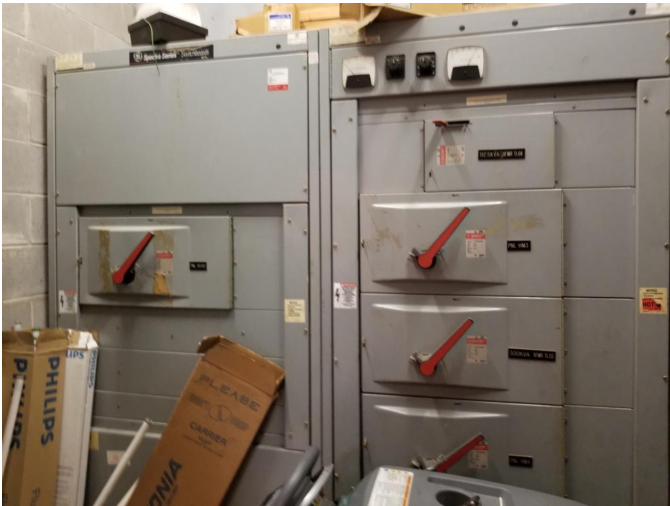
**Location:** Throughout Building  
**Distress:** Beyond Expected Life  
**Category:** Deferred Maintenance  
**Priority:** 3 - Necessary (Years 2-5)  
**Correction:** Renew System  
**Qty:** 41,668.00  
**Unit of Measure:** S.F.  
**Estimate:** \$105,420.00  
**Assessor Name:** Homero Guerrero  
**Date Created:** 10/01/2019

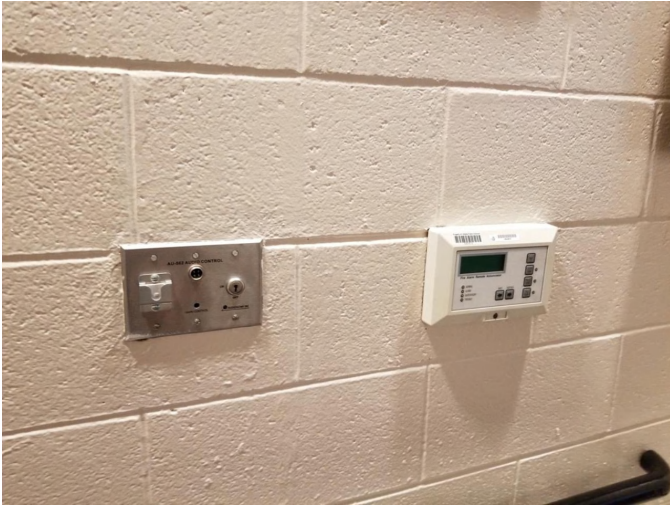
**Location:** Throughout Building  
**Distress:** Beyond Expected Life  
**Category:** Deferred Maintenance  
**Priority:** 3 - Necessary (Years 2-5)  
**Correction:** Renew System  
**Qty:** 41,668.00  
**Unit of Measure:** S.F.  
**Estimate:** \$69,211.00  
**Assessor Name:** Homero Guerrero  
**Date Created:** 02/05/2020

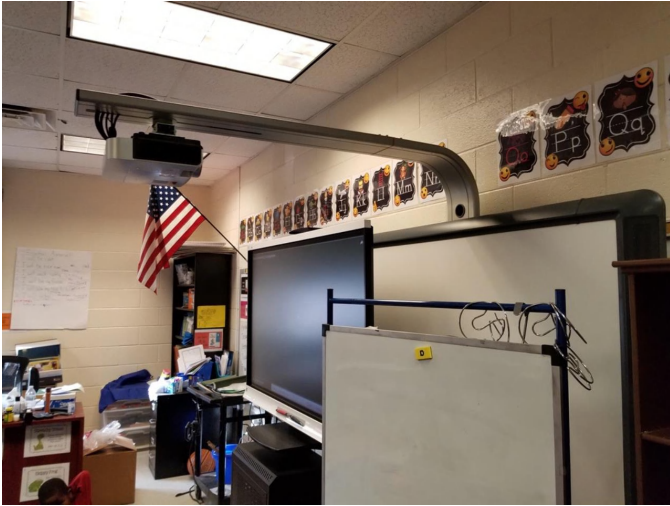
**Location:** Throughout Building  
**Distress:** Beyond Expected Life  
**Category:** Deferred Maintenance  
**Priority:** 3 - Necessary (Years 2-5)  
**Correction:** Renew System  
**Qty:** 41,668.00  
**Unit of Measure:** S.F.  
**Estimate:** \$4,125.00  
**Assessor Name:** Homero Guerrero  
**Date Created:** 02/05/2020

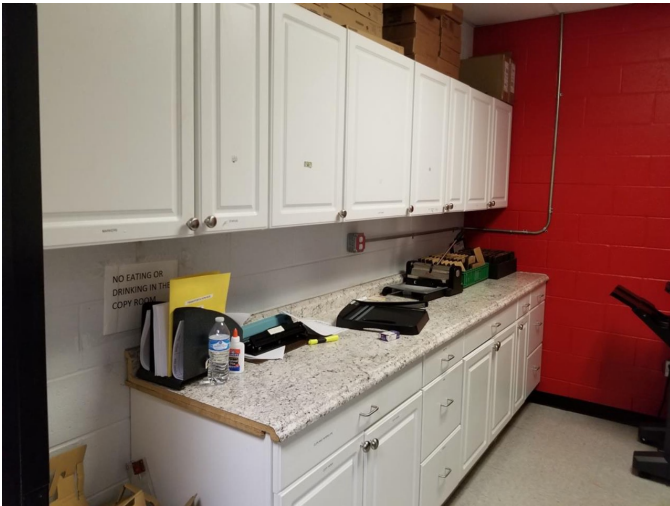
**Location:** Throughout Building  
**Distress:** Beyond Expected Life  
**Category:** Deferred Maintenance  
**Priority:** 3 - Necessary (Years 2-5)  
**Correction:** Renew System  
**Qty:** 41,668.00  
**Unit of Measure:** S.F.  
**Estimate:** \$87,544.00  
**Assessor Name:** Homero Guerrero  
**Date Created:** 02/05/2020

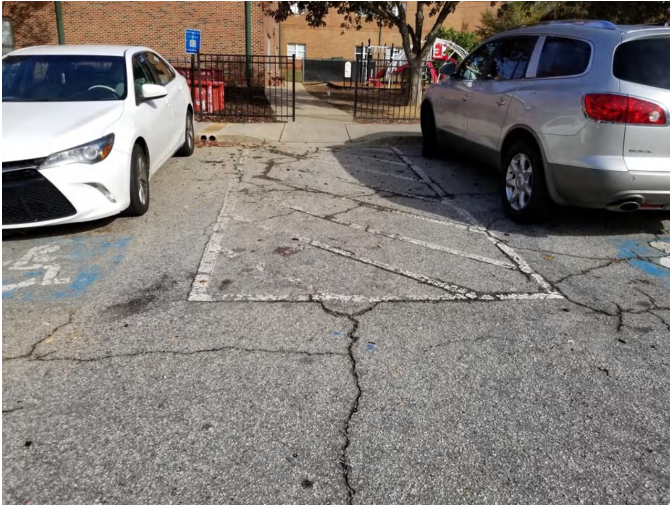
**Location:** ADA Parking  
**Distress:** Missing  
**Category:** ADA Compliance  
**Priority:** 1 - Critical Immediate Need  
**Correction:** Add handicap parking sign and post  
**Qty:** 1.00  
**Unit of Measure:** Ea.  
**Estimate:** \$398.26  
**Assessor Name:** Eduardo Lopez  
**Date Created:** 02/07/2020

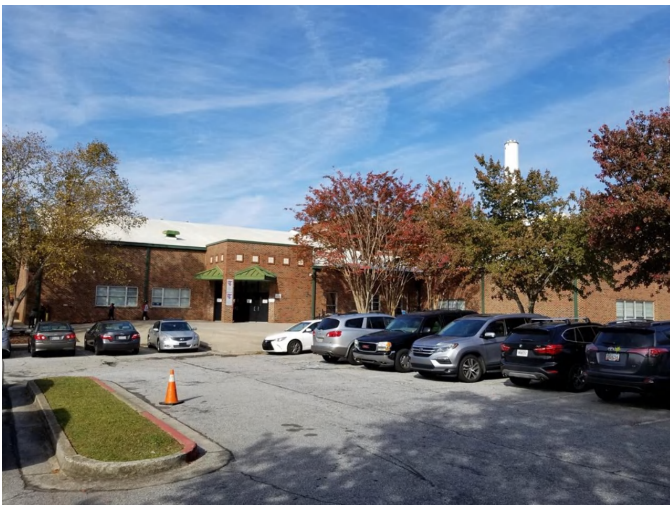
#### System: G2010 - Roadways

**Location:** Parking Lot  
**Distress:** Missing  
**Category:** Code Compliance  
**Priority:** 2 - Trending Critical (Year 1)  
**Correction:** Fire lane marking, incl. curb painting and with the words "No Parking, Fire Lane" painted in black  
**Qty:** 1,500.00  
**Unit of Measure:** L.F.  
**Estimate:** \$3,577.95  
**Assessor Name:** Eduardo Lopez  
**Date Created:** 02/07/2020

**Notes:** There is a small section of red curb in front of the building. However, there is no indication it's a Fire Lane. Fire lane markings must include curb painting and with the words "No Parking, Fire Lane" to maintain it free of obstruction at all times. Provide Fire lane markings per Local Code requirements.

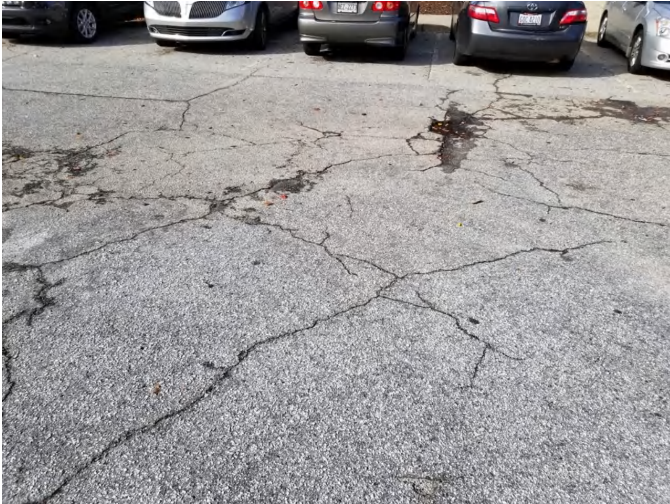
**System: G2010 - Roadways**

**Location:** Parking Lot  
**Distress:** Failing  
**Category:** Deferred Maintenance  
**Priority:** 3 - Necessary (Years 2-5)  
**Correction:** Resurface asphalt paving  
**Qty:** 1,000.00  
**Unit of Measure:** S.Y.  
**Estimate:** \$16,793.52  
**Assessor Name:** Eduardo Lopez  
**Date Created:** 02/07/2020

**Notes:** The asphalt roadway is aged, has many cracks and should be re-surfaced.

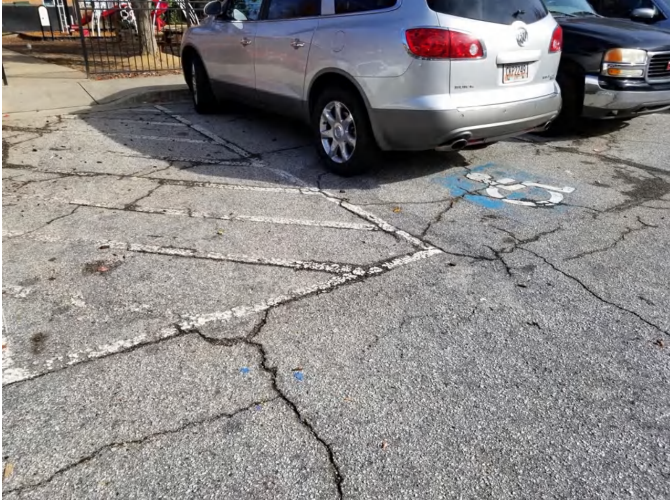
**System: G2020 - Parking Lots**

**Location:** Parking Lot  
**Distress:** Inadequate  
**Category:** Deferred Maintenance  
**Priority:** 3 - Necessary (Years 2-5)  
**Correction:** Resurface asphalt paving and restripe.  
**Qty:** 900.00  
**Unit of Measure:** S.Y.  
**Estimate:** \$13,270.51  
**Assessor Name:** Eduardo Lopez  
**Date Created:** 02/07/2020

**Notes:** The asphalt parking is aged, has many cracks and should be re-surfaced.

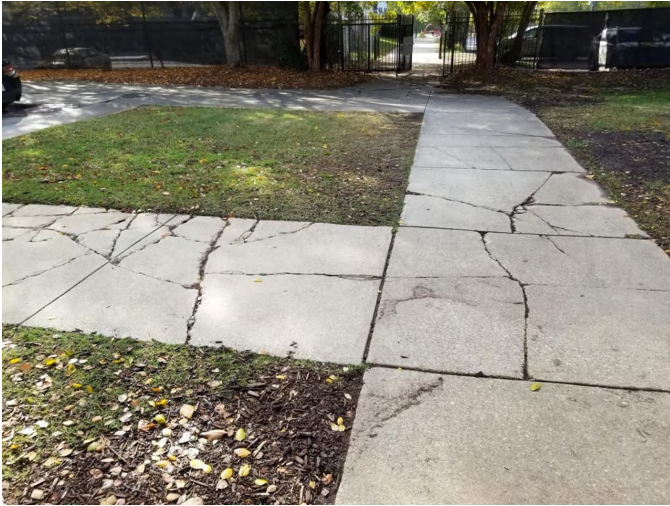
**Location:** Site  
**Distress:** Beyond Expected Life  
**Category:** ADA Compliance  
**Priority:** 3 - Necessary (Years 2-5)  
**Correction:** Renew System  
**Qty:** 75,833.00  
**Unit of Measure:** S.F.  
**Estimate:** \$194,360.00  
**Assessor Name:** Jejuan Hall  
**Date Created:** 02/02/2020
