Atlanta Public Schools/ Carver Cluster

# Finch Elementary School

## School Assessment Report

November 10, 2020

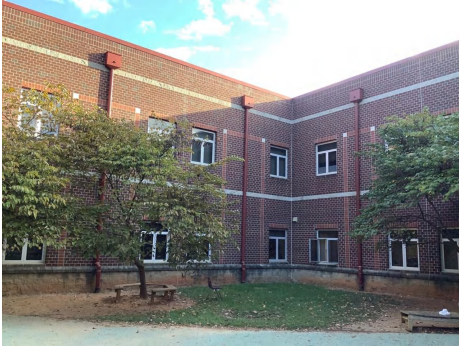
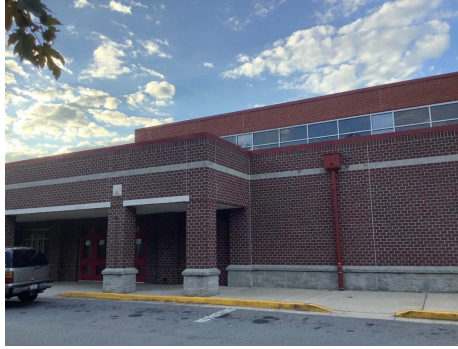
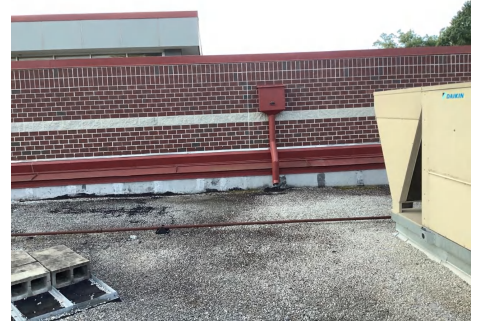
**System:** D2040 - Rain Water Drainage

**Note:** Only 25% of total roof area have roof drainage system. Reduced line item cost by proportional amount.

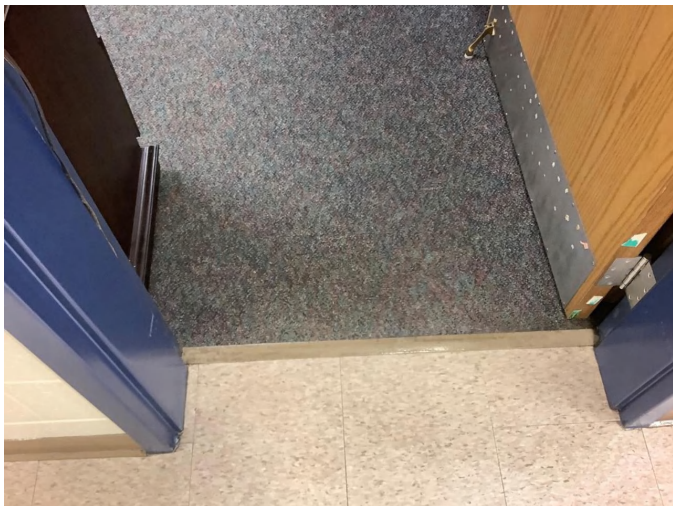
#### **System: C3020901 - Carpet**

**Location:** Media Center and Main office  
**Distress:** Beyond Expected Life  
**Category:** Deferred Maintenance  
**Priority:** 3 - Necessary (Years 2-5)  
**Correction:** Renew System  
**Qty:** 7,679.00  
**Unit of Measure:** S.F.  
**Estimate:** \$63,352.00  
**Assessor Name:** Homero Guerrero  
**Date Created:** 12/27/2019

**Notes:** The carpet is aged, worn and stained, and should be replaced.

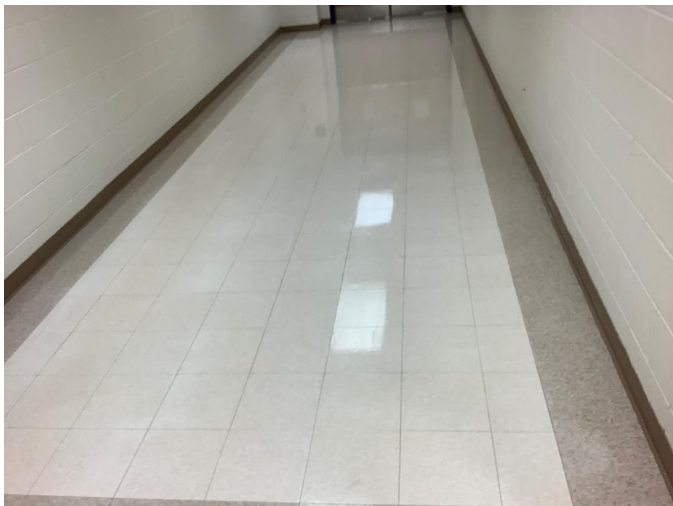
#### **System: C3020903 - VCT**

**Location:** Throughout Building  
**Distress:** Beyond Expected Life  
**Category:** Deferred Maintenance  
**Priority:** 3 - Necessary (Years 2-5)  
**Correction:** Renew System  
**Qty:** 70,735.00  
**Unit of Measure:** S.F.  
**Estimate:** \$381,545.00  
**Assessor Name:** Homero Guerrero  
**Date Created:** 12/27/2019

**Notes:** The VCT floor finish is beyond its expected service life, starting to fade in some areas and should be replaced.

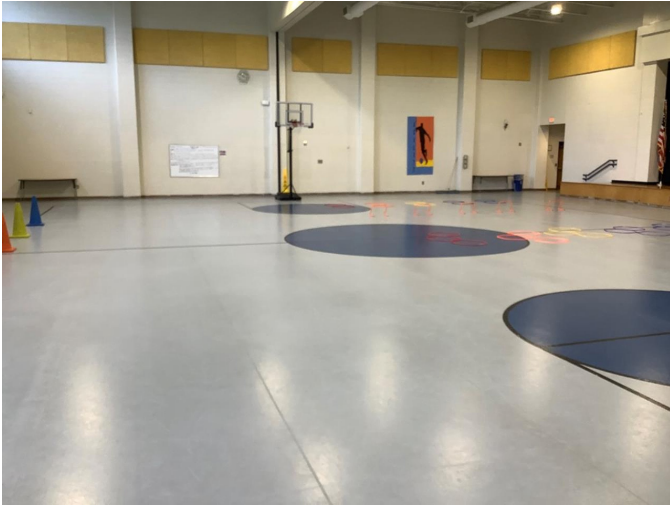
**System: C3020999 - Other - Rubber or Neoprene**

**Location:** Gym/ Multipurpose room  
**Distress:** Beyond Expected Life  
**Category:** Deferred Maintenance  
**Priority:** 3 - Necessary (Years 2-5)  
**Correction:** Renew System  
**Qty:** 5,329.00  
**Unit of Measure:** S.F.  
**Estimate:** \$156,337.00  
**Assessor Name:** Homero Guerrero  
**Date Created:** 12/27/2019

**Notes:** The Neoprene/Rubber floor finish is beyond its expected service life, worn and damaged, and is recommended for replacement.

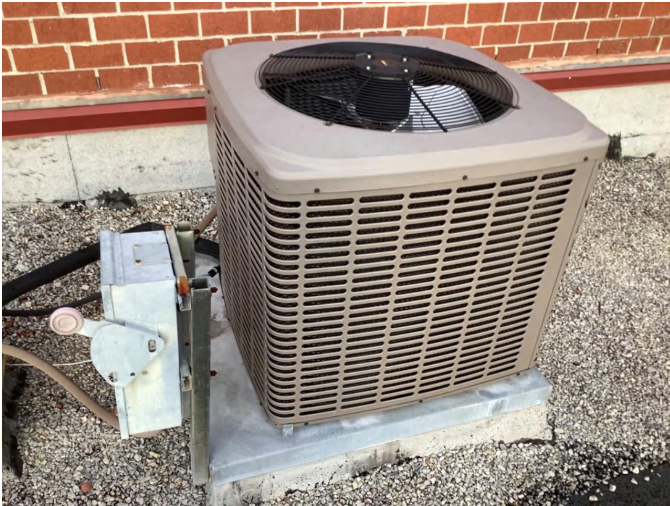
**System: D3050 - Terminal & Package Units**

**Location:** Roof  
**Distress:** Beyond Expected Life  
**Category:** Deferred Maintenance  
**Priority:** 3 - Necessary (Years 2-5)  
**Correction:** Renew System  
**Qty:** 95,024.00  
**Unit of Measure:** S.F.  
**Estimate:** \$695,101.00  
**Assessor Name:** Homero Guerrero  
**Date Created:** 10/01/2019

**Notes:** Terminal package units are beyond their expected life. Units are recommended for replacement.

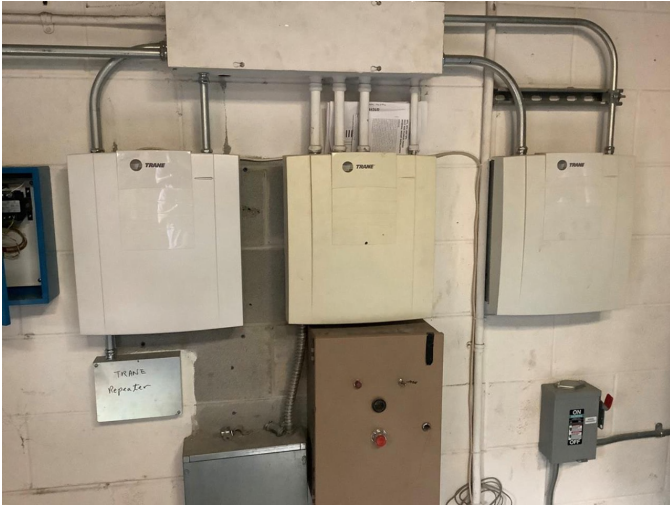
**System: D3060 - Controls & Instrumentation**

**Location:** Throughout Building  
**Distress:** Beyond Expected Life  
**Category:** Deferred Maintenance  
**Priority:** 3 - Necessary (Years 2-5)  
**Correction:** Renew System  
**Qty:** 95,024.00  
**Unit of Measure:** S.F.  
**Estimate:** \$229,958.00  
**Assessor Name:** Homero Guerrero  
**Date Created:** 10/01/2019

**Notes:** The energy monitoring and controls as well as the building automation systems are original. Several issues have surfaced over recent years and isolated upgrades have taken place to support the systems. This system is recommended for replacement or upgrade.

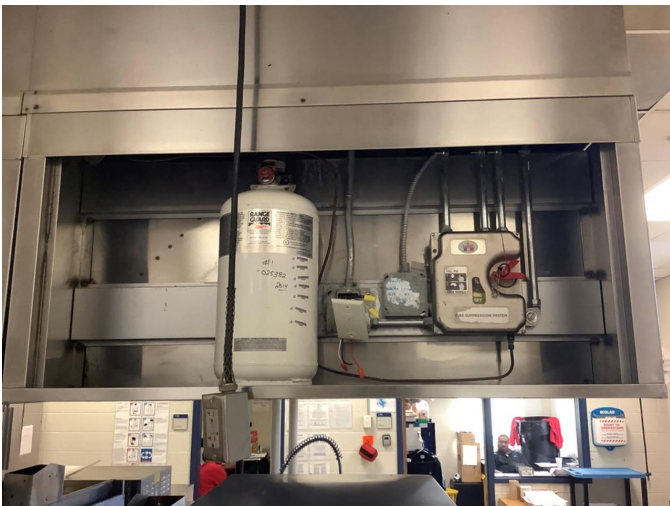
**System: D4090 - Other Fire Protection Systems**

**Location:** Kitchen  
**Distress:** Beyond Expected Life  
**Category:** Deferred Maintenance  
**Priority:** 3 - Necessary (Years 2-5)  
**Correction:** Renew System  
**Qty:** 95,024.00  
**Unit of Measure:** S.F.  
**Estimate:** \$62,716.00  
**Assessor Name:** Homero Guerrero  
**Date Created:** 10/01/2019

**Notes:** ANSUL directional extinguisher system is located in the kitchen area and it appears aged. During the time of the inspection it appeared to not have been upgraded within the past five years. With this in mind upgrades are warranted at this time.

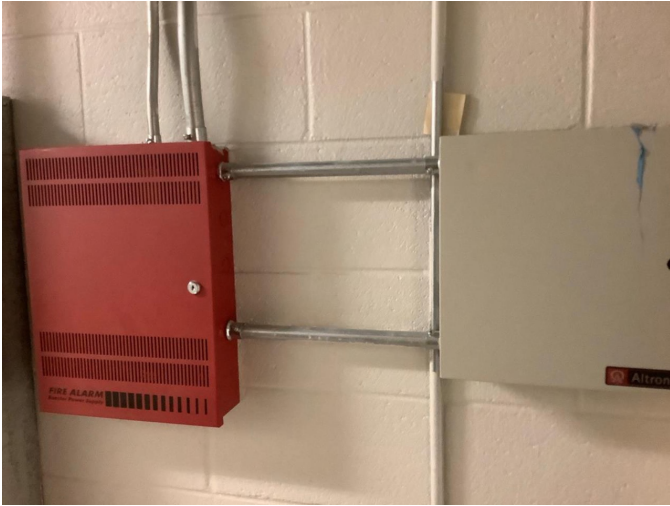
**System: D5030910 - Fire Alarm Systems**

**Location:** Throughout Building  
**Distress:** Beyond Expected Life  
**Category:** Deferred Maintenance  
**Priority:** 3 - Necessary (Years 2-5)  
**Correction:** Renew System  
**Qty:** 95,024.00  
**Unit of Measure:** S.F.  
**Estimate:** \$286,402.00  
**Assessor Name:** Homero Guerrero  
**Date Created:** 12/27/2019

**Notes:** The fire alarm system appears to be from original construction. This system is nearing the end of its expected life and upgrades are warranted.

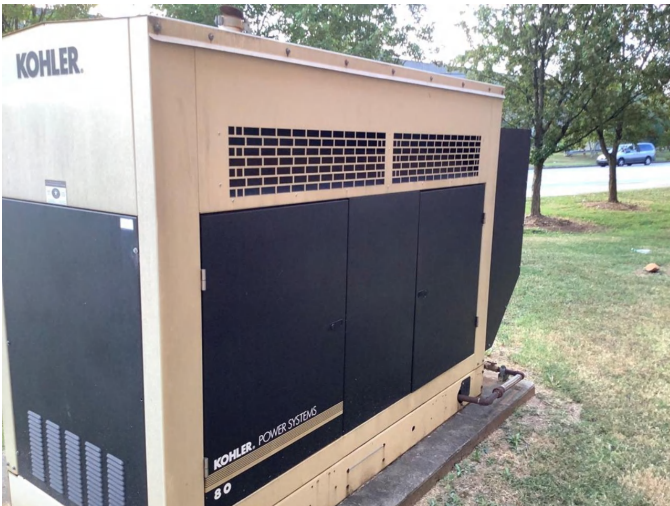
**System: D5090 - Other Electrical Systems**

**Location:** Throughout Building  
**Distress:** Beyond Expected Life  
**Category:** Deferred Maintenance  
**Priority:** 3 - Necessary (Years 2-5)  
**Correction:** Renew System  
**Qty:** 95,024.00  
**Unit of Measure:** S.F.  
**Estimate:** \$35,539.00  
**Assessor Name:** Homero Guerrero  
**Date Created:** 10/01/2019

**Notes:** The emergency generator was installed in 2004 as part of the renovation effort. The emergency lighting system and generator is recommended for upgrade.
