Atlanta Public Schools/ S. Atlanta Cluster

# Forrest Hill Academy HS

## School Assessment Report

November 10, 2020

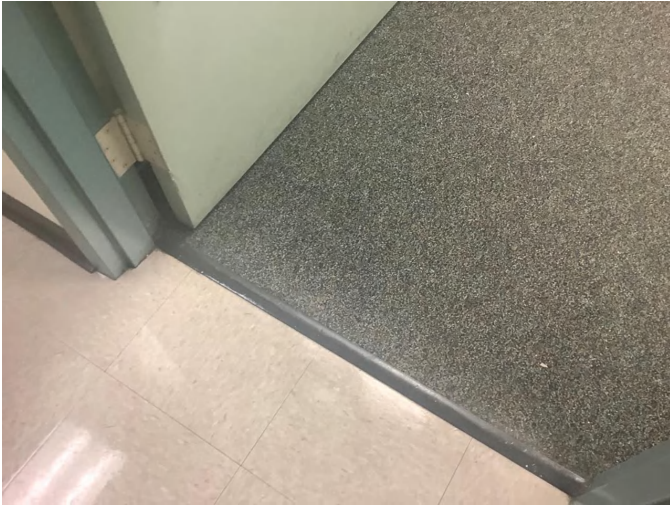
#### System: C3020901 - Carpet

**Location:** Throughout building  
**Distress:** Beyond Expected Life  
**Category:** Deferred Maintenance  
**Priority:** 3 - Necessary (Years 2-5)  
**Correction:** Renew System  
**Qty:** 12,000.00  
**Unit of Measure:** S.F.  
**Estimate:** \$99,000.00  
**Assessor Name:** Homero Guerrero  
**Date Created:** 01/25/2020

**Notes:** The carpet is aged, worn and stained, and should be replaced.
