Atlanta Public Schools/ S. Atlanta Cluster

# Heritage Academy

## School Assessment Report

November 10, 2020

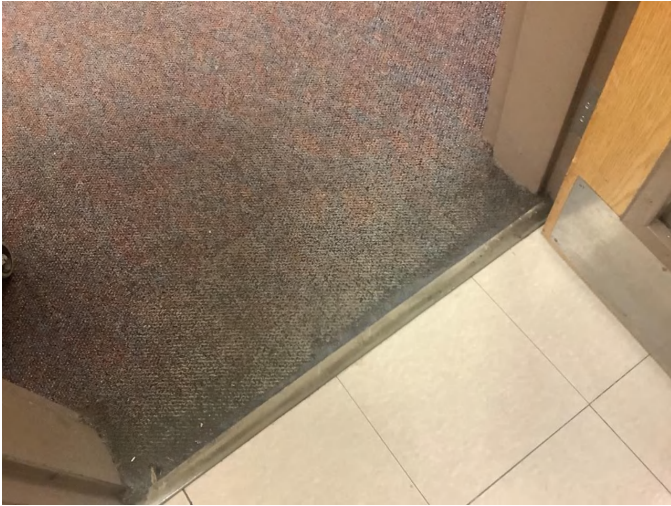
#### System: C3020901 - Carpet

**Location:** Media Center  
**Distress:** Beyond Expected Life  
**Category:** Deferred Maintenance  
**Priority:** 3 - Necessary (Years 2-5)  
**Correction:** Renew System  
**Qty:** 2,000.00  
**Unit of Measure:** S.F.  
**Estimate:** \$16,500.00  
**Assessor Name:** Homero Guerrero  
**Date Created:** 01/14/2020

**Notes:** The Carpet floor finish is beyond its expected service life, worn and damaged, and is recommended for replacement.

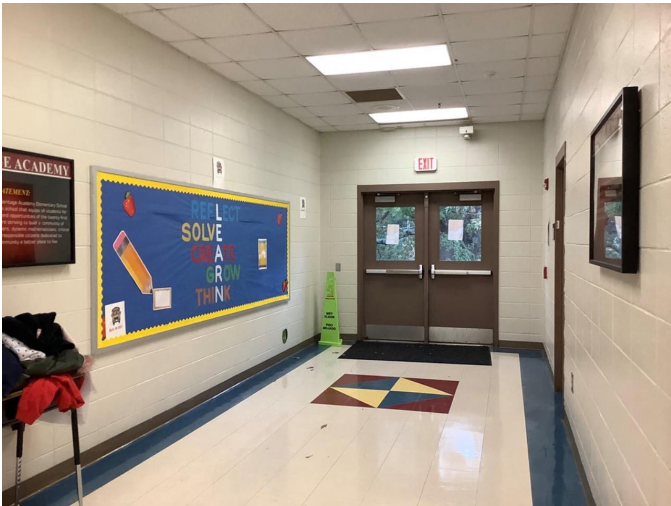
#### System: C3020903 - VCT

**Location:** Throughout Building  
**Distress:** Beyond Expected Life  
**Category:** Deferred Maintenance  
**Priority:** 3 - Necessary (Years 2-5)  
**Correction:** Renew System  
**Qty:** 73,864.00  
**Unit of Measure:** S.F.  
**Estimate:** \$398,422.00  
**Assessor Name:** Homero Guerrero  
**Date Created:** 01/09/2020

**Notes:** The VCT floor finish is beyond its expected service life, worn and damaged, and is recommended for replacement.

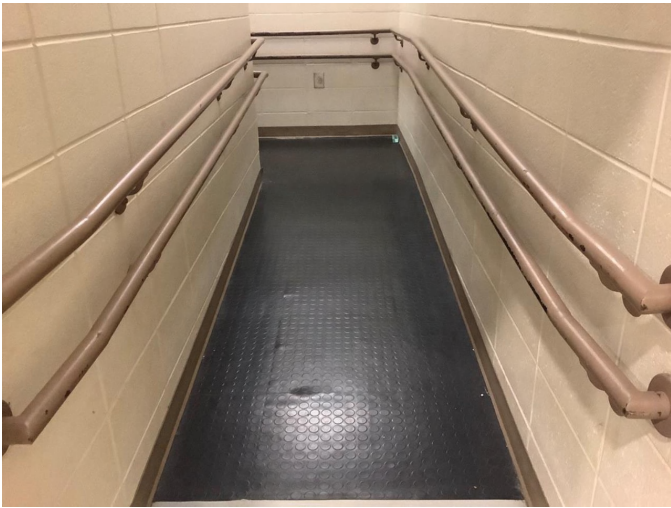
**System: C3020999 - Other - Rubber or Neoprene**

**Location:** Gym  
**Distress:** Beyond Expected Life  
**Category:** Deferred Maintenance  
**Priority:** 3 - Necessary (Years 2-5)  
**Correction:** Renew System  
**Qty:** 3,000.00  
**Unit of Measure:** S.F.  
**Estimate:** \$88,011.00  
**Assessor Name:** Homero Guerrero  
**Date Created:** 01/09/2020

**Notes:** The Rubber or Neoprene floor finish is beyond its expected service life, worn and damaged, and is recommended for replacement.

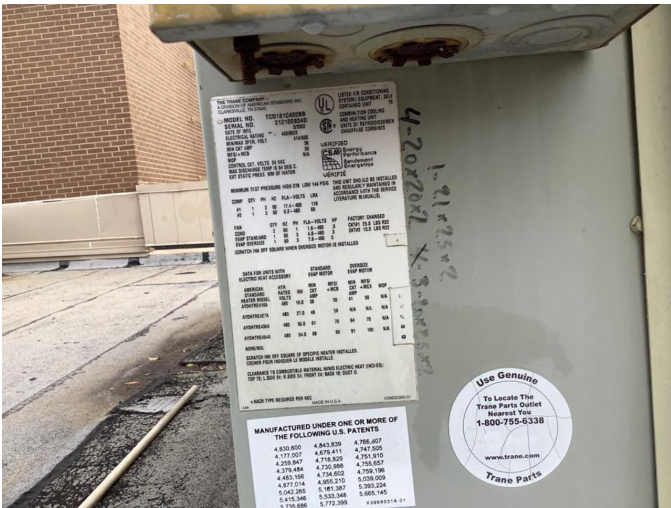
**System: D3050 - Terminal & Package Units**

**Location:** Roof  
**Distress:** Beyond Expected Life  
**Category:** Deferred Maintenance  
**Priority:** 3 - Necessary (Years 2-5)  
**Correction:** Renew System  
**Qty:** 80,864.00  
**Unit of Measure:** S.F.  
**Estimate:** \$657,343.00  
**Assessor Name:** Homero Guerrero  
**Date Created:** 09/28/2019

**Notes:** The terminal and package units are at the end of their useful life. The system is functional however upgrades are warranted.

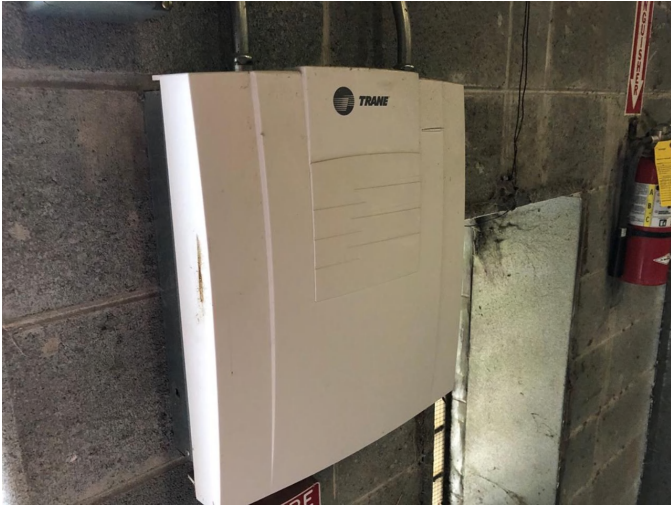
**System: D3060 - Controls & Instrumentation**

**Location:** Throughout Building  
**Distress:** Beyond Expected Life  
**Category:** Deferred Maintenance  
**Priority:** 3 - Necessary (Years 2-5)  
**Correction:** Renew System  
**Qty:** 80,864.00  
**Unit of Measure:** S.F.  
**Estimate:** \$218,818.00  
**Assessor Name:** Homero Guerrero  
**Date Created:** 02/22/2020

**Notes:** Principal, maintenance staff and multiple teachers report inconsistent operation of HVAC system, extreme variations in temperature from area to adjacent area, variations in temperature from day to day or week to week within the same space and similar extreme problems.

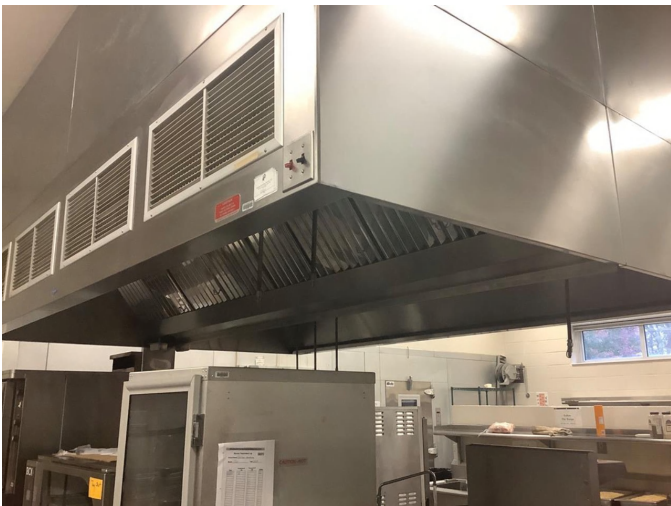
**System: D4090 - Other Fire Protection Systems**

**Location:** Kitchen  
**Distress:** Beyond Expected Life  
**Category:** Deferred Maintenance  
**Priority:** 3 - Necessary (Years 2-5)  
**Correction:** Renew System  
**Qty:** 80,864.00  
**Unit of Measure:** S.F.  
**Estimate:** \$58,707.00  
**Assessor Name:** Homero Guerrero  
**Date Created:** 09/28/2019

**Notes:** The exhaust hood system is original. This building high traffic use warrants upgrades to this system based on usage and age. This deficiency provides a budgetary consideration for upgrades to the system.
