Atlanta Public Schools/ Washington Cluster

# Hollis Innovation Academy

## School Assessment Report

November 10, 2020

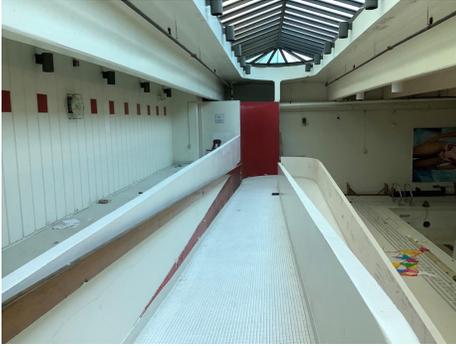
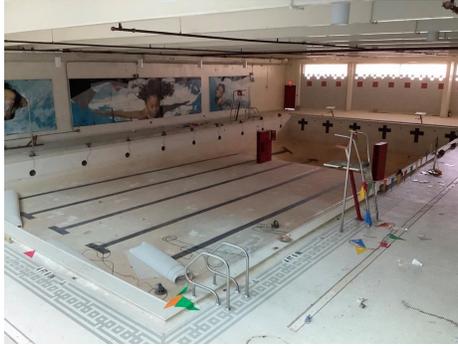
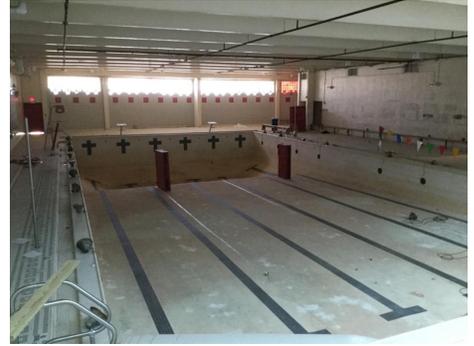
**System:** F1040 - Special Facilities Pool

**Notes:** The Pool was not included in the recent renovation efforts. The system is abandoned in place. This deficiency provides a budgetary consideration to renew the Pool for this school.

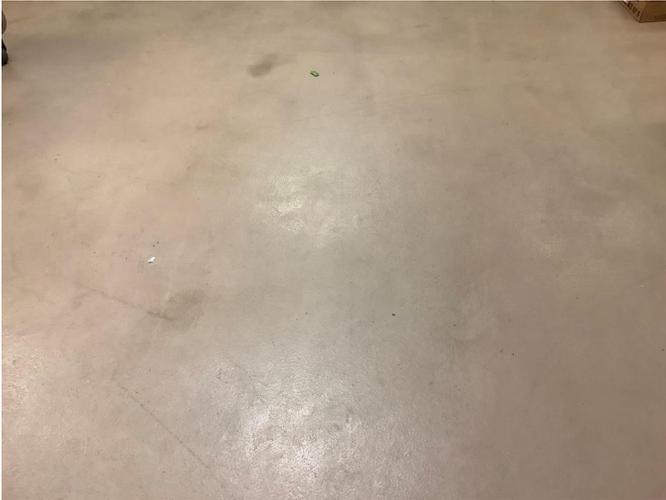
#### System: C3020405 - Epoxy

**Location:** Kitchen  
**Distress:** Beyond Expected Life  
**Category:** Deferred Maintenance  
**Priority:** 3 - Necessary (Years 2-5)  
**Correction:** Renew System  
**Qty:** 8,000.00  
**Unit of Measure:** S.F.  
**Estimate:** \$163,312.00  
**Assessor Name:** Eduardo Lopez  
**Date Created:** 12/26/2019

**Notes:** The Epoxy floor finish is beyond its expected service life, worn and damaged, and is recommended for replacement.

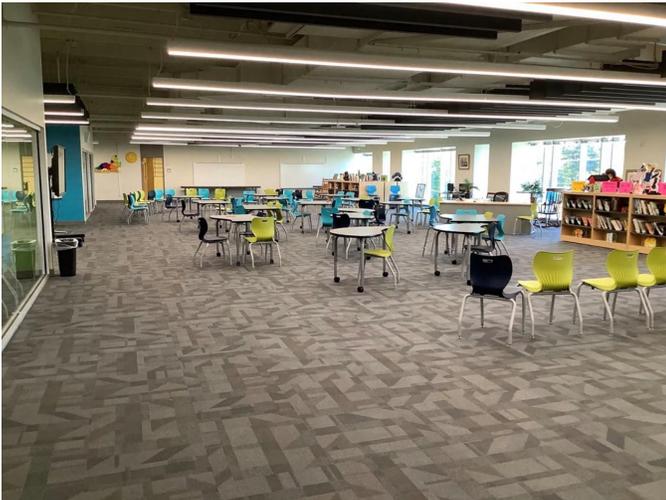
#### System: C3020901 - Carpet

**Location:** Throughout Building  
**Distress:** Beyond Expected Life  
**Category:** Deferred Maintenance  
**Priority:** 3 - Necessary (Years 2-5)  
**Correction:** Renew System  
**Qty:** 8,000.00  
**Unit of Measure:** S.F.  
**Estimate:** \$99,352.00  
**Assessor Name:** Eduardo Lopez  
**Date Created:** 12/26/2019

**Notes:** The carpet floor finish is beyond its expected service life, worn and damaged, and is recommended for replacement.

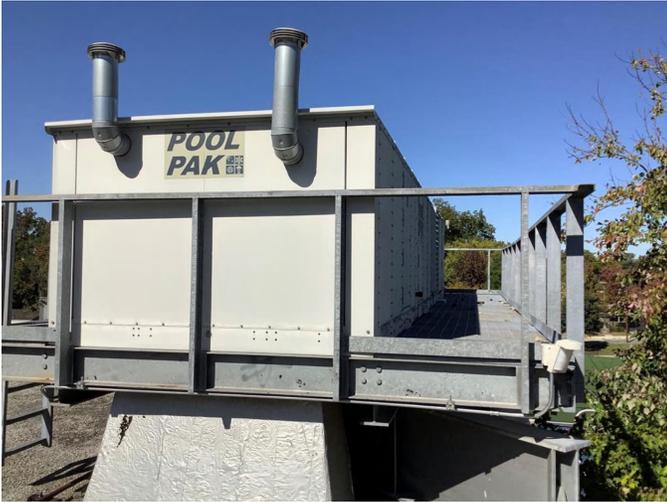
**System: D3030 - Cooling Generating Systems**

**Location:** Throughout Building  
**Distress:** Beyond Expected Life  
**Category:** Deferred Maintenance  
**Priority:** 3 - Necessary (Years 2-5)  
**Correction:** Renew System  
**Qty:** 228,355.00  
**Unit of Measure:** S.F.  
**Estimate:** \$1,647,810.00  
**Assessor Name:** Eduardo Lopez  
**Date Created:** 10/06/2020

**Notes:** The cooling generating system is beyond its expected service life and should be scheduled for replacement.

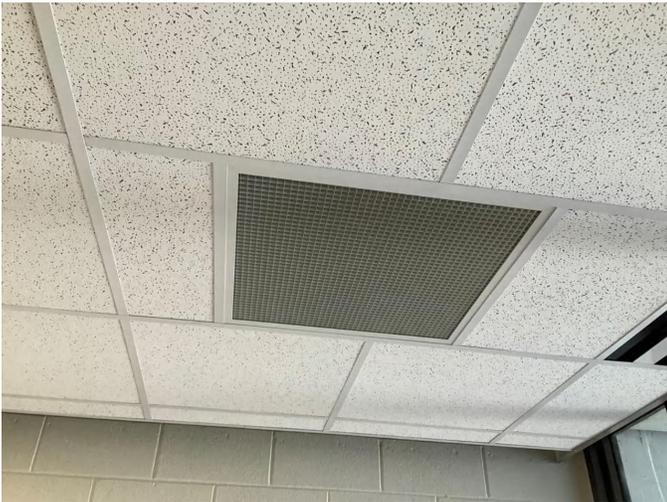
**System: D3040 - Distribution Systems**

**Location:** Throughout Building  
**Distress:** Beyond Expected Life  
**Category:** Deferred Maintenance  
**Priority:** 3 - Necessary (Years 2-5)  
**Correction:** Renew System  
**Qty:** 228,355.00  
**Unit of Measure:** S.F.  
**Estimate:** \$2,886,179.00  
**Assessor Name:** Eduardo Lopez  
**Date Created:** 10/06/2020

**Notes:** The distribution system is beyond its expected service life and should be scheduled for replacement.

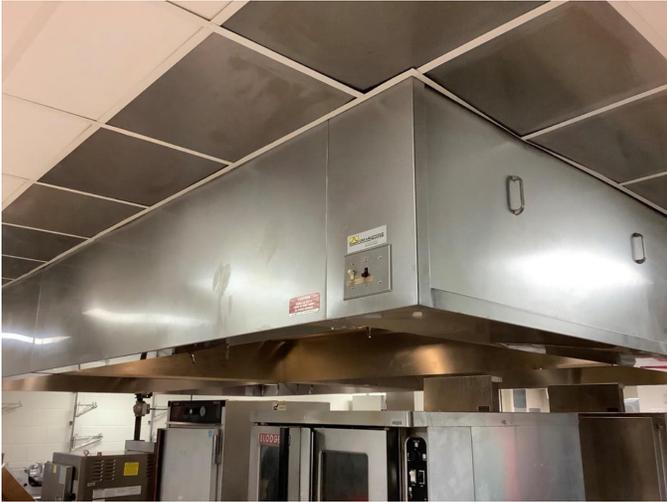
**System: D4090 - Other Fire Protection Systems**

**Location:** Throughout Building  
**Distress:** Beyond Expected Life  
**Category:** Deferred Maintenance  
**Priority:** 3 - Necessary (Years 2-5)  
**Correction:** Renew System  
**Qty:** 228,355.00  
**Unit of Measure:** S.F.  
**Estimate:** \$165,786.00  
**Assessor Name:** Eduardo Lopez  
**Date Created:** 10/01/2019

**Notes:** The kitchen exhaust hood system warrants upgrades based on usage and age. This deficiency provides a budgetary consideration for universal upgrades to the system.

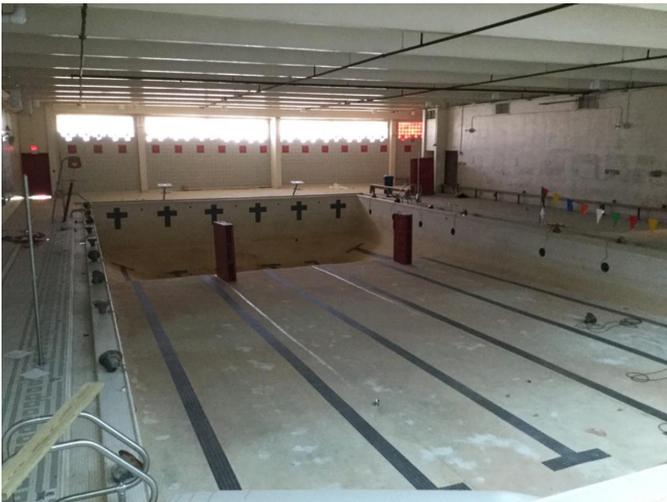
**System: F1040 - Special Facilities Pool**

**Location:** Pool  
**Distress:** Beyond Expected Life  
**Category:** Deferred Maintenance  
**Priority:** 3 - Necessary (Years 2-5)  
**Correction:** Renew System  
**Qty:** 228,355.00  
**Unit of Measure:** S.F.  
**Estimate:** \$434,560.00  
**Assessor Name:** Eduardo Lopez  
**Date Created:** 02/21/2020

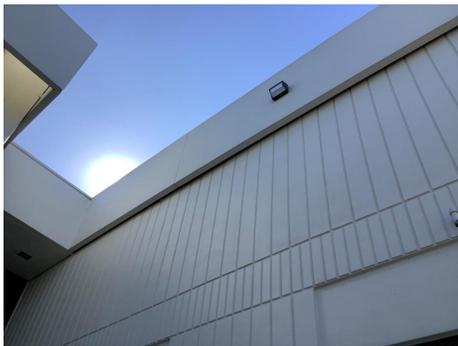
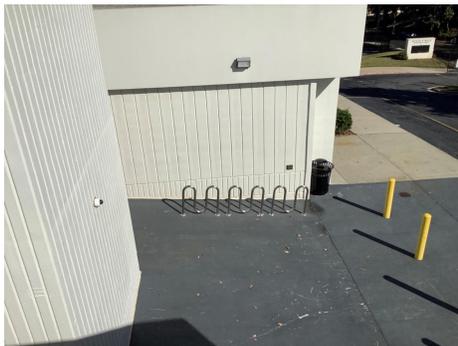
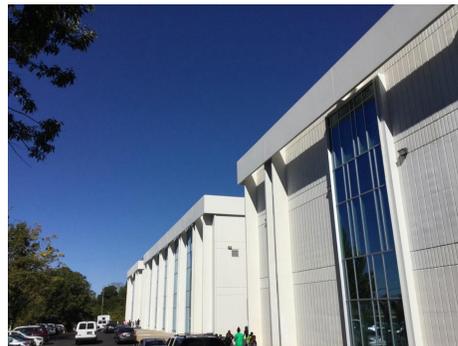
**System:** G4020 - Site Lighting

**Note:** Site lighting fixtures are original. Exterior building lighting fixtures were replaced during 2004 renovation, but are included in D5020 Lighting & Branch Wiring.

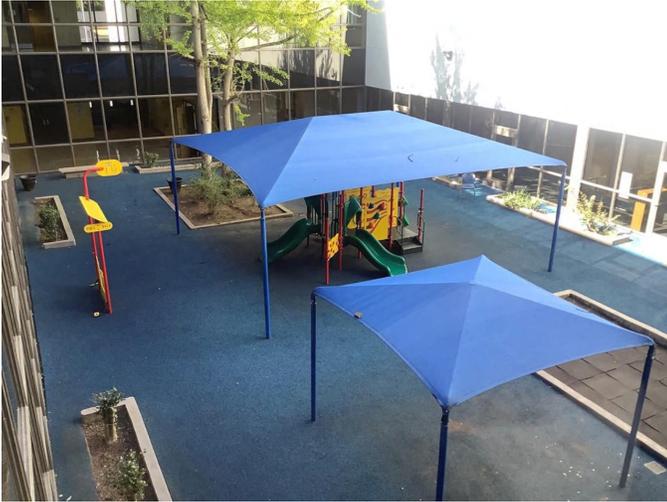
#### **System: G2040950 - Playing Field**

**Location:** Site  
**Distress:** Beyond Expected Life  
**Category:** Deferred Maintenance  
**Priority:** 3 - Necessary (Years 2-5)  
**Correction:** Renew System  
**Qty:** 228,355.00  
**Unit of Measure:** S.F.  
**Estimate:** \$200,952.00  
**Assessor Name:** Hayden Collins  
**Date Created:** 12/27/2019
