Humphries Elementary School

School Assessment Report

November 10, 2020

Humphries Elementary School (Buildings 2031, 2040,2032,2033,2050,2030) are located at 3029 Humphries Drive, Atlanta, GA. The total square footage of the building is 66,228, and was constructed in 1940. There were building renovations done in 1967,1994,1996 and 2020.

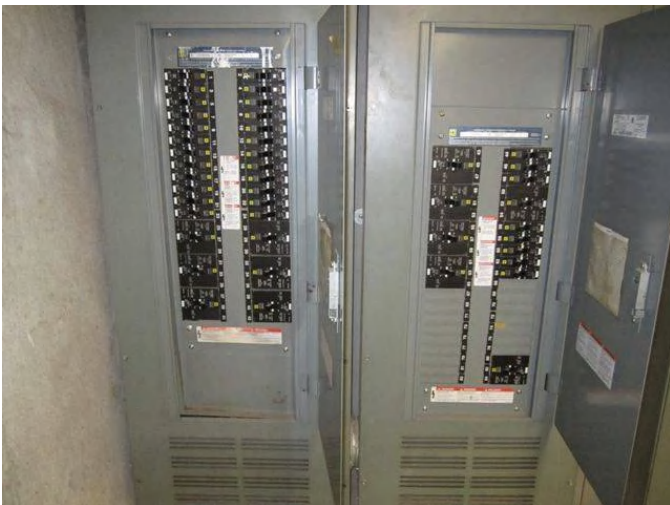
System: D5010 - Electrical Service/Distribution

Location: Throughout building
Distress: Beyond Expected Life
Category: Deferred Maintenance
Priority: 4 - Recommended (Years 6-10)
Correction: Renew System
Qty: 21,994.00
Unit of Measure: S.F.
Estimate: \$53,225.00
Assessor Name: Eduardo Lopez
Date Created: 07/29/2013

Notes: The electrical service/distribution system is aged and should be replaced and upgraded for compliance with current code requirements.

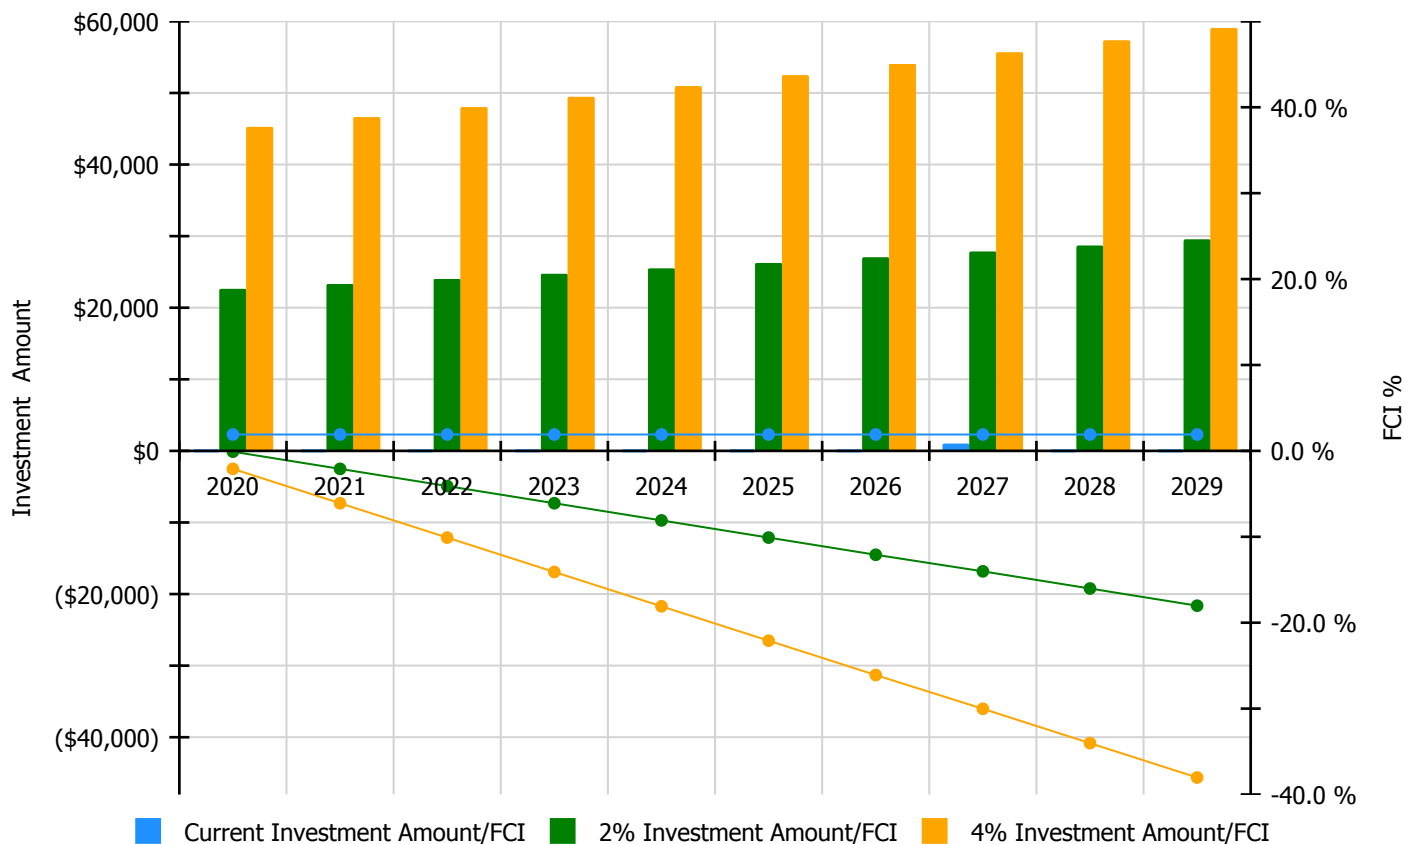
Facility Investment vs. FCI Forecast

- Current FCI: a variable investment amount based on renewing expired systems to maintain the current FCI for the building
- 2% Investment: an annual investment of 2% of the replacement value of the building, escalated for inflation
- 4% Investment: an annual investment of 4% of the replacement value of the building, escalated for inflation

Year	Investment Amount Current FCI - 1.91%	2% Investment		4% Investment	
		Amount	FCI	Amount	FCI
2020	\$0	\$22,627.00	-0.09 %	\$45,255.00	-2.09 %
2021	\$0	\$23,306.00	-2.09 %	\$46,613.00	-6.09 %
2022	\$0	\$24,005.00	-4.09 %	\$48,011.00	-10.09 %
2023	\$0	\$24,726.00	-6.09 %	\$49,451.00	-14.09 %
2024	\$0	\$25,467.00	-8.09 %	\$50,935.00	-18.09 %
2025	\$0	\$26,231.00	-10.09 %	\$52,463.00	-22.09 %
2026	\$0	\$27,018.00	-12.09 %	\$54,037.00	-26.09 %
2027	\$998	\$27,829.00	-14.02 %	\$55,658.00	-30.02 %
2028	\$0	\$28,664.00	-16.02 %	\$57,328.00	-34.02 %
2029	\$0	\$29,524.00	-18.02 %	\$59,047.00	-38.02 %
Total:	\$998	\$259,397.00		\$518,798.00

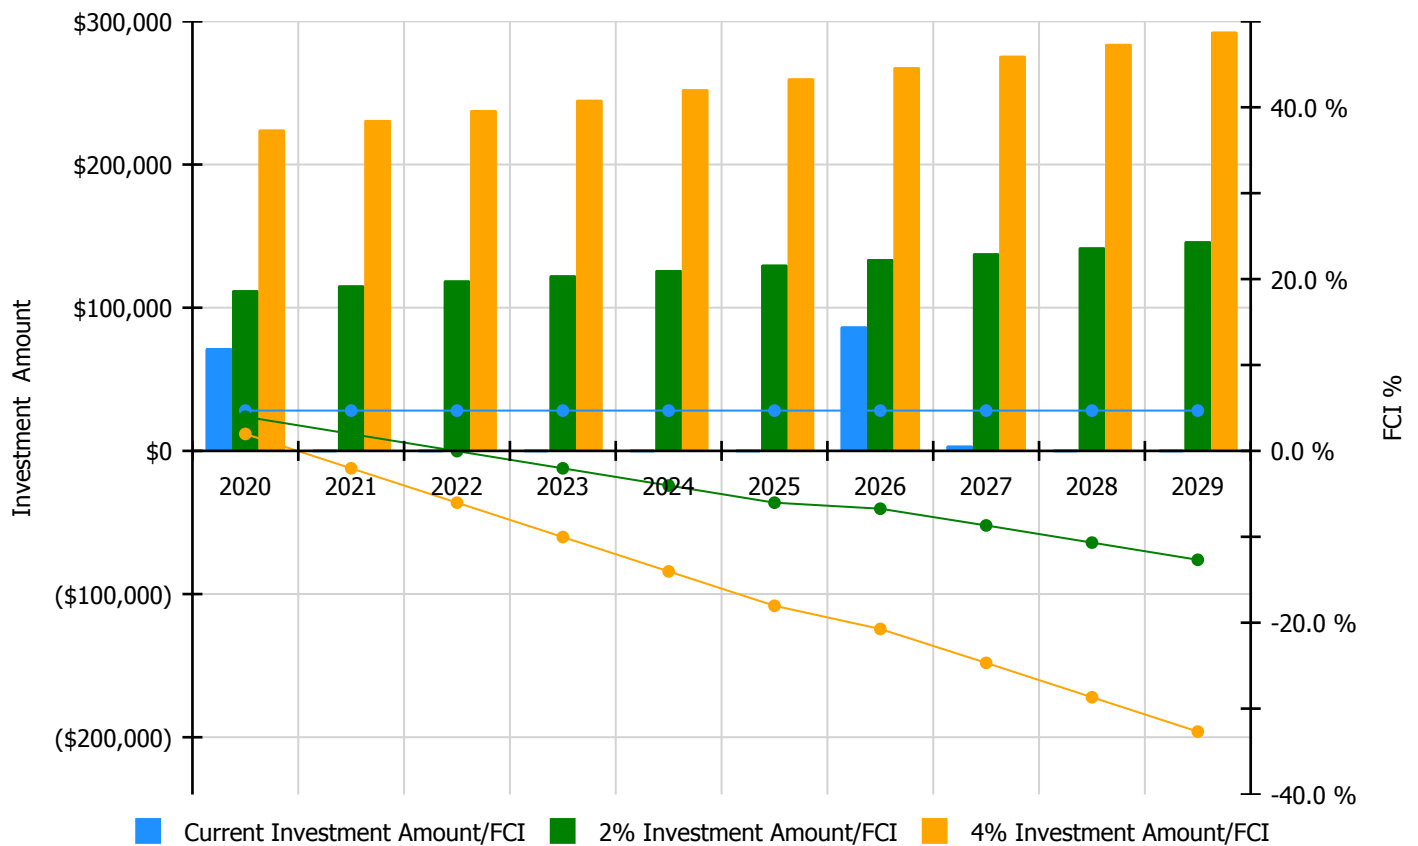
Facility Investment vs. FCI Forecast

- Current FCI: a variable investment amount based on renewing expired systems to maintain the current FCI for the building
- 2% Investment: an annual investment of 2% of the replacement value of the building, escalated for inflation
- 4% Investment: an annual investment of 4% of the replacement value of the building, escalated for inflation

Year	Investment Amount Current FCI - 4.69%	2% Investment		4% Investment	
		Amount	FCI	Amount	FCI
2020	\$71,786	\$112,205.00	3.97 %	\$224,410.00	1.97 %
2021	\$0	\$115,571.00	1.97 %	\$231,142.00	-2.03 %
2022	\$0	\$119,038.00	-0.03 %	\$238,077.00	-6.03 %
2023	\$0	\$122,609.00	-2.03 %	\$245,219.00	-10.03 %
2024	\$0	\$126,288.00	-4.03 %	\$252,575.00	-14.03 %
2025	\$0	\$130,076.00	-6.03 %	\$260,153.00	-18.03 %
2026	\$86,907	\$133,979.00	-6.73 %	\$267,957.00	-20.73 %
2027	\$3,679	\$137,998.00	-8.68 %	\$275,996.00	-24.68 %
2028	\$0	\$142,138.00	-10.68 %	\$284,276.00	-28.68 %
2029	\$0	\$146,402.00	-12.68 %	\$292,804.00	-32.68 %
Total:	\$162,371	\$1,286,304.00		\$2,572,609.00

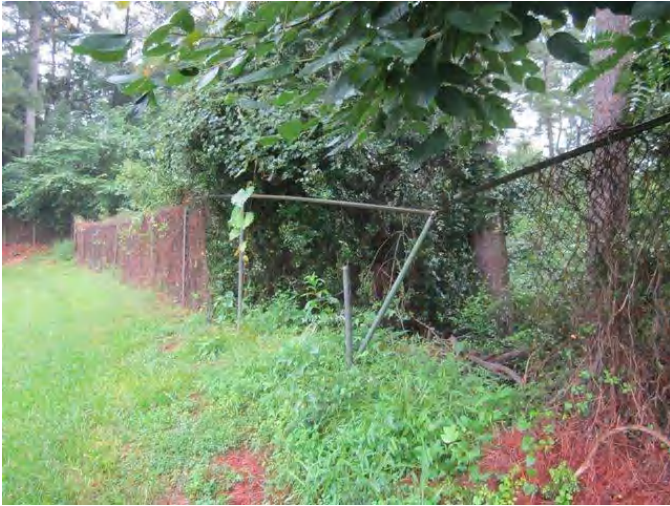
System: G2040 - Site Development

Location: Site
Distress: Failing
Category: Deferred Maintenance
Priority: 2 - Trending Critical (Year 1)
Correction: Replace and/or add fencing for security/appearance
Qty: 1,920.00
Unit of Measure: L.F.
Estimate: \$173,226.05
Assessor Name: Eduardo Lopez
Date Created: 07/31/2013

Notes: R & R fencing at site.

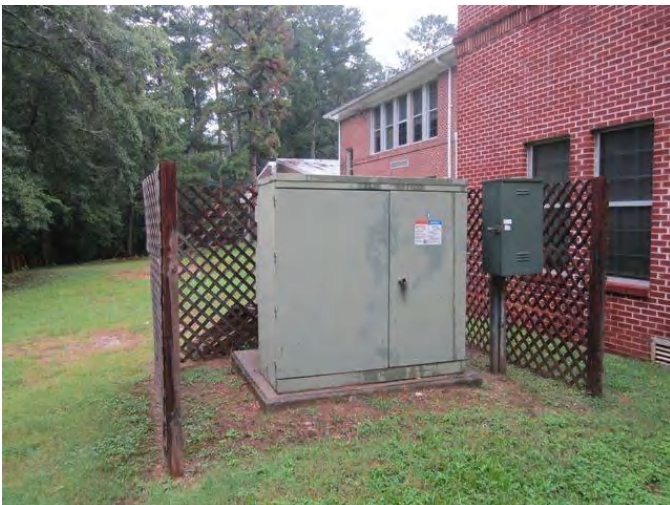
System: G4010 - Electrical Distribution

Location: Site
Distress: Beyond Expected Life
Category: Deferred Maintenance
Priority: 4 - Recommended (Years 6-10)
Correction: Renew System
Qty: 66,228.00
Unit of Measure: S.F.
Estimate: \$176,299.00
Assessor Name: Eduardo Lopez
Date Created: 07/29/2013
