Atlanta Public Schools/ Washington Cluster

# Jones, M.A. Elementary School

## School Assessment Report

November 10, 2020

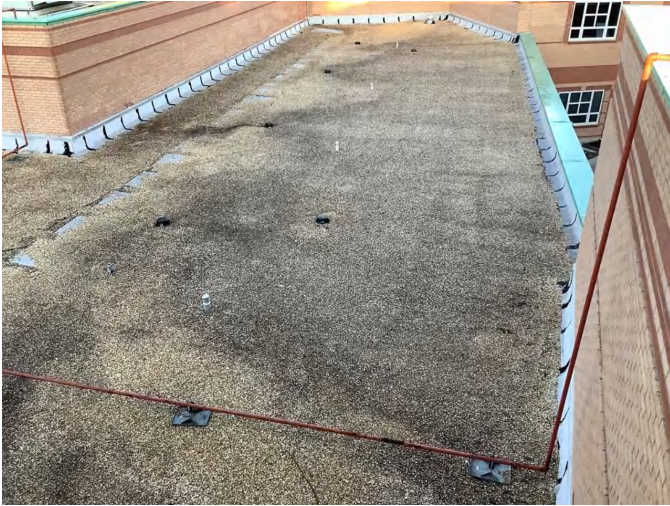
#### System: B3010105 - Built-Up

**Location:** Roof  
**Distress:** Inadequate  
**Category:** Facility Integrity  
**Priority:** 2 - Trending Critical (Year 1)  
**Correction:** Minor BUR membrane repairs, 2% of roof area  
**Qty:** 100.00  
**Unit of Measure:** Sq.  
**Estimate:** \$75,476.41  
**Assessor Name:** Eduardo Lopez  
**Date Created:** 10/06/2020

**Notes:** Built-up roof covering is in deteriorating conditions with signs of water leaks throughout and should be repaired.

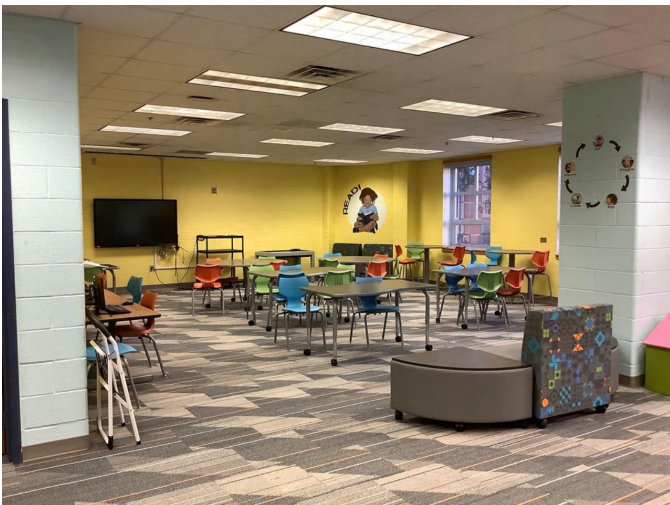
#### System: C3020901 - Carpet

**Location:** Media Center  
**Distress:** Beyond Expected Life  
**Category:** Deferred Maintenance  
**Priority:** 3 - Necessary (Years 2-5)  
**Correction:** Renew System  
**Qty:** 5,000.00  
**Unit of Measure:** S.F.  
**Estimate:** \$41,250.00  
**Assessor Name:** Eduardo Lopez  
**Date Created:** 12/19/2019

**Notes:** The Carpet floor finish is beyond its expected service life, worn and damaged, and is recommended for replacement.

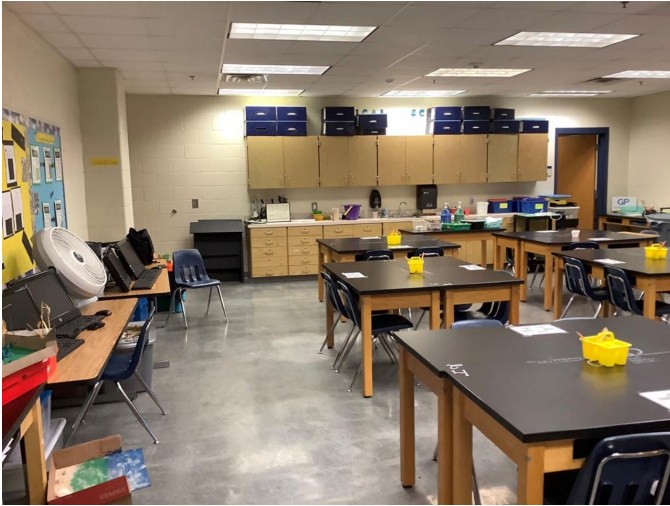
**System: C3020999 - Other - Concrete Finish w/Sealer**

**Location:** Science Labs  
**Distress:** Beyond Expected Life  
**Category:** Deferred Maintenance  
**Priority:** 3 - Necessary (Years 2-5)  
**Correction:** Renew System  
**Qty:** 2,000.00  
**Unit of Measure:** S.F.  
**Estimate:** \$15,114.00  
**Assessor Name:** Eduardo Lopez  
**Date Created:** 12/19/2019

**Notes:** The Concrete Finish w/Sealer floor finish is beyond its expected service life, worn and damaged, and is recommended for replacement.

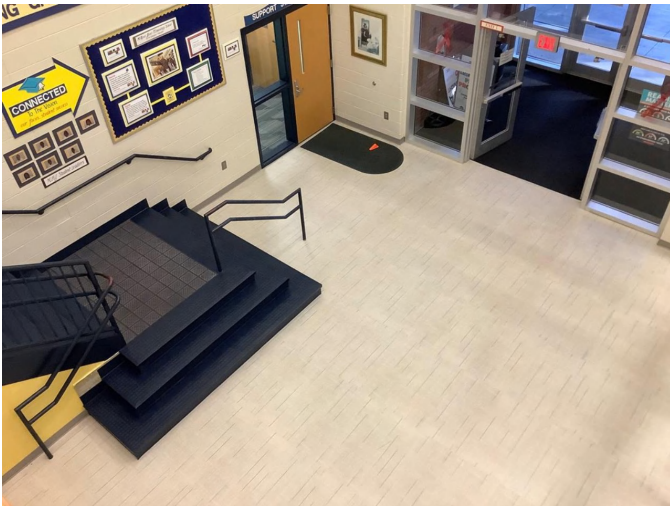
**System: C3020999 - Other - Rubber or Neoprene**

**Location:** Stairs  
**Distress:** Beyond Expected Life  
**Category:** Deferred Maintenance  
**Priority:** 3 - Necessary (Years 2-5)  
**Correction:** Renew System  
**Qty:** 1,000.00  
**Unit of Measure:** S.F.  
**Estimate:** \$29,337.00  
**Assessor Name:** Eduardo Lopez  
**Date Created:** 12/19/2019

**Notes:** The Rubber or Neoprene floor finish is beyond its expected service life, worn and damaged, and is recommended for replacement.

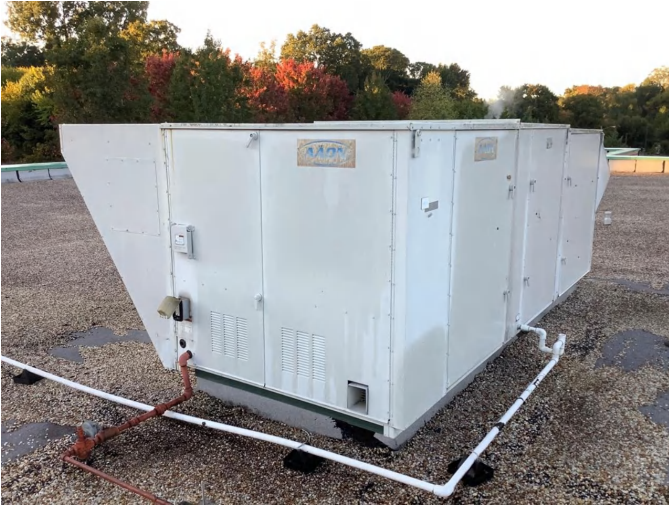
**System: D3050 - Terminal & Package Units**

**Location:** Roof  
**Distress:** Beyond Expected Life  
**Category:** Deferred Maintenance  
**Priority:** 3 - Necessary (Years 2-5)  
**Correction:** Renew System  
**Qty:** 92,272.00  
**Unit of Measure:** S.F.  
**Estimate:** \$674,970.00  
**Assessor Name:** Eduardo Lopez  
**Date Created:** 10/06/2020

**Notes:** The terminal and package units are beyond its expected service life and should be scheduled for replacement.

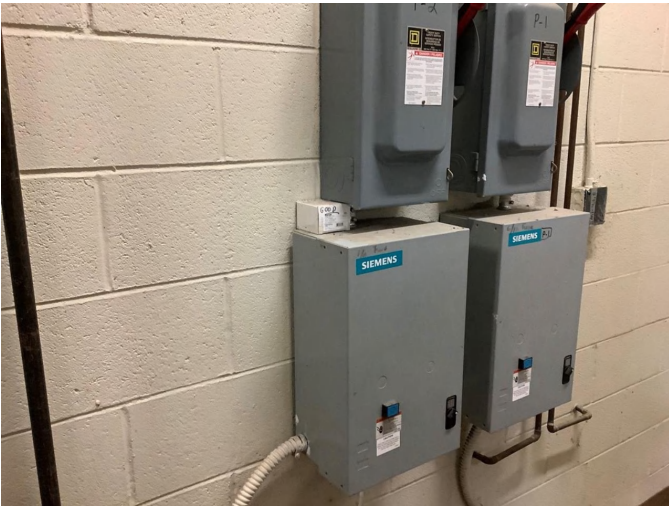
**System: D3060 - Controls & Instrumentation**

**Location:** Throughout building  
**Distress:** Beyond Expected Life  
**Category:** Deferred Maintenance  
**Priority:** 3 - Necessary (Years 2-5)  
**Correction:** Renew System  
**Qty:** 92,272.00  
**Unit of Measure:** S.F.  
**Estimate:** \$235,478.00  
**Assessor Name:** Eduardo Lopez  
**Date Created:** 02/22/2020

**Notes:** Building HVAC control system is not communicating properly, which is leading to air conditioning issues.
