Atlanta Public Schools/ Jackson Cluster

King, M.L. Middle School

School Assessment Report

November 10, 2020

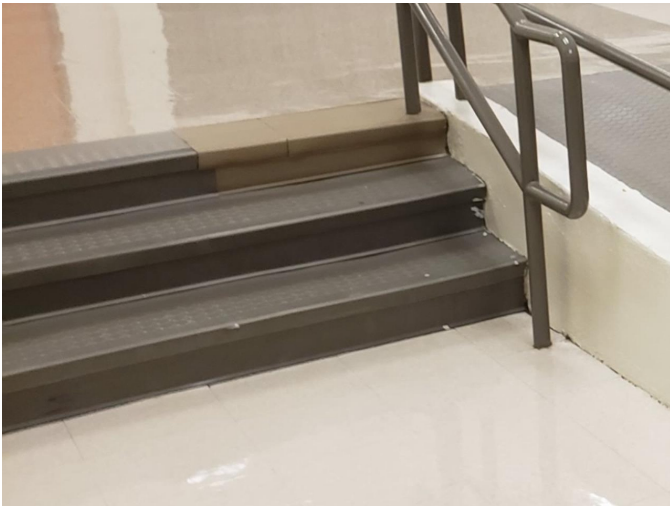
System: C3020999 - Other - Rubber or Neoprene

Location: Classroom Pods
Distress: Beyond Expected Life
Category: Deferred Maintenance
Priority: 3 - Necessary (Years 2-5)
Correction: Renew System
Qty: 636.00
Unit of Measure: S.F.
Estimate: \$18,658.00
Assessor Name: Jejuan Hall
Date Created: 09/19/2019

Notes: The rubber flooring is aged, some areas patched/missing, and should be replaced.

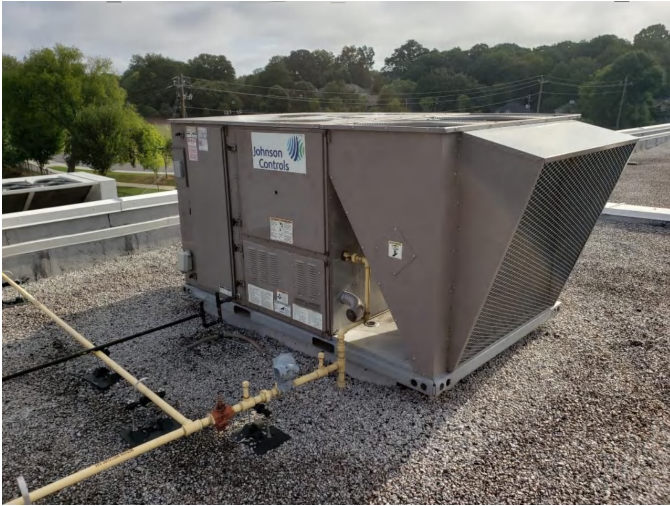
System: D3050 - Terminal & Package Units

Location: Throughout building
Distress: Beyond Expected Life
Category: Deferred Maintenance
Priority: 3 - Necessary (Years 2-5)
Correction: Renew System
Qty: 176,547.00
Unit of Measure: S.F.
Estimate: \$219,448.00
Assessor Name: Jejuan Hall
Date Created: 10/01/2019

Notes: The terminal and package units are at the end of their useful life. The system is functional however upgrades are warranted.

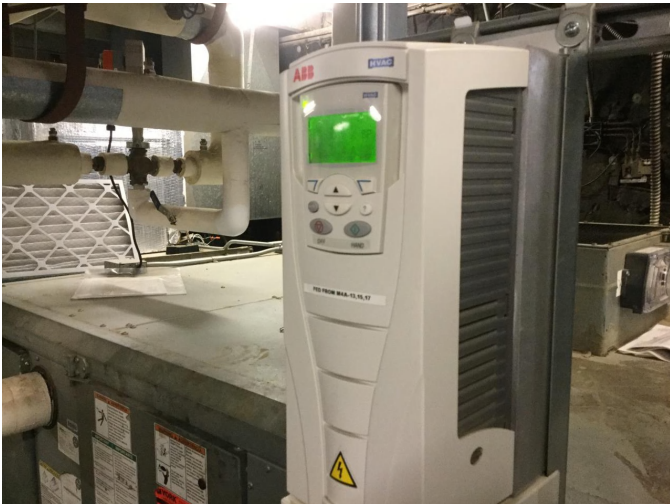
System: D3060 - Controls & Instrumentation

Location: Throughout building
Distress: Beyond Expected Life
Category: Deferred Maintenance
Priority: 3 - Necessary (Years 2-5)
Correction: Renew System
Qty: 176,547.00
Unit of Measure: S.F.
Estimate: \$557,359.00
Assessor Name: Jejuan Hall
Date Created: 10/01/2019

Notes: The heating generation systems, exhaust and ventilation systems, energy monitoring and controls as well as the building automation systems are original. Several issues have surfaced over recent years and isolated upgrades have taken place to support the systems. This deficiency provides a budgetary consideration for a universal upgrade.

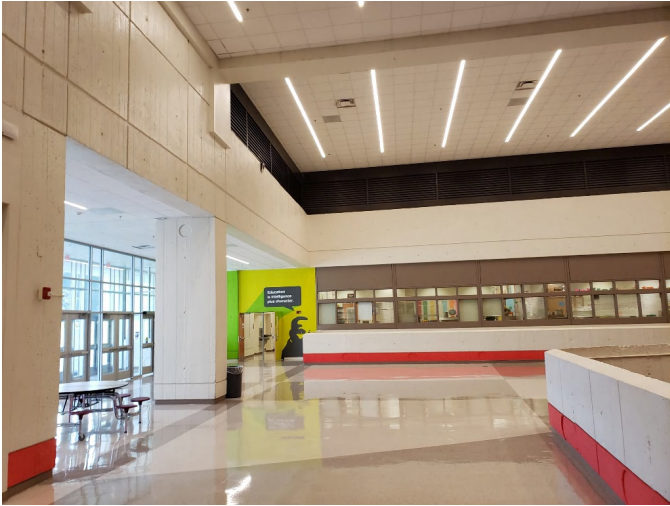
System: D5020 - Lighting

Location: 1973 Bldg 401.1_401.2
Distress: Missing
Category: Code Compliance
Priority: 3 - Necessary (Years 2-5)
Correction: Replace and/or add Exit Light fixtures w/wiring
Qty: 1.00
Unit of Measure: Ea.
Estimate: \$740.70
Assessor Name: Jejuan Hall
Date Created: 10/13/2019
