Atlanta Public Schools/ S. Atlanta Cluster

# Long Middle School

## School Assessment Report

November 10, 2020

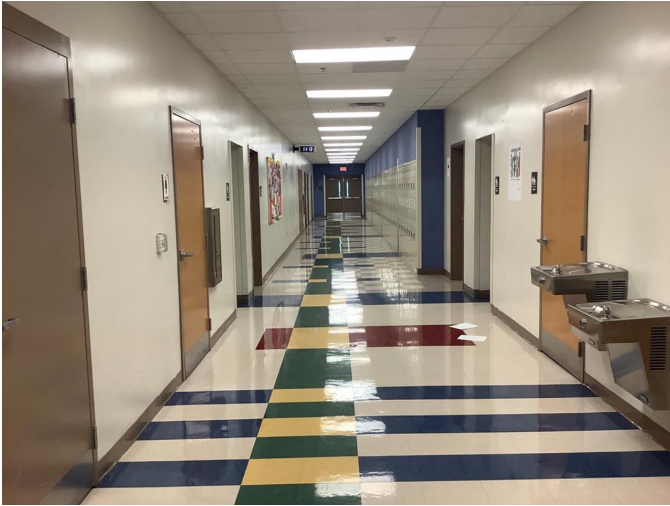
#### System: D2020 - Domestic Water Distribution

**Location:** Throughout Building  
**Distress:** Beyond Expected Life  
**Category:** Deferred Maintenance  
**Priority:** 3 - Necessary (Years 2-5)  
**Correction:** Renew System  
**Qty:** 102,585.00  
**Unit of Measure:** S.F.  
**Estimate:** \$65,449.00  
**Assessor Name:** Homero Guerrero  
**Date Created:** 02/22/2020

**Notes:** The domestic water distribution system consists of galvanized and copper pipes, valves and domestic water supply. The system is beyond its expected life cycle and upgrades are recommended.

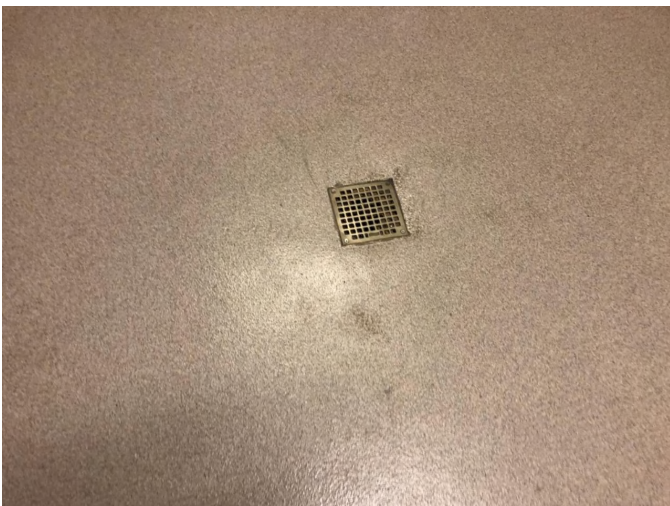
#### System: D2030 - Sanitary Waste

**Location:** Restrooms  
**Distress:** Beyond Expected Life  
**Category:** Deferred Maintenance  
**Priority:** 3 - Necessary (Years 2-5)  
**Correction:** Renew System  
**Qty:** 102,585.00  
**Unit of Measure:** S.F.  
**Estimate:** \$154,596.00  
**Assessor Name:** Homero Guerrero  
**Date Created:** 07/30/2013

**Notes:** The sanitary waste piping is original to the buildings construction. There were no reported issues during the time of the inspection however; based on age this system is recommended for upgrade.

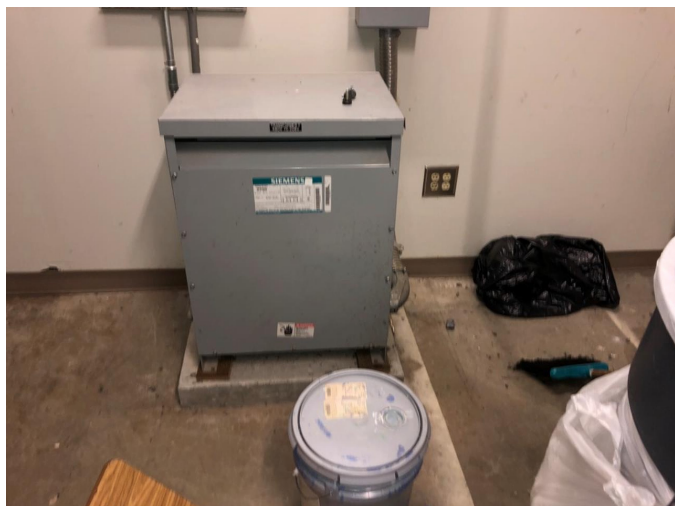
**System: D5010 - Electrical Service/Distribution**

**Location:** Electrical Room  
**Distress:** Beyond Expected Life  
**Category:** Deferred Maintenance  
**Priority:** 3 - Necessary (Years 2-5)  
**Correction:** Renew System  
**Qty:** 102,585.00  
**Unit of Measure:** S.F.  
**Estimate:** \$197,476.00  
**Assessor Name:** Homero Guerrero  
**Date Created:** 02/22/2020

**Notes:** The electrical service/distribution system is beyond its expected service life and should be scheduled for replacement.

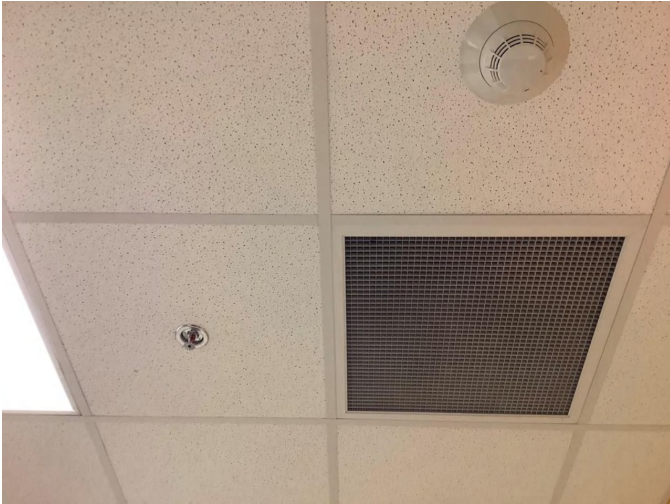
#### System: C3030 - Ceiling Finishes

**Location:** Throughout Building  
**Distress:** Beyond Expected Life  
**Category:** Deferred Maintenance  
**Priority:** 3 - Necessary (Years 2-5)  
**Correction:** Renew System  
**Qty:** 22,652.00  
**Unit of Measure:** S.F.  
**Estimate:** \$193,357.00  
**Assessor Name:** Homero Guerrero  
**Date Created:** 09/17/2015

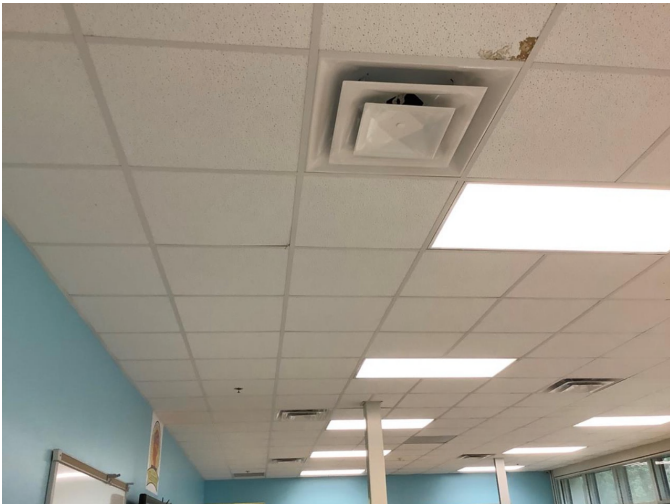
#### System: D3040 - Distribution Systems

**Location:** Throughout Building  
**Distress:** Beyond Expected Life  
**Category:** Deferred Maintenance  
**Priority:** 3 - Necessary (Years 2-5)  
**Correction:** Renew System  
**Qty:** 22,652.00  
**Unit of Measure:** S.F.  
**Estimate:** \$237,212.00  
**Assessor Name:** Homero Guerrero  
**Date Created:** 09/17/2015

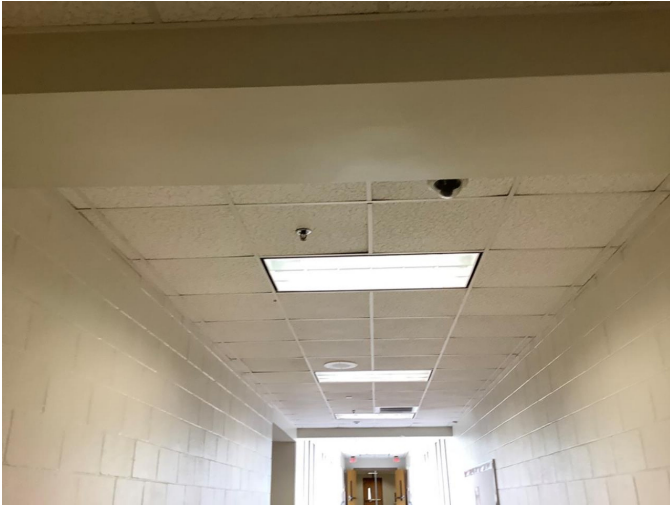
**System: D5020 - Lighting**

**Location:** Throughout Building  
**Distress:** Beyond Expected Life  
**Category:** Deferred Maintenance  
**Priority:** 3 - Necessary (Years 2-5)  
**Correction:** Renew System  
**Qty:** 22,652.00  
**Unit of Measure:** S.F.  
**Estimate:** \$153,988.00  
**Assessor Name:** Homero Guerrero  
**Date Created:** 01/16/2020

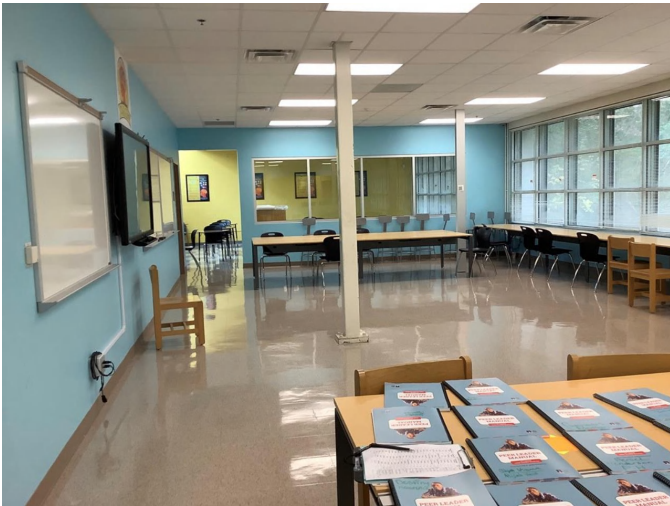
**System: E1020 - Institutional Equipment**

**Location:** Throughout Building  
**Distress:** Beyond Expected Life  
**Category:** Deferred Maintenance  
**Priority:** 3 - Necessary (Years 2-5)  
**Correction:** Renew System  
**Qty:** 22,652.00  
**Unit of Measure:** S.F.  
**Estimate:** \$2,492.00  
**Assessor Name:** Homero Guerrero  
**Date Created:** 09/17/2015

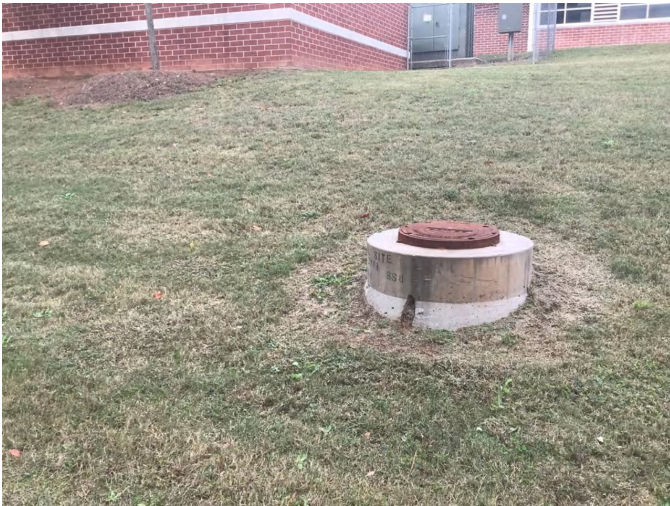
#### System: G3020 - Sanitary Sewer

**Location:** Site  
**Distress:** Beyond Expected Life  
**Category:** Deferred Maintenance  
**Priority:** 3 - Necessary (Years 2-5)  
**Correction:** Renew System  
**Qty:** 159,254.00  
**Unit of Measure:** S.F.  
**Estimate:** \$367,877.00  
**Assessor Name:** Hayden Collins  
**Date Created:** 07/29/2013
