Atlanta Public Schools/ Mays Cluster

Miles Elementary School

School Assessment Report

November 10, 2020

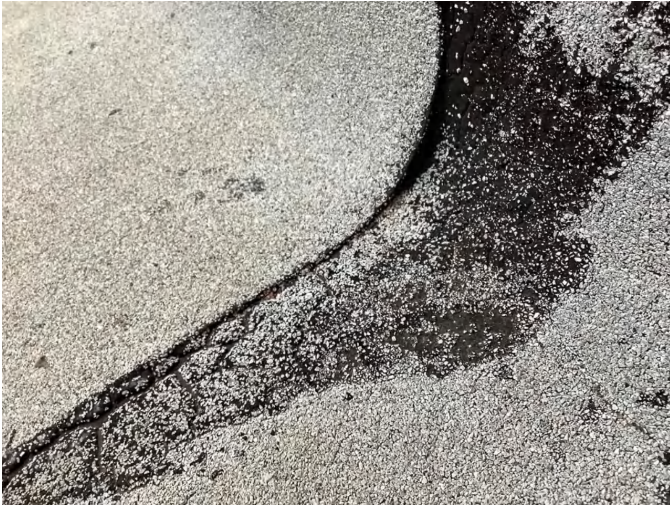
System: B3010105 - Built-Up

Location: Roof
Distress: Beyond Expected Life
Category: Deferred Maintenance
Priority: 3 - Necessary (Years 2-5)
Correction: Renew System
Qty: 82,211.00
Unit of Measure: S.F.
Estimate: \$922,860.00
Assessor Name: Eduardo Lopez
Date Created: 02/20/2020

Notes: The built-up roof is leaking and the seams are splitting near the flashing and expansion joints. This is causing damage to the interior finishes. This deficiency provides a budgetary consideration for the repair of the damaged roof sections near the mechanical equipment and the most northern section of the roof.

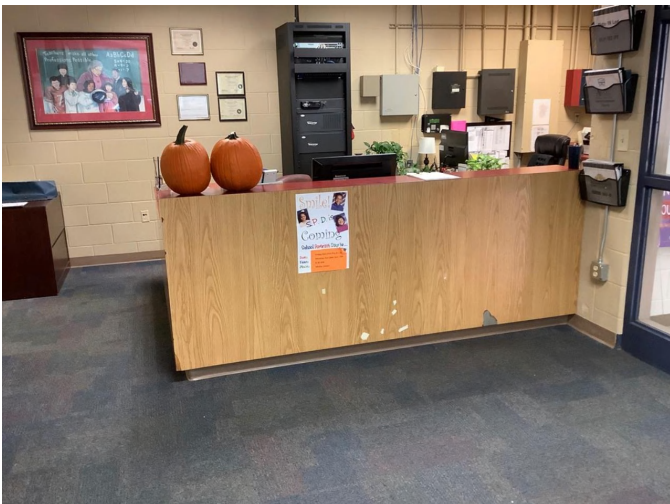
System: C3020901 - Carpet

Location: Throughout Building
Distress: Beyond Expected Life
Category: Deferred Maintenance
Priority: 3 - Necessary (Years 2-5)
Correction: Renew System
Qty: 10,000.00
Unit of Measure: S.F.
Estimate: \$82,500.00
Assessor Name: Eduardo Lopez
Date Created: 12/13/2019

Notes: The Carpet floor finish is beyond its expected service life, worn and damaged, and is recommended for replacement.

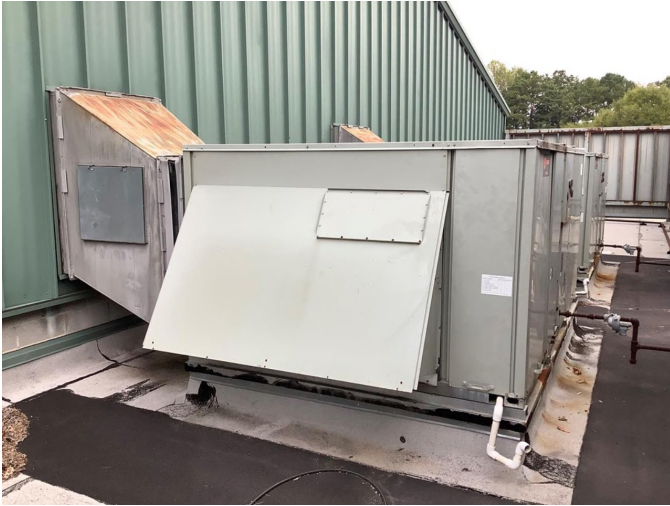
System: D3020 - Heat Generating Systems

Location: Throughout Building
Distress: Beyond Expected Life
Category: Deferred Maintenance
Priority: 3 - Necessary (Years 2-5)
Correction: Renew System
Qty: 82,211.00
Unit of Measure: S.F.
Estimate: \$371,676.00
Assessor Name: Eduardo Lopez
Date Created: 10/06/2020

Notes: The heat generating system is beyond its expected service life and should be scheduled for replacement.

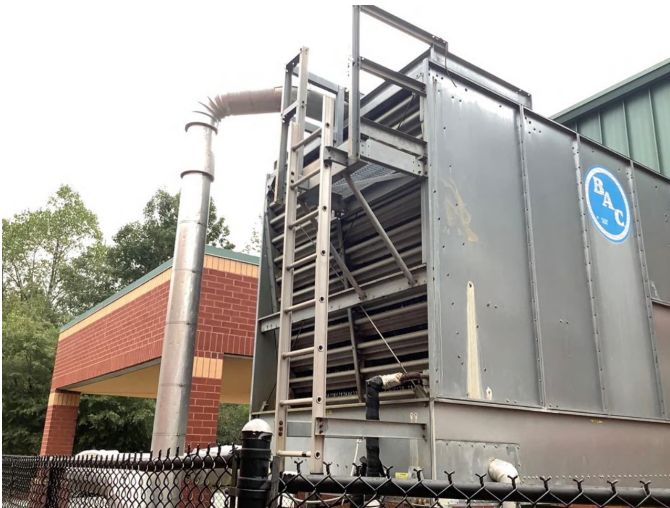
System: D3030 - Cooling Generating Systems

Location: Throughout Building
Distress: Beyond Expected Life
Category: Deferred Maintenance
Priority: 3 - Necessary (Years 2-5)
Correction: Renew System
Qty: 82,211.00
Unit of Measure: S.F.
Estimate: \$633,929.00
Assessor Name: Eduardo Lopez
Date Created: 10/06/2020

Notes: The cooling generating system is beyond its expected service life and should be scheduled for replacement.

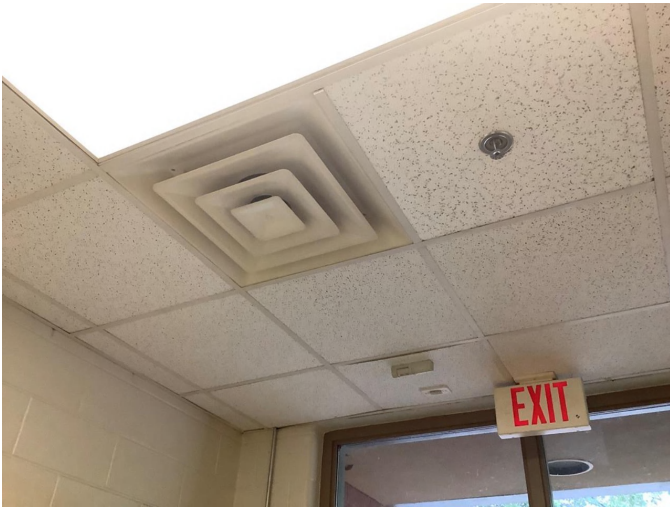
System: D3040 - Distribution Systems

Location: Throughout Building
Distress: Beyond Expected Life
Category: Deferred Maintenance
Priority: 3 - Necessary (Years 2-5)
Correction: Renew System
Qty: 82,211.00
Unit of Measure: S.F.
Estimate: \$1,104,176.00
Assessor Name: Eduardo Lopez
Date Created: 10/06/2020

Notes: The distribution system is beyond its expected service life and should be scheduled for replacement.

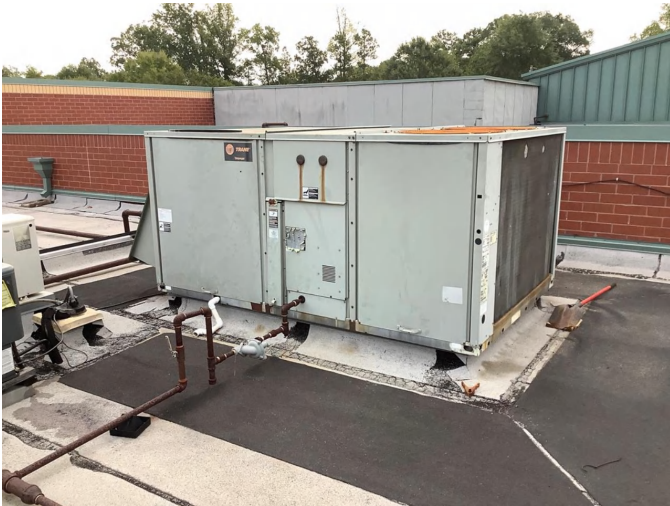
System: D3050 - Terminal & Package Units

Location: Roof
Distress: Beyond Expected Life
Category: Deferred Maintenance
Priority: 3 - Necessary (Years 2-5)
Correction: Renew System
Qty: 82,211.00
Unit of Measure: S.F.
Estimate: \$691,806.00
Assessor Name: Eduardo Lopez
Date Created: 12/13/2019

Notes: The terminal and package units are at the end of their useful life. The system is functional however upgrades are warranted.

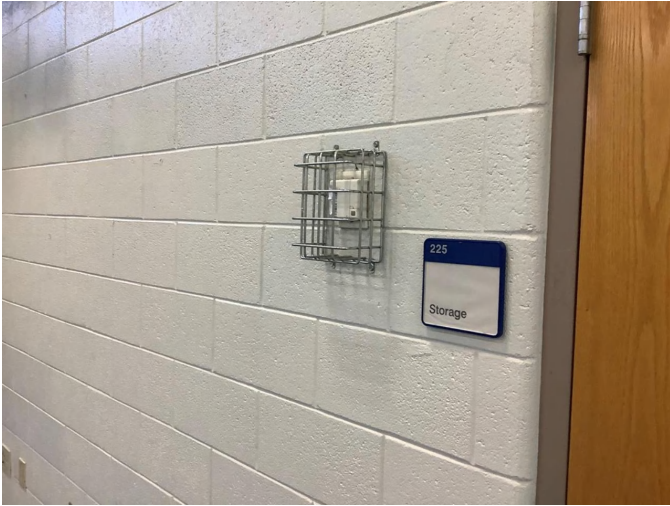
System: D3060 - Controls & Instrumentation

Location: Mechanical Rooms
Distress: Beyond Expected Life
Category: Deferred Maintenance
Priority: 3 - Necessary (Years 2-5)
Correction: Renew System
Qty: 82,211.00
Unit of Measure: S.F.
Estimate: \$229,698.00
Assessor Name: Eduardo Lopez
Date Created: 12/13/2019

Notes: The heating generation systems, exhaust and ventilation systems and controls as well as the building automation systems have been upgraded from original construction. Several issues have surfaced over recent years and isolated upgrades have taken place to support the systems. This deficiency provides a budgetary consideration for a universal upgrade and is expected to be completed with the recommended HVAC upgrades included in this report.

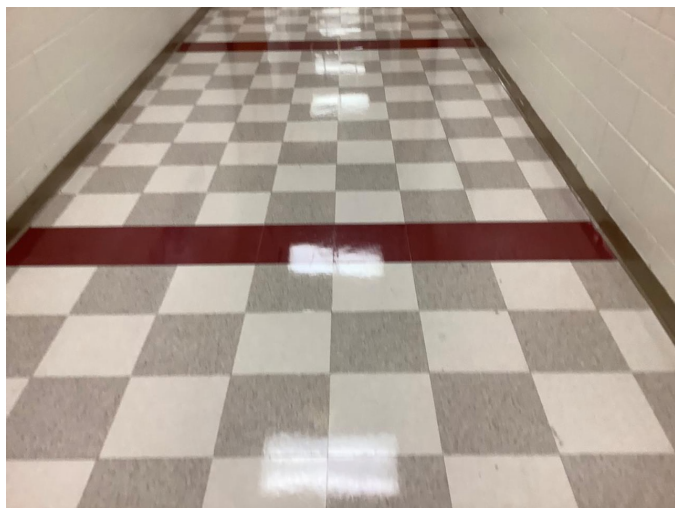
System: C3020903 - VCT

Location: Throughout Building
Distress: Beyond Expected Life
Category: Deferred Maintenance
Priority: 4 - Recommended (Years 6-10)
Correction: Renew System
Qty: 64,211.00
Unit of Measure: S.F.
Estimate: \$346,354.00
Assessor Name: Eduardo Lopez
Date Created: 12/13/2019

Notes: The VCT floor finish is beyond its expected service life, worn and damaged, and is recommended for replacement.
