Atlanta Public Schools/ N. Atlanta Cluster

# North Atlanta High School

## School Assessment Report

November 10, 2020

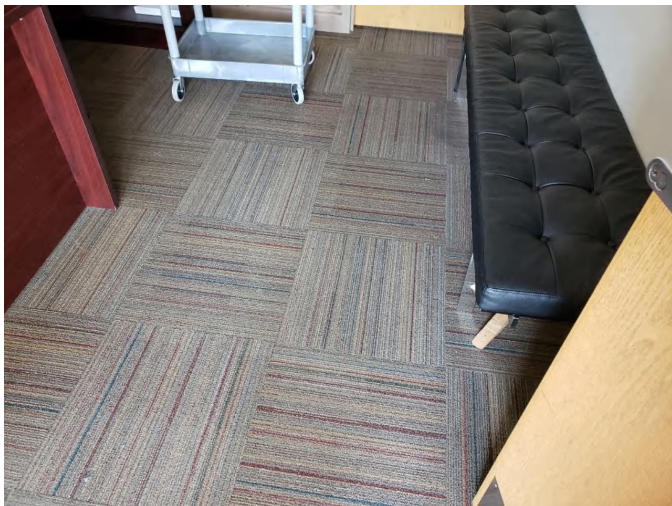
#### System: C3020901 - Carpet

**Location:** 1977 Bldg 5010  
**Distress:** Beyond Expected Life  
**Category:** Deferred Maintenance  
**Priority:** 3 - Necessary (Years 2-5)  
**Correction:** Renew System  
**Qty:** 19,064.00  
**Unit of Measure:** S.F.  
**Estimate:** \$157,278.00  
**Assessor Name:** Eduardo Lopez  
**Date Created:** 10/08/2020

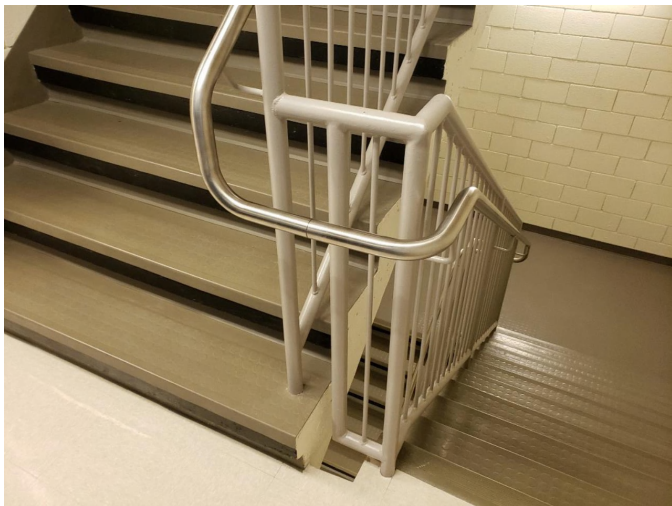
#### System: C3020999 - Other - Rubber or Neoprene

**Location:** 1977 Bldg 5010  
**Distress:** Beyond Expected Life  
**Category:** Deferred Maintenance  
**Priority:** 3 - Necessary (Years 2-5)  
**Correction:** Renew System  
**Qty:** 2,727.00  
**Unit of Measure:** S.F.  
**Estimate:** \$80,002.00  
**Assessor Name:** Eduardo Lopez  
**Date Created:** 10/08/2020

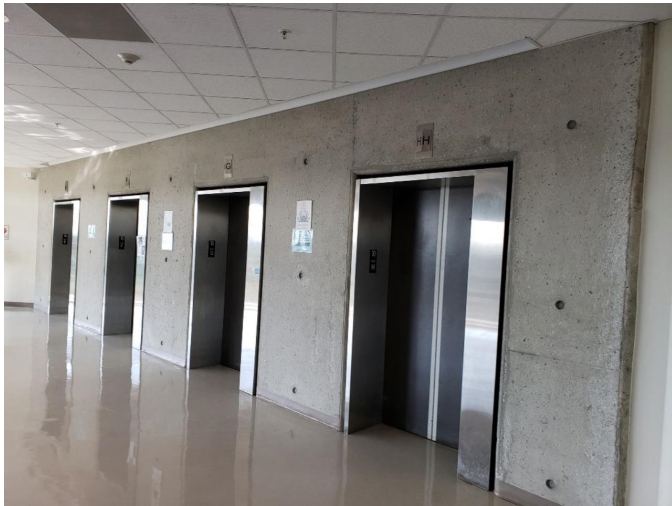
**System: D1010 - Elevators and Lifts**

**Location:** 1977 Bldg 5010  
**Distress:** Beyond Expected Life  
**Category:** Deferred Maintenance  
**Priority:** 3 - Necessary (Years 2-5)  
**Correction:** Renew System  
**Qty:** 383,001.00  
**Unit of Measure:** S.F.  
**Estimate:** \$2,127,571.00  
**Assessor Name:** Eduardo Lopez  
**Date Created:** 10/08/2020

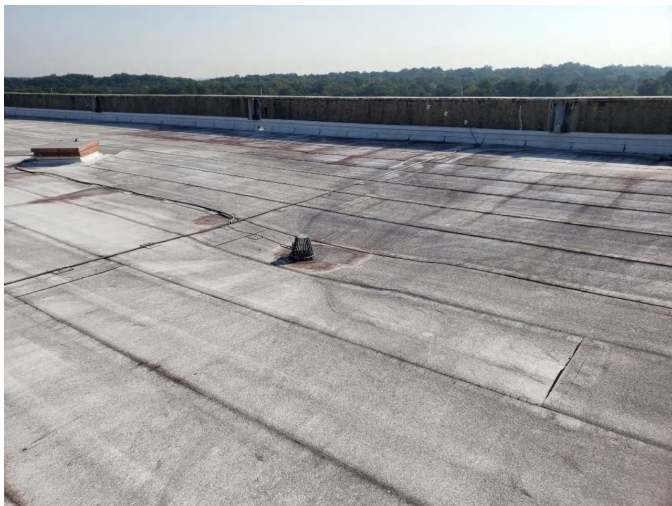
**System: D2040 - Rain Water Drainage**

**Location:** Rooftop  
**Distress:** Beyond Expected Life  
**Category:** Deferred Maintenance  
**Priority:** 3 - Necessary (Years 2-5)  
**Correction:** Renew System  
**Qty:** 41,580.00  
**Unit of Measure:** S.F.  
**Estimate:** \$21,497.00  
**Assessor Name:** Eduardo Lopez  
**Date Created:** 02/22/2020

**Notes:** Rain water drainage system is beyond its useful life and should be replaced.

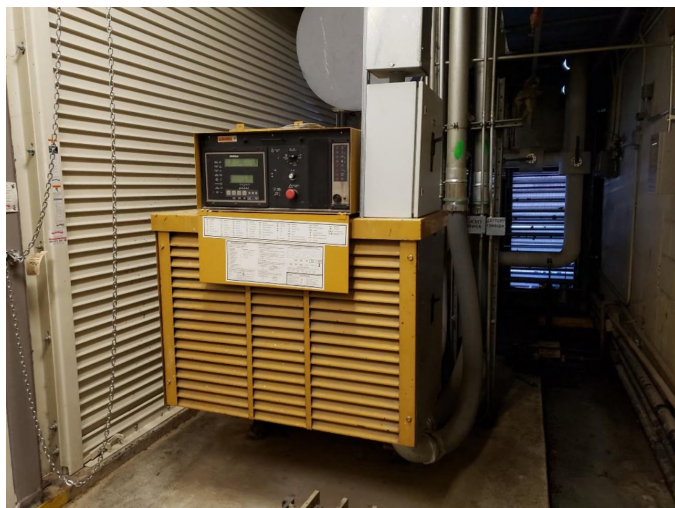
**System: D5090 - Other Electrical Systems**

**Location:** Mechanical room and electrical room

**Distress:** Beyond Expected Life

**Notes:** Emergency generator is beyond its useful life and should be replaced.

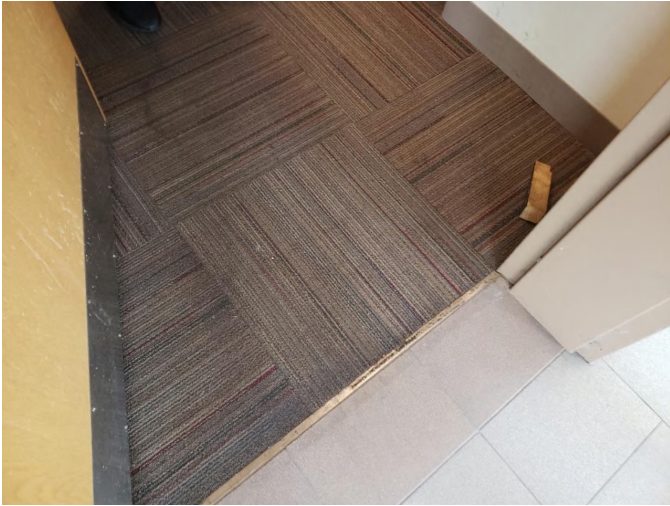
#### System: C3020901 - Carpet

**Location:** 2013 Addition 5020  
**Distress:** Beyond Expected Life  
**Category:** Deferred Maintenance  
**Priority:** 3 - Necessary (Years 2-5)  
**Correction:** Renew System  
**Qty:** 6,917.00  
**Unit of Measure:** S.F.  
**Estimate:** \$57,065.00  
**Assessor Name:** Eduardo Lopez  
**Date Created:** 10/08/2020

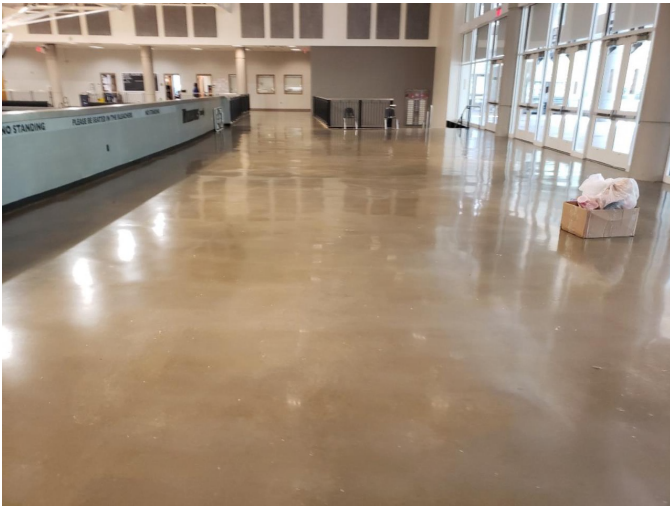
#### System: C3020999 - Other - Concrete Finish w/Sealer

**Location:** 2013 Addition 5020  
**Distress:** Beyond Expected Life  
**Category:** Deferred Maintenance  
**Priority:** 3 - Necessary (Years 2-5)  
**Correction:** Renew System  
**Qty:** 11,922.00  
**Unit of Measure:** S.F.  
**Estimate:** \$90,095.00  
**Assessor Name:** Eduardo Lopez  
**Date Created:** 10/08/2020

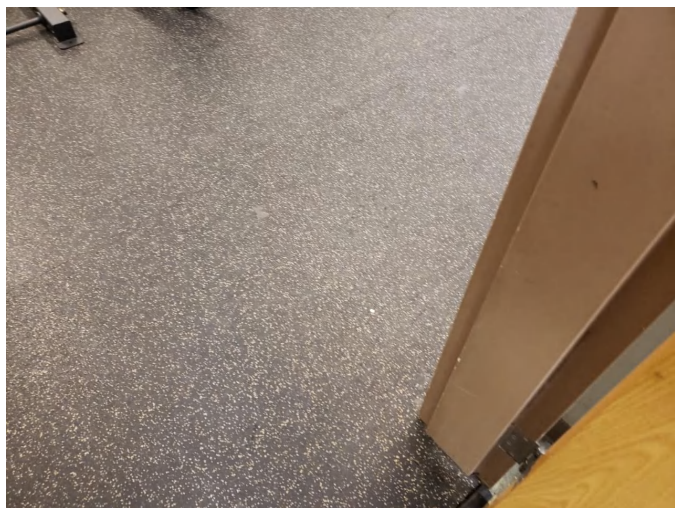
**System: C3020999 - Other - Rubber or Neoprene**

**Location:** 2013 Addition 5020  
**Distress:** Beyond Expected Life  
**Category:** Deferred Maintenance  
**Priority:** 3 - Necessary (Years 2-5)  
**Correction:** Renew System  
**Qty:** 2,442.00  
**Unit of Measure:** S.F.  
**Estimate:** \$71,641.00  
**Assessor Name:** Eduardo Lopez  
**Date Created:** 10/08/2020
