Atlanta Public Schools/ Jackson Cluster

# Parkside Elementary School

## School Assessment Report

November 10, 2020

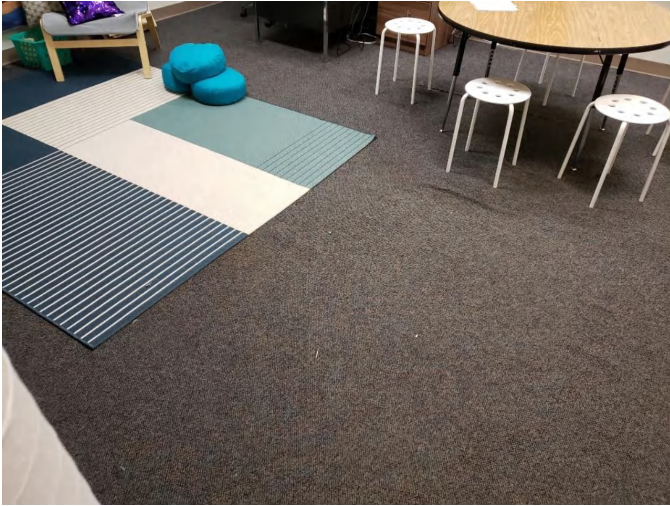
#### System: C3020901 - Carpet

**Location:** Throughout building  
**Distress:** Beyond Expected Life  
**Category:** Deferred Maintenance  
**Priority:** 3 - Necessary (Years 2-5)  
**Correction:** Renew System  
**Qty:** 5,949.00  
**Unit of Measure:** S.F.  
**Estimate:** \$49,079.00  
**Assessor Name:** Hayden Collins  
**Date Created:** 01/16/2020

**Notes:** The office carpet is aged, stained, frayed, and should be replaced.

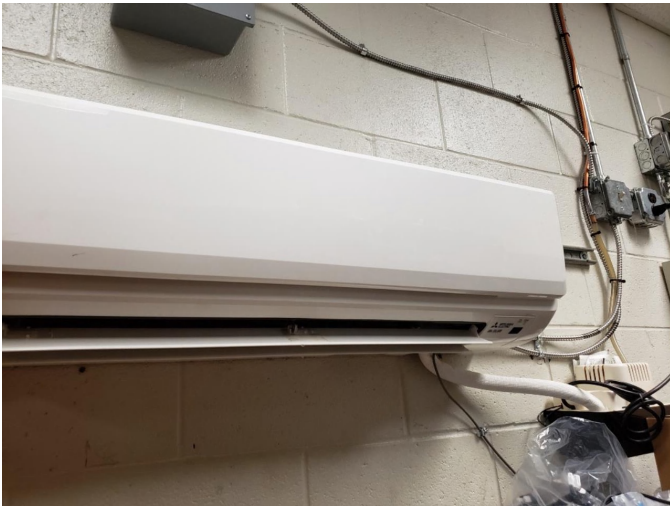
#### System: D3050 - Terminal & Package Units

**Location:** Throughout building  
**Distress:** Beyond Expected Life  
**Category:** Deferred Maintenance  
**Priority:** 3 - Necessary (Years 2-5)  
**Correction:** Renew System  
**Qty:** 80,836.00  
**Unit of Measure:** S.F.  
**Estimate:** \$657,116.00  
**Assessor Name:** Hayden Collins  
**Date Created:** 01/16/2020

**Notes:** The system is beyond its expected service life and should be scheduled for replacement.

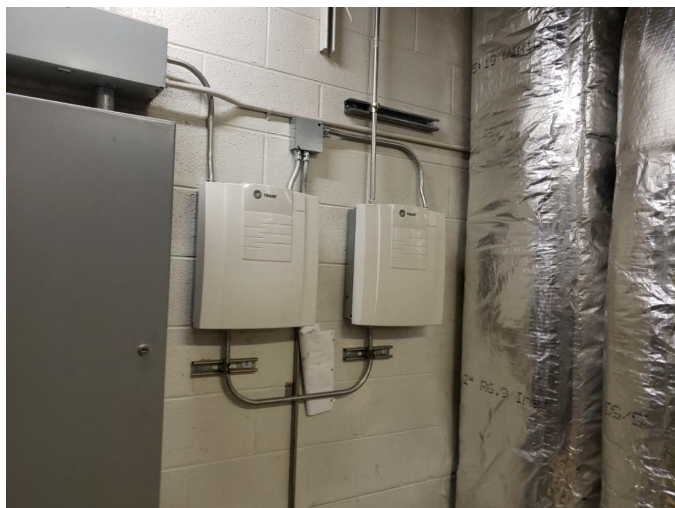
**System: D3060 - Controls & Instrumentation**

**Location:** Throughout building  
**Distress:** Beyond Expected Life  
**Category:** Deferred Maintenance  
**Priority:** 3 - Necessary (Years 2-5)  
**Correction:** Renew System  
**Qty:** 80,836.00  
**Unit of Measure:** S.F.  
**Estimate:** \$218,742.00  
**Assessor Name:** Hayden Collins  
**Date Created:** 01/16/2020

**Notes:** The system is beyond its expected service life and should be scheduled for replacement.

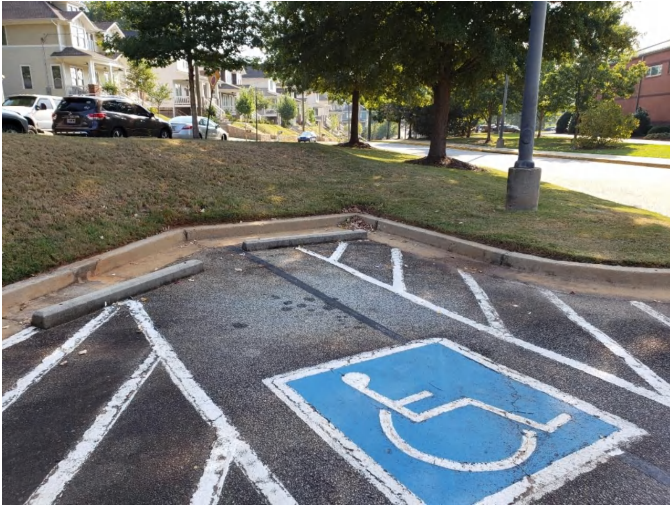
#### System: G2020 - Parking Lots

**Location:** ADA Parking  
**Distress:** Missing  
**Category:** ADA Compliance  
**Priority:** 1 - Critical Immediate Need  
**Correction:** Add handicap parking sign and post  
**Qty:** 2.00  
**Unit of Measure:** Ea.  
**Estimate:** \$796.52  
**Assessor Name:** Eduardo Lopez  
**Date Created:** 01/16/2020

**Notes:** The handicap parking spaces are missing their dedicated signage and should be provided per ADA Standards.

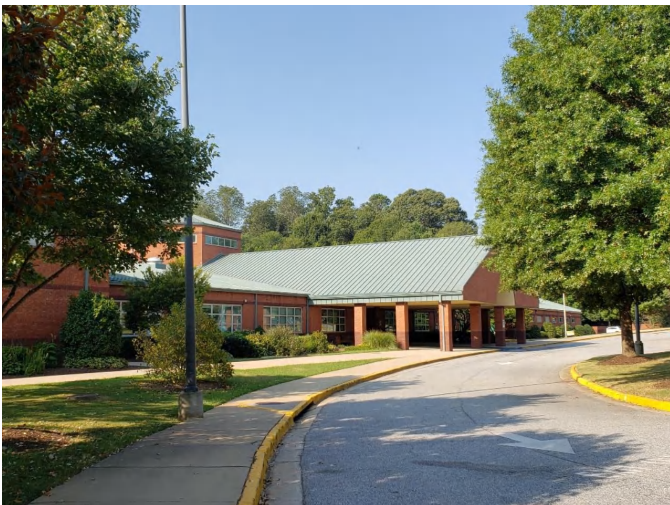
#### System: G2010 - Roadways

**Location:** Site  
**Distress:** Non Compliant  
**Category:** Code Compliance  
**Priority:** 2 - Trending Critical (Year 1)  
**Correction:** Fire lane marking, incl. curb painting and with the words "No Parking, Fire Lane" painted in black  
**Qty:** 1,000.00  
**Unit of Measure:** L.F.  
**Estimate:** \$2,385.30  
**Assessor Name:** Eduardo Lopez  
**Date Created:** 01/16/2020

**Notes:** There is a section of yellow striping in front of the building. However, there is no indication it's a Fire Lane. Fire lane markings must include curb painting and with the words "No Parking, Fire Lane" to maintain it free of obstruction at all times. Provide Fire lane markings per Local Code requirements.

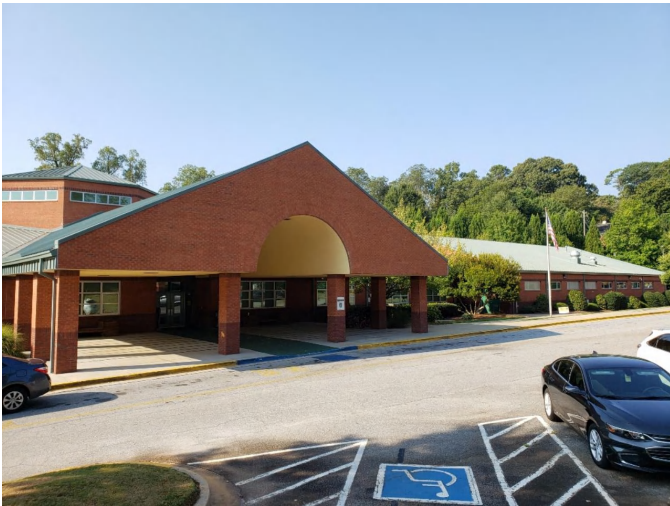
**System: G2010 - Roadways**

**Location:** ADA Parking

**Distress:** Missing
