Atlanta Public Schools/ Mays Cluster

# Peyton Forest Elementary School

## School Assessment Report

November 10, 2020

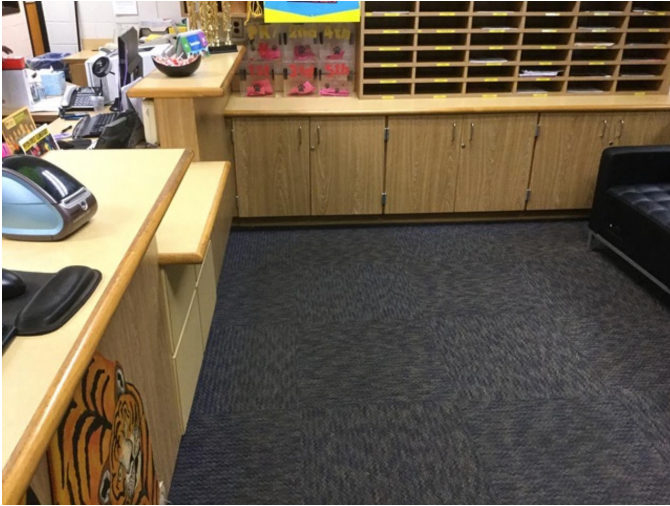
#### **System: C3020901 - Carpet**

**Location:** Throughout Building  
**Distress:** Beyond Expected Life  
**Category:** Deferred Maintenance  
**Priority:** 3 - Necessary (Years 2-5)  
**Correction:** Renew System  
**Qty:** 4,647.00  
**Unit of Measure:** S.F.  
**Estimate:** \$38,338.00  
**Assessor Name:** Eduardo Lopez  
**Date Created:** 10/29/2019

**Notes:** The carpet finish is beyond its expected service life, worn and damaged, and is recommended for replacement.

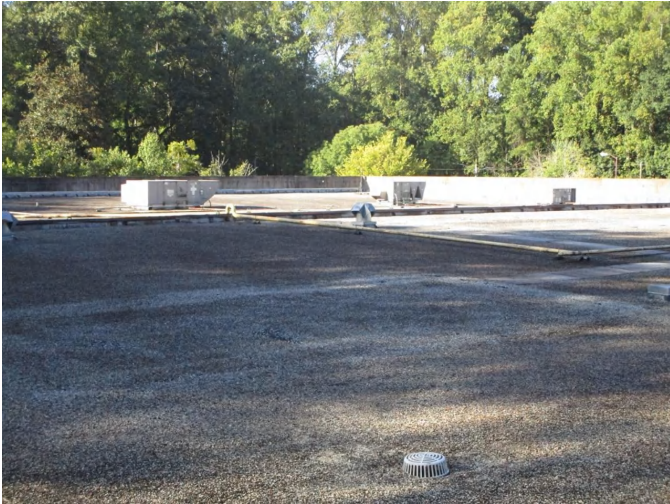
#### **System: D2040 - Rain Water Drainage**

**Location:** Rooftop  
**Distress:** Beyond Expected Life  
**Category:** Deferred Maintenance  
**Priority:** 3 - Necessary (Years 2-5)  
**Correction:** Renew System  
**Qty:** 45,270.00  
**Unit of Measure:** S.F.  
**Estimate:** \$22,409.00  
**Assessor Name:** Eduardo Lopez  
**Date Created:** 10/01/2019

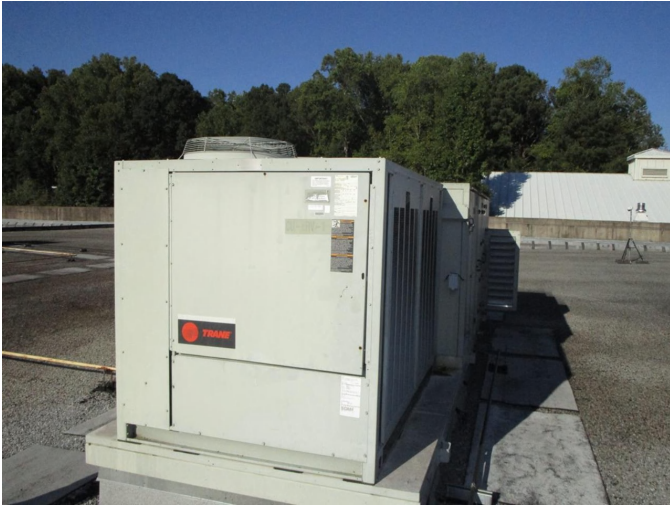
**System: D3050 - Terminal & Package Units**

**Location:** Throughout Building  
**Distress:** Beyond Expected Life  
**Category:** Deferred Maintenance  
**Priority:** 3 - Necessary (Years 2-5)  
**Correction:** Renew System  
**Qty:** 45,270.00  
**Unit of Measure:** S.F.  
**Estimate:** \$296,790.00  
**Assessor Name:** Eduardo Lopez  
**Date Created:** 10/06/2020

**Notes:** The system is beyond its expected service life and should be scheduled for replacement.

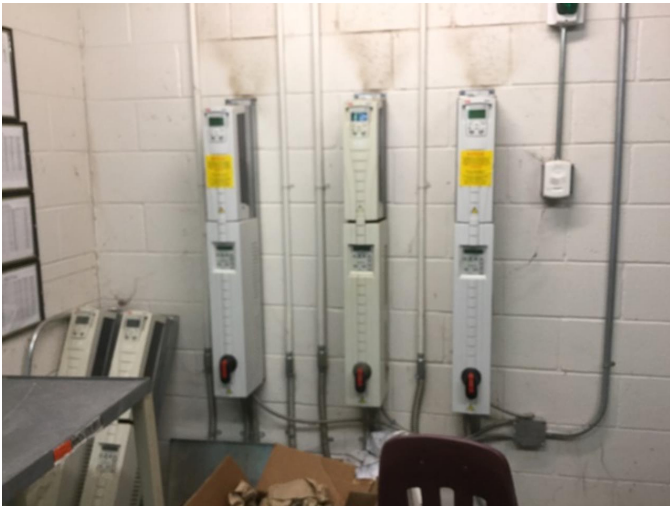
**System: D3060 - Controls & Instrumentation**

**Location:** Throughout Building  
**Distress:** Beyond Expected Life  
**Category:** Deferred Maintenance  
**Priority:** 3 - Necessary (Years 2-5)  
**Correction:** Renew System  
**Qty:** 45,270.00  
**Unit of Measure:** S.F.  
**Estimate:** \$124,493.00  
**Assessor Name:** Eduardo Lopez  
**Date Created:** 10/06/2020

**Notes:** The controls and instrumentation is beyond its expected service life and should be scheduled for replacement.

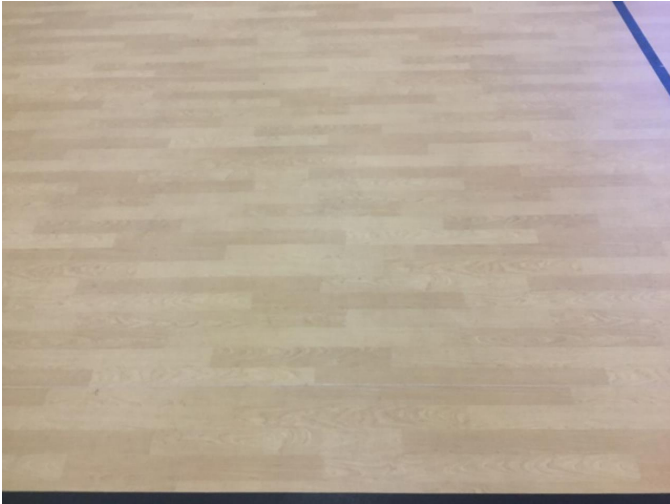
#### System: C3020999 - Other - Rubber or Neoprene

**Location:** Gym  
**Distress:** Beyond Expected Life  
**Category:** Deferred Maintenance  
**Priority:** 3 - Necessary (Years 2-5)  
**Correction:** Renew System  
**Qty:** 5,550.00  
**Unit of Measure:** S.F.  
**Estimate:** \$162,820.00  
**Assessor Name:** Eduardo Lopez  
**Date Created:** 01/16/2020
