Atlanta Public Schools/ N. Atlanta Cluster

Rivers, E Elementary School

School Assessment Report

November 10, 2020

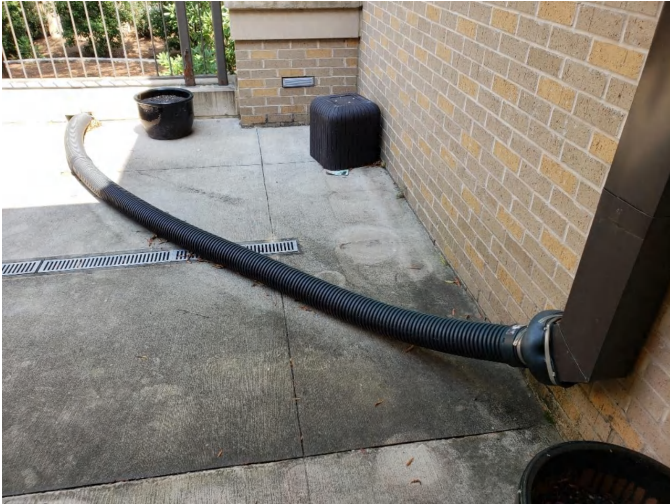
System: D2040 - Rain Water Drainage

Location: 3rd Floor Patio
Distress: Inadequate
Category: Mission Integrity
Priority: 1 - Critical Immediate Need
Correction: Replace pipe or gutter distribution
Qty: 150.00
Unit of Measure: L.F.
Estimate: \$11,527.76
Assessor Name: Homero Guerrero
Date Created: 09/23/2015

Notes: Provisional flexible drains were installed due to inadequate drainage size in patio. However, it should be properly fixed by installing downspouts to drain at grade level. Remove and relocate downspouts in patio.

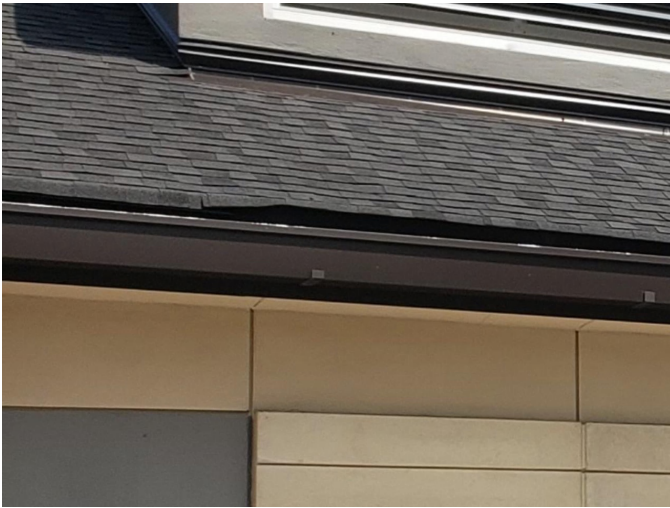
System: B3010140 - Shingle & Tile

Location: Roof Edge
Distress: Inadequate
Category: Facility Integrity
Priority: 2 - Trending Critical (Year 1)
Correction: R/R Gutters & downspouts
Qty: 1,200.00
Unit of Measure: L.F.
Estimate: \$44,893.17
Assessor Name: Homero Guerrero
Date Created: 09/23/2015

Notes: Elevation of roof material is higher than the elevation of the gutter allowing water to sheet flow over the gutter system. Provide splash guard or remove and replace gutter at proper elevation and reduce the projection of the asphalt shingle to allow proper flow into the gutter system.
