Atlanta Public Schools/ S. Atlanta Cluster

South Atlanta High School

School Assessment Report

November 10, 2020

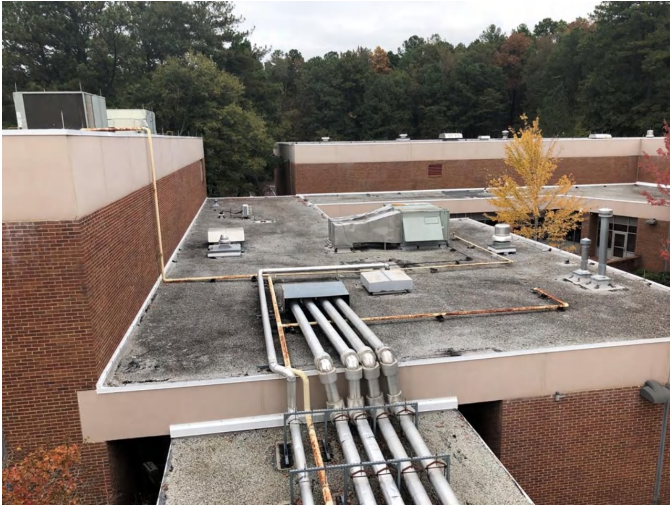
System: B3010105 - Built-Up

Location: Roof
Distress: Beyond Expected Life
Category: Deferred Maintenance
Priority: 3 - Necessary (Years 2-5)
Correction: Renew System
Qty: 150,000.00
Unit of Measure: S.F.
Estimate: \$1,683,825.00
Assessor Name: Homero Guerrero
Date Created: 02/14/2020

The roofing system is a built up system that was reported to be original to the buildings construction. This system has exceeded its expected life cycle and is recommended for replacement.

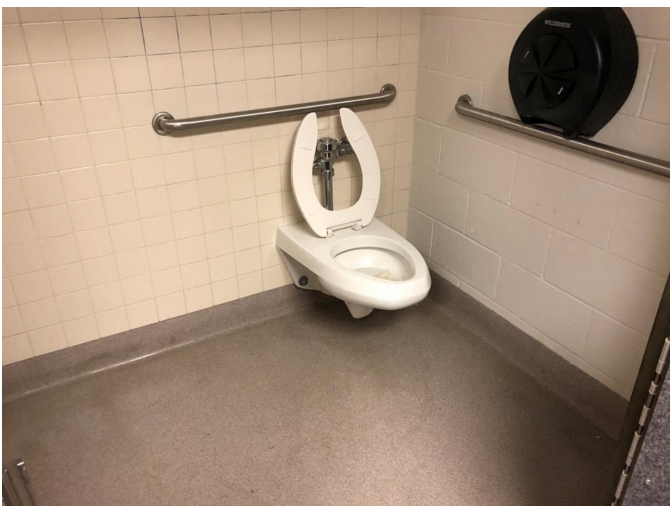
System: C3010220 - Tile

Location: Restrooms
Distress: Beyond Expected Life
Category: Deferred Maintenance
Priority: 3 - Necessary (Years 2-5)
Correction: Renew System
Qty: 7,000.00
Unit of Measure: S.F.
Estimate: \$97,125.00
Assessor Name: Homero Guerrero
Date Created: 02/14/2020

The tile floor finish is beyond its expected service life, worn and damaged, and is recommended for replacement.

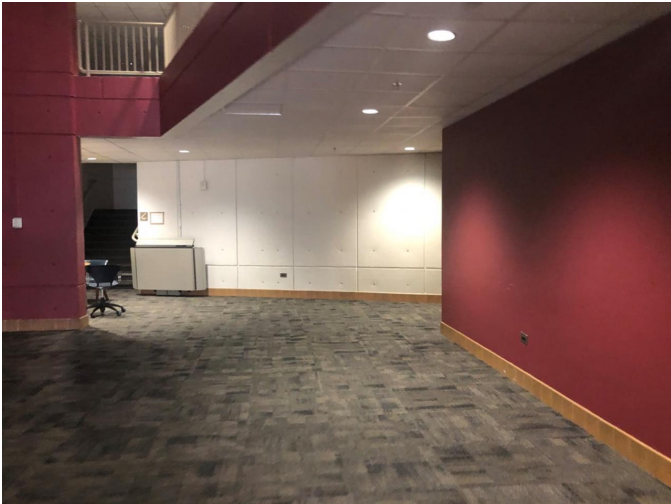
System: C3020901 - Carpet

Location: Throughout building
Distress: Beyond Expected Life
Category: Deferred Maintenance
Priority: 3 - Necessary (Years 2-5)
Correction: Renew System
Qty: 10,000.00
Unit of Measure: S.F.
Estimate: \$82,500.00
Assessor Name: Homero Guerrero
Date Created: 02/14/2020

Notes: The carpet floor finish is beyond its expected service life, worn and damaged, and is recommended for replacement.

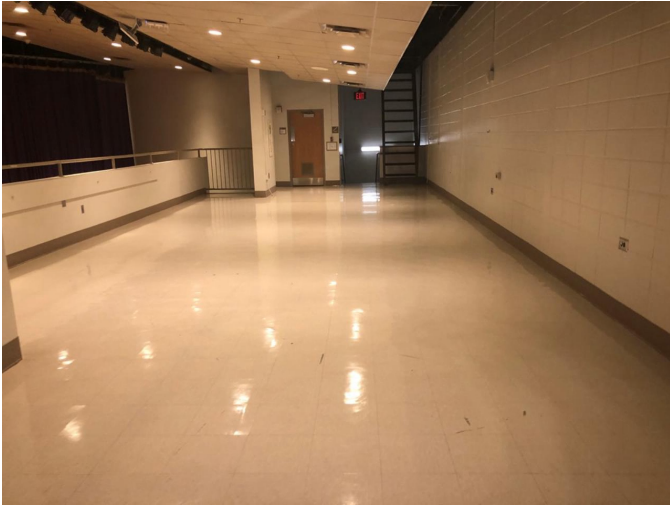
System: C3020903 - VCT

Location: Throughout building
Distress: Beyond Expected Life
Category: Deferred Maintenance
Priority: 3 - Necessary (Years 2-5)
Correction: Renew System
Qty: 240,779.00
Unit of Measure: S.F.
Estimate: \$1,298,762.00
Assessor Name: Homero Guerrero
Date Created: 02/14/2020

The VCT floor finish is beyond its expected service life, worn and damaged, and is recommended for replacement.

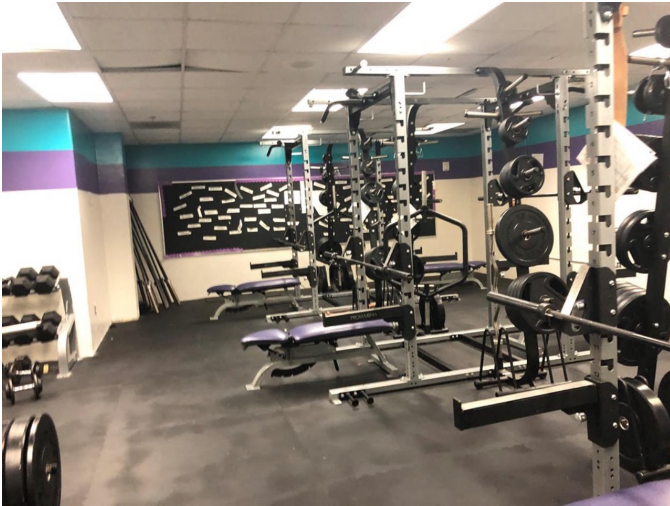
System: C3020999 - Other - Rubber or Neoprene

Location: Weight Room
Distress: Beyond Expected Life
Category: Deferred Maintenance
Priority: 3 - Necessary (Years 2-5)
Correction: Renew System
Qty: 2,000.00
Unit of Measure: S.F.
Estimate: \$58,674.00
Assessor Name: Homero Guerrero
Date Created: 02/14/2020

Notes: The neoprene floor finish is beyond its expected service life, worn and damaged, and is recommended for replacement.

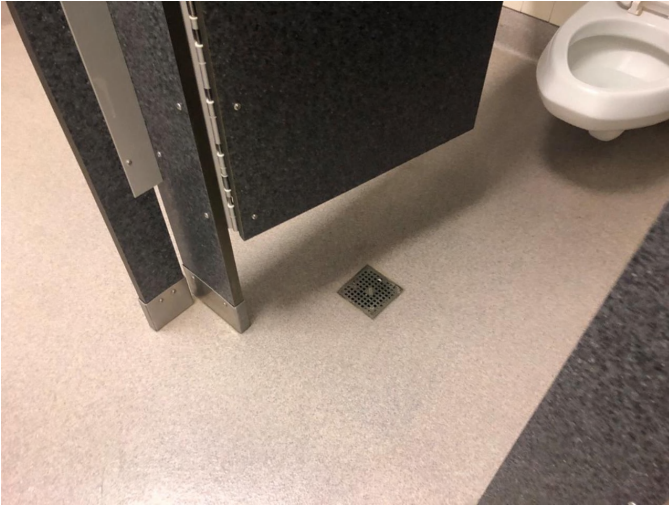
System: D2030 - Sanitary Waste

Location: Throughout building
Distress: Beyond Expected Life
Category: Deferred Maintenance
Priority: 3 - Necessary (Years 2-5)
Correction: Renew System
Qty: 277,779.00
Unit of Measure: S.F.
Estimate: \$537,780.00
Assessor Name: Homero Guerrero
Date Created: 02/14/2020

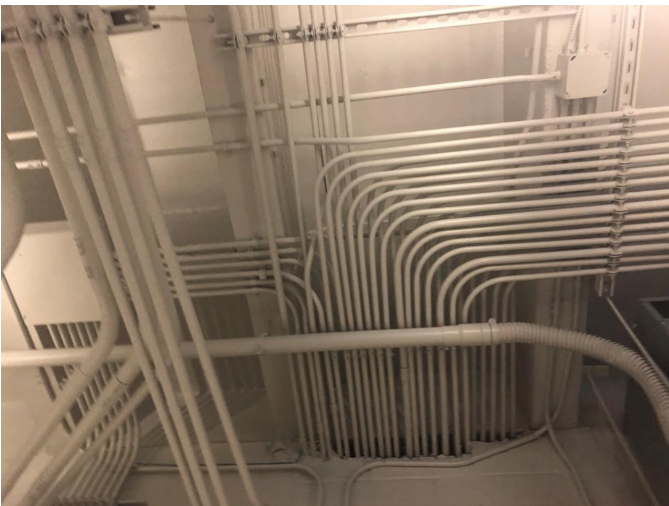
System: D5020 - Branch Wiring

Location: Throughout building
Distress: Beyond Expected Life
Category: Deferred Maintenance
Priority: 3 - Necessary (Years 2-5)
Correction: Renew System
Qty: 277,779.00
Unit of Measure: S.F.
Estimate: \$1,457,506.00
Assessor Name: Homero Guerrero
Date Created: 02/14/2020

The original branch wiring system is operational but is aged and should be replaced with an energy efficient system.

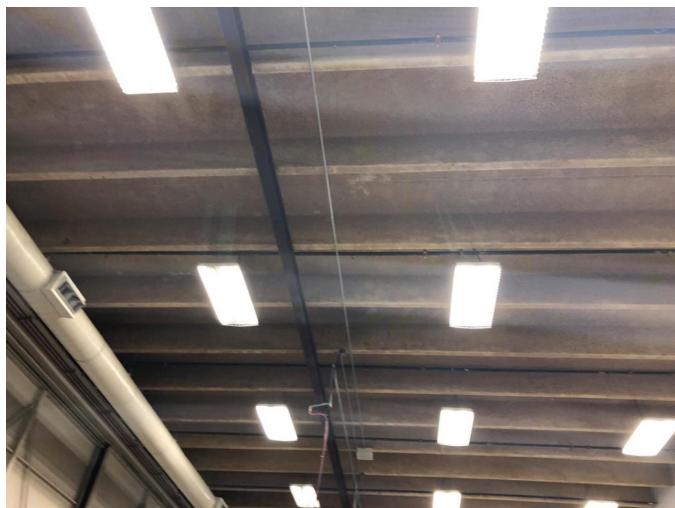
System: D5020 - Lighting

Location: Throughout building
Distress: Beyond Expected Life
Category: Deferred Maintenance
Priority: 3 - Necessary (Years 2-5)
Correction: Renew System
Qty: 277,779.00
Unit of Measure: S.F.
Estimate: \$2,190,843.00
Assessor Name: Homero Guerrero
Date Created: 02/14/2020

The original lighting system is operational but is aged and should be replaced with an energy efficient system.
