Atlanta Public Schools/ N. Atlanta Cluster

Sutton Middle School

School Assessment Report

November 10, 2020

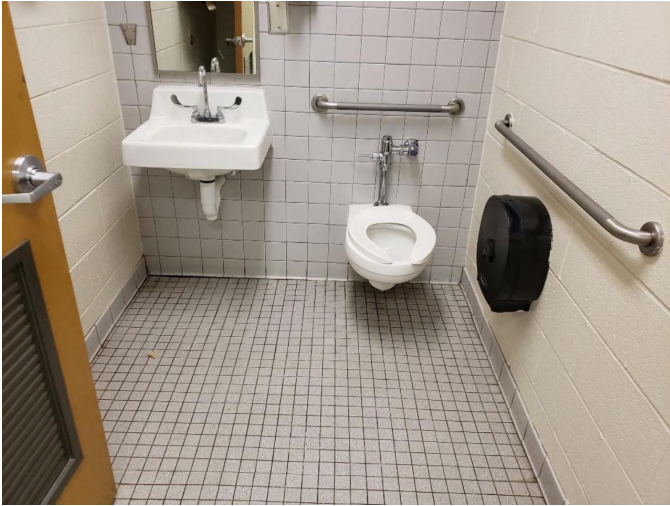
System: C3010220 - Tile

Location: Restroom
Distress: Beyond Expected Life
Category: Deferred Maintenance
Priority: 3 - Necessary (Years 2-5)
Correction: Renew System
Qty: 4,000.00
Unit of Measure: S.F.
Estimate: \$55,500.00
Assessor Name: Jejuan Hall
Date Created: 01/27/2020

Notes: The ceramic tile floor finish is beyond its expected service life and should be replaced in conjunction with other recommended renovations.

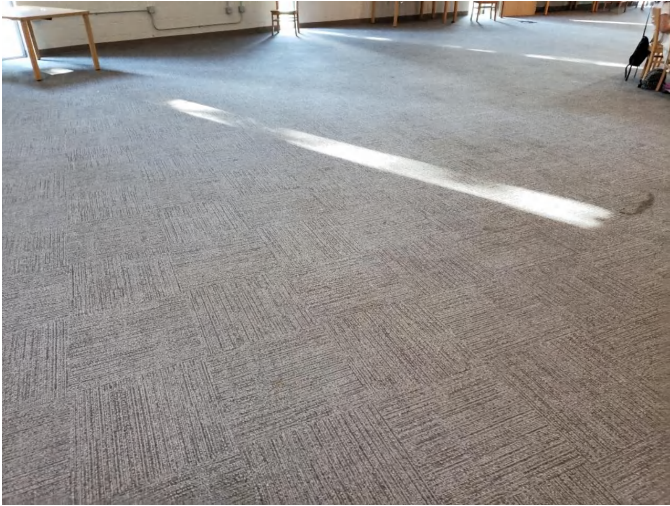
System: C3020901 - Carpet

Location: Media Center
Distress: Beyond Expected Life
Category: Deferred Maintenance
Priority: 3 - Necessary (Years 2-5)
Correction: Renew System
Qty: 4,000.00
Unit of Measure: S.F.
Estimate: \$49,676.00
Assessor Name: Homero Guerrero
Date Created: 01/27/2020

Notes: The carpet floor finish is beyond its expected service life, faded and stained, and should be replaced.
