Atlanta Public Schools/ Carver Cluster

# Sylvan Hills Middle School

## School Assessment Report

November 10, 2020

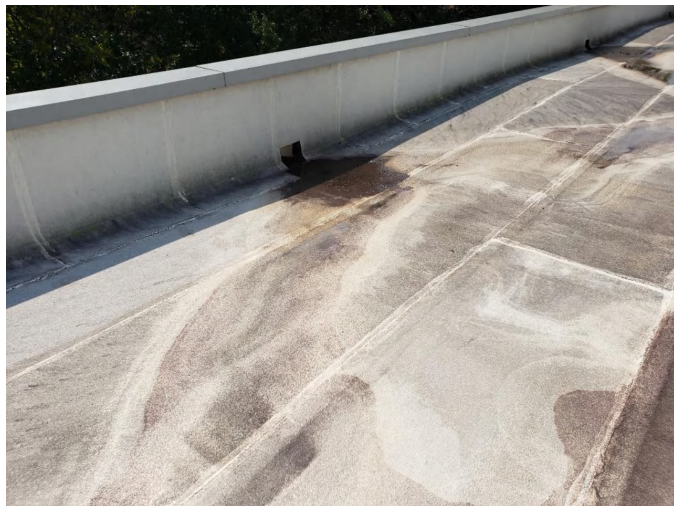
#### **System: B3010105 - Built-Up**

**Location:** Roof  
**Distress:** Failing  
**Category:** Facility Integrity  
**Priority:** 2 - Trending Critical (Year 1)  
**Correction:** R/R BU Roof  
**Qty:** 2,000.00  
**Unit of Measure:** S.F.  
**Estimate:** \$16,819.40  
**Assessor Name:** Homero Guerrero  
**Date Created:** 10/14/2015

**Notes:** The roof scuppers bottom level is above the roof deck and is not adequate for water to drain, water ponds in front of scupper and could eventually seep into the building. The water is mostly from condensation of the units. Provide effective cricket design in areas around mechanical equipment and drop scupper bottom level and/or roof level in conflictive areas to insure adequate drainage.

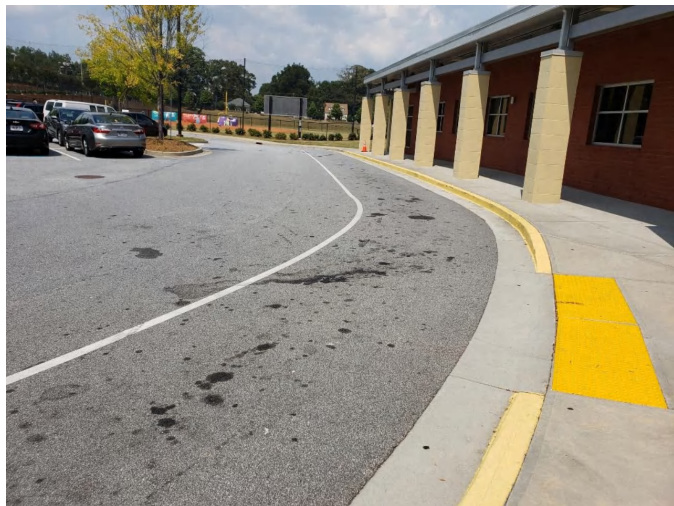
#### System: G2010 - Roadways

**Location:** Site

**Distress:** Non Compliant
