Campus Report

Campus: Transportation - Metropolitan
Report: Dec 15, 2014

1958 Bldg Main**Executive Summary**

Site

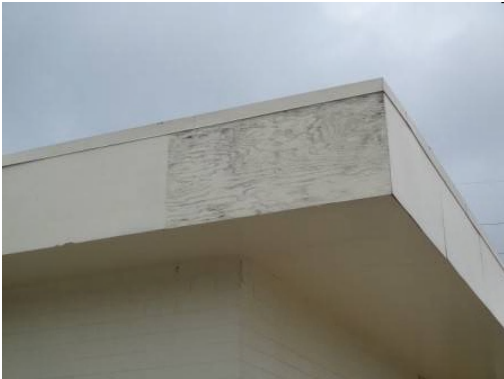
System: B2010 - Exterior Walls

Analysis: The system is in good condition. The system was installed in 1958. It has a 100-year service life. However, in the assessment, it was found to be currently deficient and is non-renewable.

Notes: Original plywood fascia has deteriorated to point of failure. Replace with prefinished metal panel system.

Location: Building Systems
Material: Exterior Walls
Distress: Failing
Category: Deferred Maintenance
Priority: 2 - Trending Critical (Year 1)
Correction: Replace Soffit/Fasica
Qty: 800-S.F.
Estimate: \$20,004.22
Created: Bill Watson, 08/19/2013
Last Updated: Joanne Romaneli, 08/26/2013

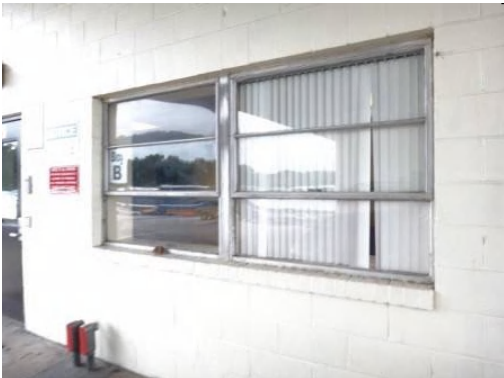
System: B2020 - Exterior Windows

Analysis: The system is in poor condition. The system was installed in 1958. It has a 30-year service life which expired in 1988.

Location: Building Systems
Material: System
Distress: Beyond Expected Life
Category: Deferred Maintenance
Priority: 3 - Necessary (Years 2-5)
Correction: Renew System
Qty: 1-Ea.
Estimate: \$166,197.82
Created: Bill Watson, 08/07/2013
Last Updated: Joanne Romaneli, 08/26/2013

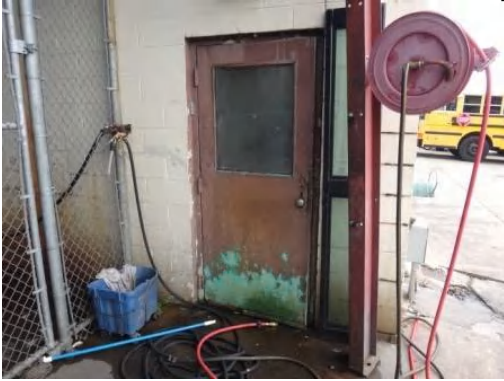
System: B2030 - Exterior Doors

Analysis: The system is in good condition. The system was installed in 1993. It has a 30-year service life. However, in the assessment, it was found to be currently deficient.

Notes: Although most doors have been replaced - 3 exterior doors are significantly damaged and in need of replacement.

Location: Building Systems
Material: Exterior Doors
Distress: Damaged
Category: Deferred Maintenance
Priority: 3 - Necessary (Years 2-5)
Correction: Replace Hollow Steel Doors
Qty: 3-Ea.
Estimate: \$6,255.17
Created: Bill Watson, 08/08/2013
Last Updated: Joanne Romaneli, 08/26/2013

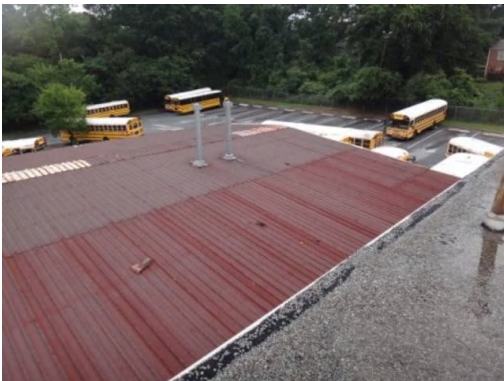
System: B3010 - Roof Coverings

Analysis: The system is in good condition. The system was installed in 2000. It has a 20-year service life. However, in the assessment, it was found to be currently deficient.

Notes: Metal roof covering has serious corrosion and should be replaced.

Location: Building Systems
Material: Roof Covering
Distress: Failing
Category: Deferred Maintenance
Priority: 4 - Recommended (Years 6-10)
Correction: R/R Batten Seam Metal Roof
Qty: 1,800-S.F.
Estimate: \$40,964.30
Created: Eduardo Lopez, 06/18/2014
Last Updated: Eduardo Lopez, 06/19/2014

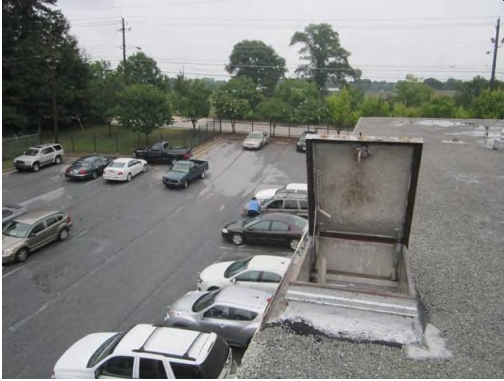
System: B3020 - Roof Openings

Analysis: The system is in fair condition. The system was installed at an unknown date. It has a 30-year service life.

Notes: Roof hatch location is too close to roof edge, lacks OSHA recommended ladder extensions, and is a safety risk.

Location: Building Systems
Material: System
Distress: Non Compliant
Category: Code Compliance
Priority: 2 - Trending Critical (Year 1)
Correction: Renew System
Qty: 1-Ea.
Estimate: \$13,157.33
Created: Bill Watson, 08/07/2013
Last Updated: Joanne Romaneli, 08/26/2013

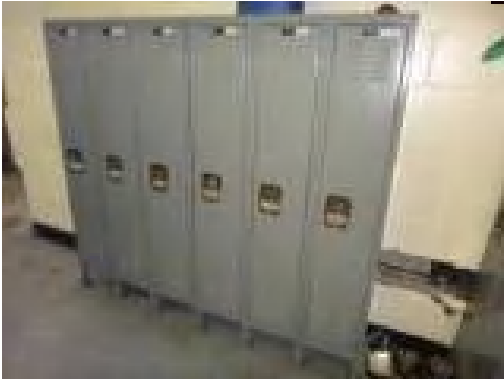
System: C1030 - Fittings

Analysis: The system is in fair condition. The system was installed in 1993. It has a 20-year service life. However, in the assessment, it was found to be currently deficient.

Location: Building Systems
Material: System
Distress: Beyond Expected Life
Category: Deferred Maintenance
Priority: 3 - Necessary (Years 2-5)
Correction: Renew System
Qty: 1-Ea.
Estimate: \$72,019.06
Created: Bill Watson, 08/07/2013
Last Updated: Joanne Romaneli, 08/27/2013

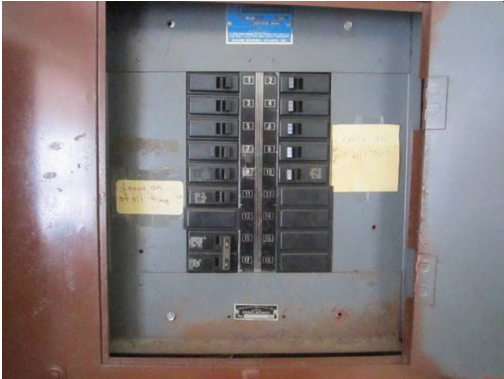
System: D5010 - Electrical Service/Distribution

Analysis: The system is in poor condition. The system was installed in 1958. It has a 20-year service life which expired in 1978.

Location: Building Systems
Material: System
Distress: Beyond Expected Life
Category: Deferred Maintenance
Priority: 3 - Necessary (Years 2-5)
Correction: Renew System
Qty: 1-Ea.
Estimate: \$69,249.09
Created: Bill Watson, 08/07/2013
Last Updated: Joanne Romaneli, 08/26/2013

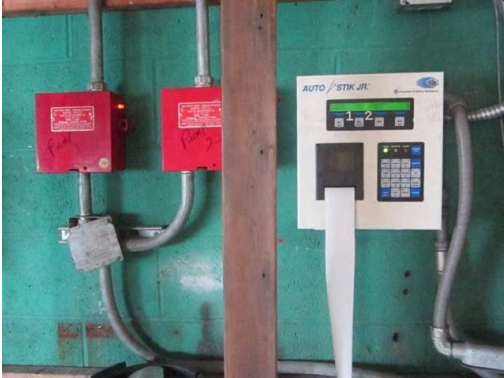
System: D5030 - Communications and Security

Analysis: The system is in poor condition. The system was installed in 1993. It has a 15-year service life which expired in 2008.

Location: Building Systems
Material: System
Distress: Beyond Expected Life
Category: Deferred Maintenance
Priority: 3 - Necessary (Years 2-5)
Correction: Renew System
Qty: 1-Ea.
Estimate: \$115,992.23
Created: Bill Watson, 08/07/2013
Last Updated: Joanne Romaneli, 08/27/2013

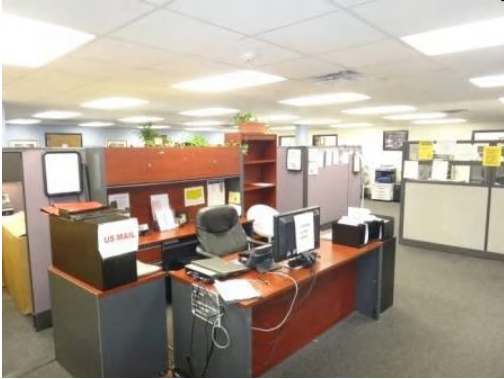
System: E2010 - Fixed Furnishings

Analysis: The system is in poor condition. The system was installed in 1958. It has a 20-year service life which expired in 1978.

Location: Building Systems
Material: System
Distress: Beyond Expected Life
Category: Deferred Maintenance
Priority: 3 - Necessary (Years 2-5)
Correction: Renew System
Qty: 1-Ea.
Estimate: \$47,435.63
Created: Bill Watson, 08/07/2013
Last Updated: Joanne Romanelli, 08/27/2013

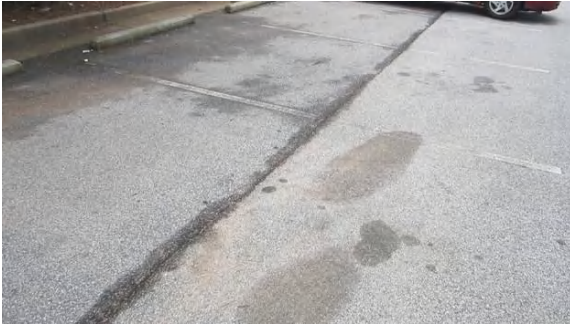
System: G2020 - Parking Lots

Analysis: The system is in good condition. The system was installed in 1998. It has a 35-year service life. However, in the assessment, it was found to be currently deficient.

Notes: Asphalt is cracked and parking lines faded.

Location: Building Systems
Material: Parking Lots
Distress: Beyond Expected Life
Category: Deferred Maintenance
Priority: 2 - Trending Critical (Year 1)
Correction: Resurface asphalt paving and restripe.
Qty: 1,200-S.Y.
Estimate: \$49,850.23
Created: Bill Watson, 08/05/2013
Last Updated: Joanne Romaneli, 08/27/2013

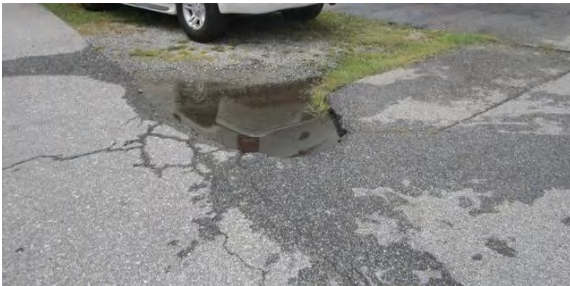
System: G2020 - Parking Lots

Analysis: The system is in good condition. The system was installed in 1998. It has a 35-year service life. However, in the assessment, it was found to be currently deficient.

Notes: Damaged concrete surfaces evident at several locations.

Location: Building Systems
Material: Parking Lots
Distress: Damaged
Category: Deferred Maintenance
Priority: 3 - Necessary (Years 2-5)
Correction: Remove and replace concrete parking slab.
Qty: 1,000-S.F.
Estimate: \$3,807.15
Created: Bill Watson, 08/01/2013
Last Updated: Joanne Romaneli, 08/27/2013

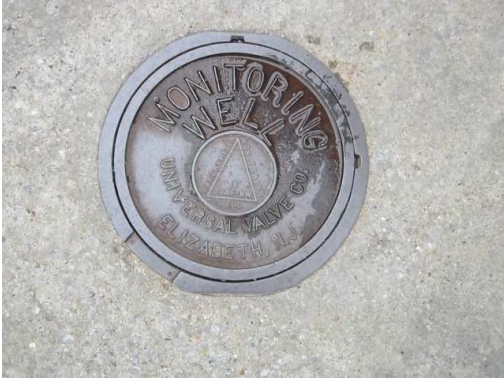
System: G3010 - Water Supply

Analysis: The system is in poor condition. The system was installed in 1958. It has a 50-year service life which expired in 2008.

Location: Building Systems
Material: System
Distress: Beyond Expected Life
Category: Deferred Maintenance
Priority: 3 - Necessary (Years 2-5)
Correction: Renew System
Qty: 1-Ea.
Estimate: \$24,929.67
Created: Bill Watson, 08/07/2013
Last Updated: Joanne Romaneli, 08/27/2013

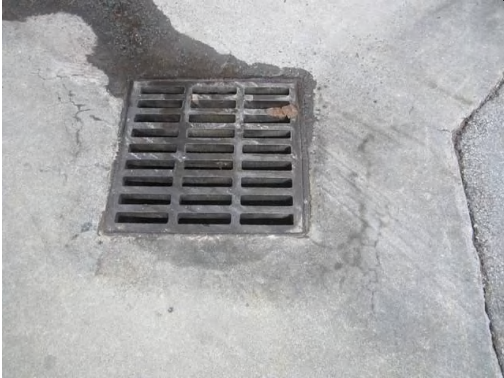
System: G3030 - Storm Sewer

Analysis: The system is in poor condition. The system was installed in 1958. It has a 50-year service life which expired in 2008.

Notes: Despite good site (natural) drainage - the storm sewer system is beyond its expected service life.

Location: Building Systems
Material: System
Distress: Beyond Expected Life
Category: Deferred Maintenance
Priority: 4 - Recommended (Years 6-10)
Correction: Renew System
Qty: 1-Ea.
Estimate: \$29,430.86
Created: Bill Watson, 08/07/2013
Last Updated: Joanne Romaneli, 08/27/2013
