Atlanta Public Schools/ Jackson Cluster

Whitefoord Early Learning Center

School Assessment Report

November 10, 2020

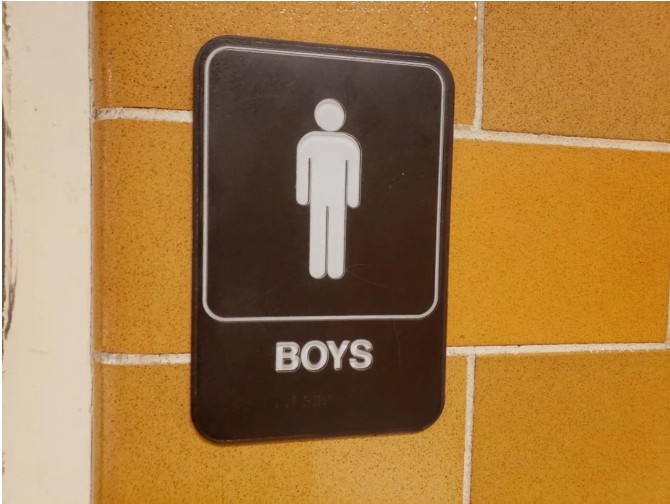
System: C1030 - Fittings

Location: Throughout Building
Distress: Beyond Expected Life
Category: ADA Compliance
Priority: 3 - Necessary (Years 2-5)
Correction: Renew System
Qty: 37,458.00
Unit of Measure: S.F.
Estimate: \$117,843.00
Assessor Name: Jejuan Hall
Date Created: 09/17/2015

Notes: Fittings, such as signage and railing, are beyond their expected service life, should be replaced and upgraded for compliance with ADA standards.

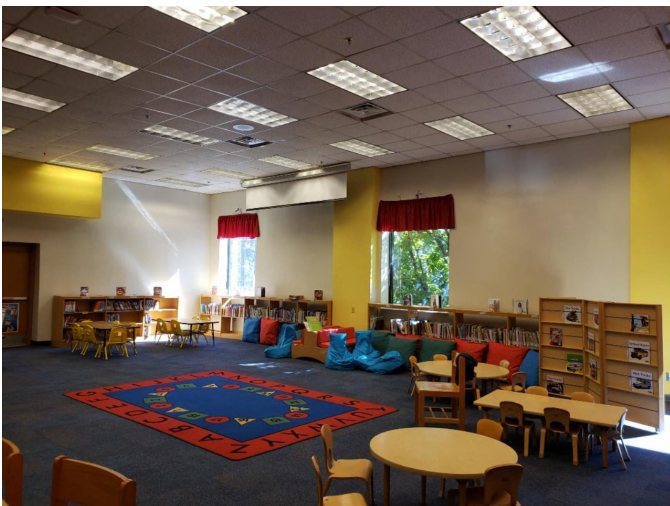
System: C3020901 - Carpet

Location: Media Center
Distress: Beyond Expected Life
Category: Deferred Maintenance
Priority: 3 - Necessary (Years 2-5)
Correction: Renew System
Qty: 3,032.00
Unit of Measure: S.F.
Estimate: \$25,014.00
Assessor Name: Joanne Romanelli
Date Created: 01/27/2020

Notes: The carpet is aged, worn and stained, and should be replaced.

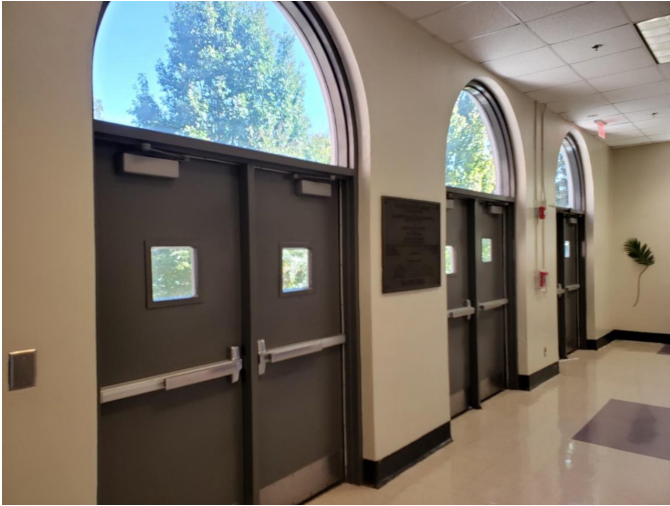
System: C3020903 - VCT

Location: Throughout Building
Distress: Beyond Expected Life
Category: Deferred Maintenance
Priority: 3 - Necessary (Years 2-5)
Correction: Renew System
Qty: 33,055.00
Unit of Measure: S.F.
Estimate: \$178,299.00
Assessor Name: Joanne Romanelli
Date Created: 01/27/2020

Notes: The VCT floor finish is beyond its expected service life, worn and damaged, and is recommended for replacement.

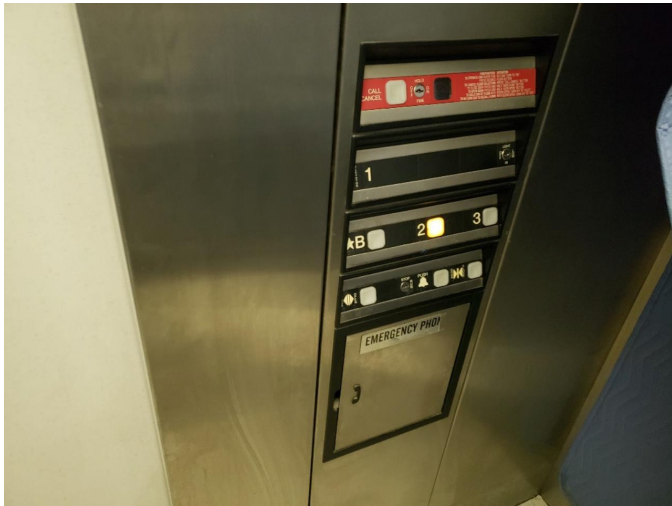
System: D1010 - Elevators and Lifts

Location: main corridor
Distress: Beyond Expected Life
Category: Deferred Maintenance
Priority: 3 - Necessary (Years 2-5)
Correction: Renew System
Qty: 37,458.00
Unit of Measure: S.F.
Estimate: \$56,449.00
Assessor Name: Joanne Romanelli
Date Created: 09/17/2015

Notes: The elevator system has exceeded its life cycle and recommended for upgrade.

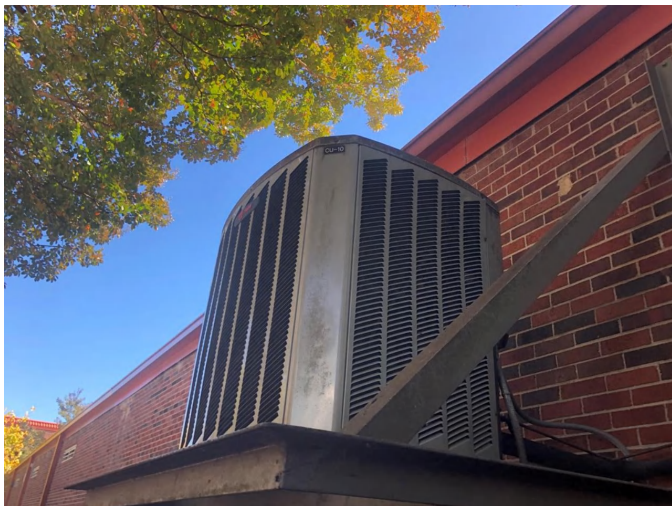
System: D3050 - Terminal & Package Units

Location: Rooftop and around building
Distress: Beyond Expected Life
Category: Deferred Maintenance
Priority: 3 - Necessary (Years 2-5)
Correction: Renew System
Qty: 37,458.00
Unit of Measure: S.F.
Estimate: \$683,983.00
Assessor Name: Joanne Romanelli
Date Created: 08/13/2013

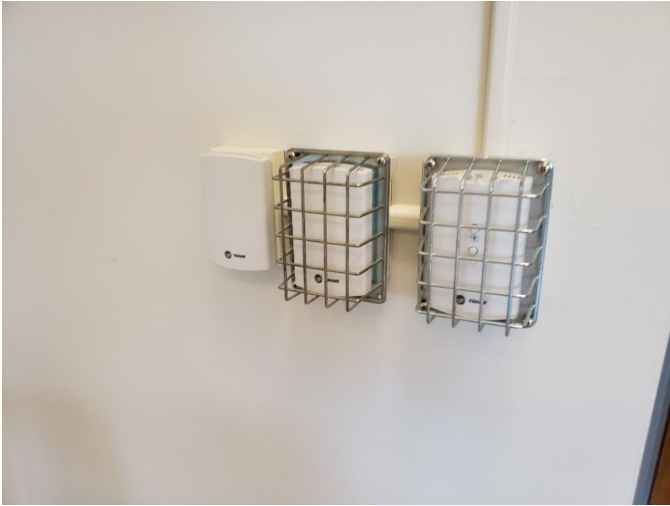
System: D3060 - Controls & Instrumentation

Location: Throughout Building
Distress: Beyond Expected Life
Category: Deferred Maintenance
Priority: 3 - Necessary (Years 2-5)
Correction: Renew System
Qty: 37,458.00
Unit of Measure: S.F.
Estimate: \$98,065.00
Assessor Name: Joanne Romanelli
Date Created: 08/13/2013

Notes: The heating generation systems, exhaust and ventilation systems, energy monitoring and controls as well as the building automation systems are beyond their expected service life and should be replaced.

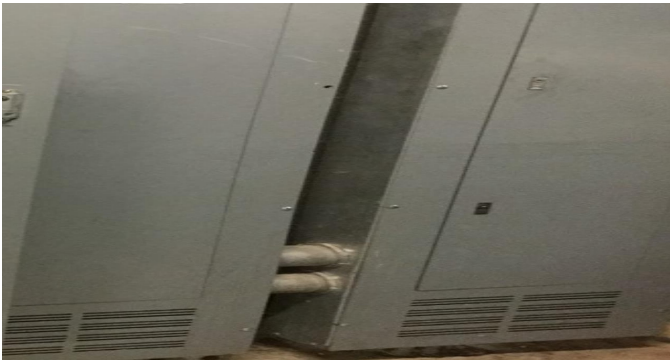
System: D5010 - Electrical Service/Distribution

Location: Throughout Building
Distress: Beyond Expected Life
Category: Deferred Maintenance
Priority: 3 - Necessary (Years 2-5)
Correction: Renew System
Qty: 37,458.00
Unit of Measure: S.F.
Estimate: \$102,185.00
Assessor Name: Joanne Romanelli
Date Created: 09/17/2015

Notes: The electrical service/distribution system is aged and should be replaced and upgraded for compliance with current code requirements.

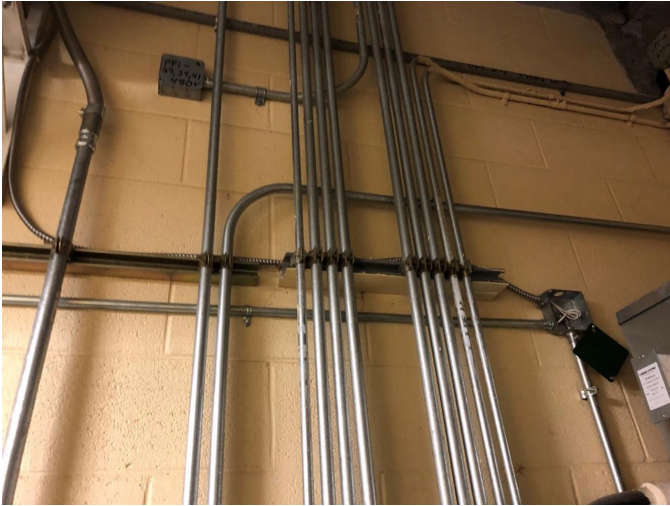
System: D5020 - Branch Wiring

Location: Throughout Building
Distress: Beyond Expected Life
Category: Deferred Maintenance
Priority: 3 - Necessary (Years 2-5)
Correction: Renew System
Qty: 37,458.00
Unit of Measure: S.F.
Estimate: \$210,551.00
Assessor Name: Joanne Romanelli
Date Created: 08/13/2013

Notes: The branch wiring system is beyond its expected life cycle. Replacement or upgrades are recommended.

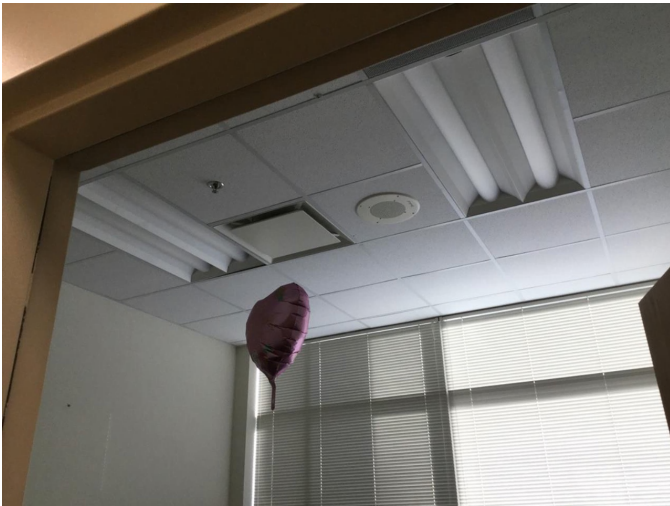
System: D5020 - Lighting

Location: Throughout Building
Distress: Beyond Expected Life
Category: Deferred Maintenance
Priority: 3 - Necessary (Years 2-5)
Correction: Renew System
Qty: 37,458.00
Unit of Measure: S.F.
Estimate: \$315,621.00
Assessor Name: Joanne Romanelli
Date Created: 01/27/2020

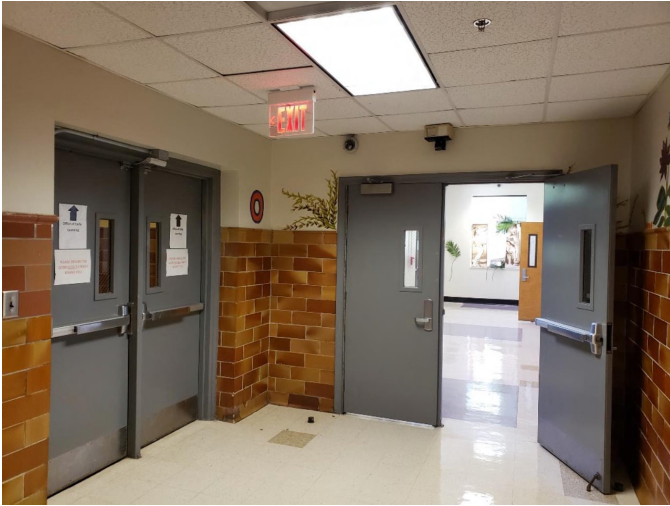
System: D5030810 - Security & Detection Systems

Location: Throughout Building
Distress: Beyond Expected Life
Category: Deferred Maintenance
Priority: 3 - Necessary (Years 2-5)
Correction: Renew System
Qty: 37,458.00
Unit of Measure: S.F.
Estimate: \$62,218.00
Assessor Name: Joanne Romanelli
Date Created: 01/27/2020

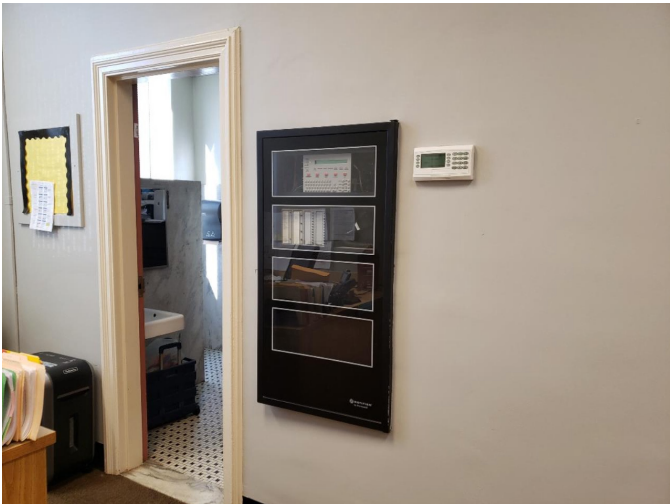
System: D5030910 - Fire Alarm Systems

Location: Throughout Building
Distress: Beyond Expected Life
Category: Deferred Maintenance
Priority: 3 - Necessary (Years 2-5)
Correction: Renew System
Qty: 37,458.00
Unit of Measure: S.F.
Estimate: \$112,898.00
Assessor Name: Joanne Romanelli
Date Created: 01/27/2020

Notes: The fire alarm system is beyond its expected service life and upgrades are warranted.

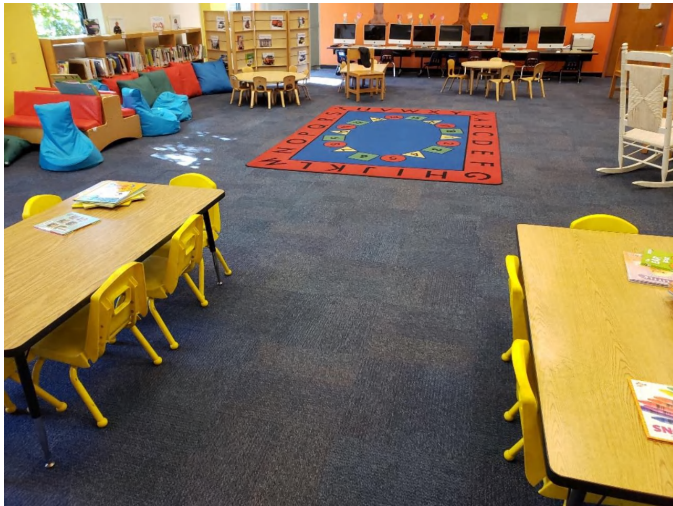
System: E1020 - Institutional Equipment

Location: Media Center
Distress: Beyond Expected Life
Category: Deferred Maintenance
Priority: 3 - Necessary (Years 2-5)
Correction: Renew System
Qty: 37,458.00
Unit of Measure: S.F.
Estimate: \$4,120.00
Assessor Name: Joanne Romanelli
Date Created: 09/17/2015

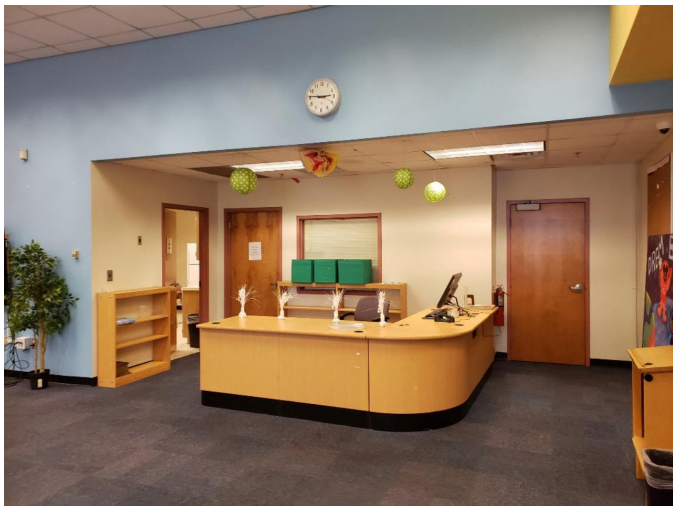
System: E2010 - Fixed Furnishings

Location: Throughout Building
Distress: Beyond Expected Life
Category: Deferred Maintenance
Priority: 3 - Necessary (Years 2-5)
Correction: Renew System
Qty: 37,458.00
Unit of Measure: S.F.
Estimate: \$85,704.00
Assessor Name: Joanne Romanelli
Date Created: 09/17/2015

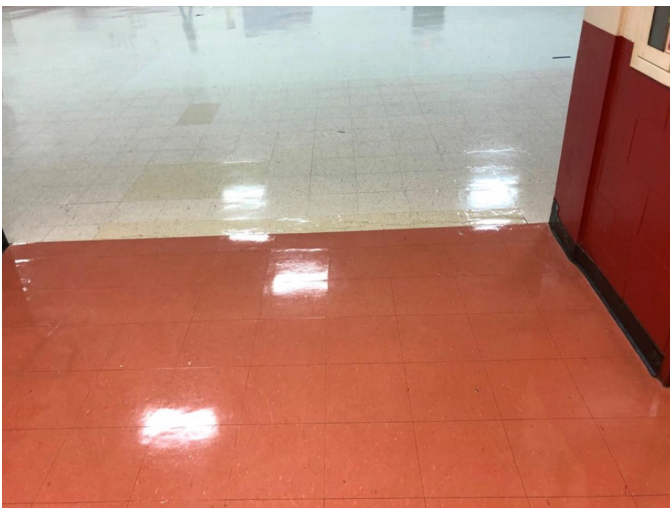
System: C3020903 - VCT

Location: Throughout Building
Distress: Beyond Expected Life
Category: Deferred Maintenance
Priority: 3 - Necessary (Years 2-5)
Correction: Renew System
Qty: 18,691.00
Unit of Measure: S.F.
Estimate: \$100,819.00
Assessor Name: Homero Guerrero
Date Created: 01/27/2020

Notes: for replacement.

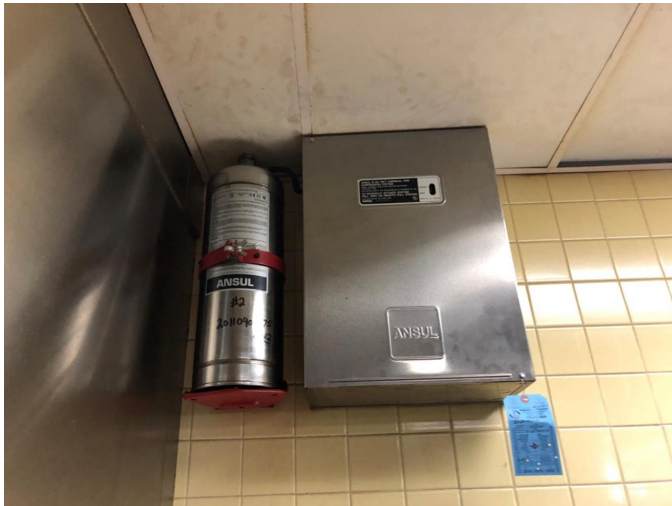
System: D4090 - Other Fire Protection Systems

Location: Kitchen
Distress: Beyond Expected Life
Category: Deferred Maintenance
Priority: 3 - Necessary (Years 2-5)
Correction: Renew System
Qty: 21,980.00
Unit of Measure: S.F.
Estimate: \$15,957.00
Assessor Name: Homero Guerrero
Date Created: 08/13/2013

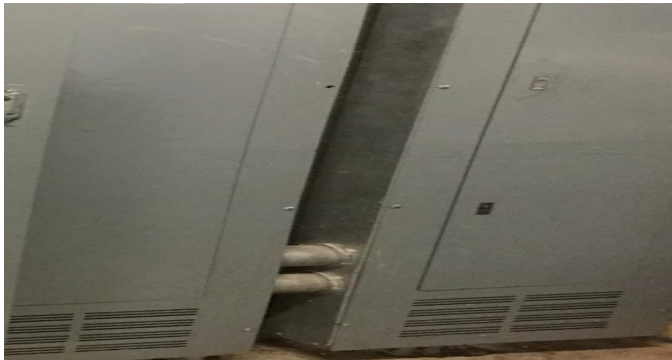
System: D5010 - Electrical Service/Distribution

Location: Throughout Building
Distress: Beyond Expected Life
Category: Deferred Maintenance
Priority: 3 - Necessary (Years 2-5)
Correction: Renew System
Qty: 21,980.00
Unit of Measure: S.F.
Estimate: \$61,654.00
Assessor Name: Homero Guerrero
Date Created: 09/17/2015

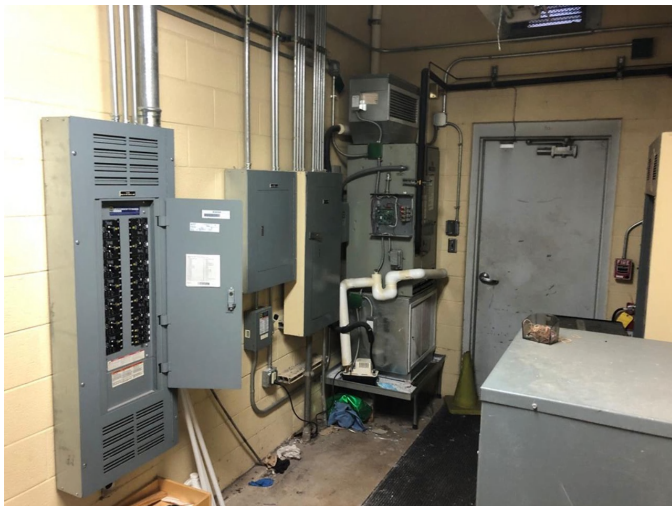
System: D5020 - Branch Wiring

Location: Throughout Building
Distress: Beyond Expected Life
Category: Deferred Maintenance
Priority: 3 - Necessary (Years 2-5)
Correction: Renew System
Qty: 21,980.00
Unit of Measure: S.F.
Estimate: \$114,846.00
Assessor Name: Homero Guerrero
Date Created: 09/17/2015

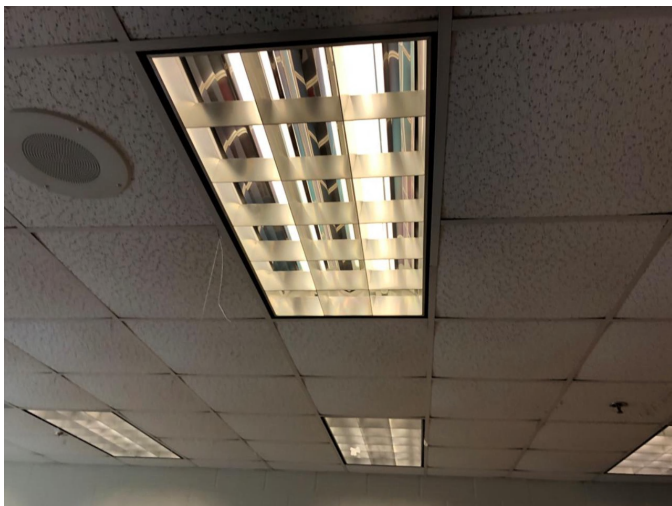
System: D5020 - Lighting

Location: Throughout Building
Distress: Beyond Expected Life
Category: Deferred Maintenance
Priority: 3 - Necessary (Years 2-5)
Correction: Renew System
Qty: 21,980.00
Unit of Measure: S.F.
Estimate: \$204,304.00
Assessor Name: Homero Guerrero
Date Created: 01/27/2020

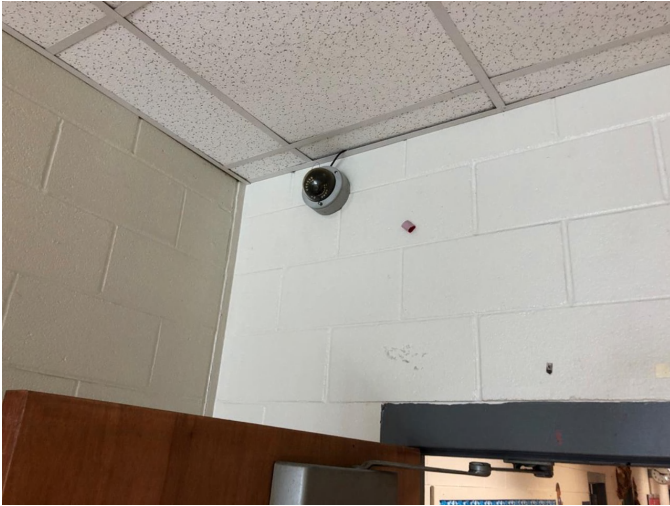
System: D5030810 - Security & Detection Systems

Location: Throughout Building
Distress: Beyond Expected Life
Category: Deferred Maintenance
Priority: 3 - Necessary (Years 2-5)
Correction: Renew System
Qty: 21,980.00
Unit of Measure: S.F.
Estimate: \$36,509.00
Assessor Name: Homero Guerrero
Date Created: 01/27/2020

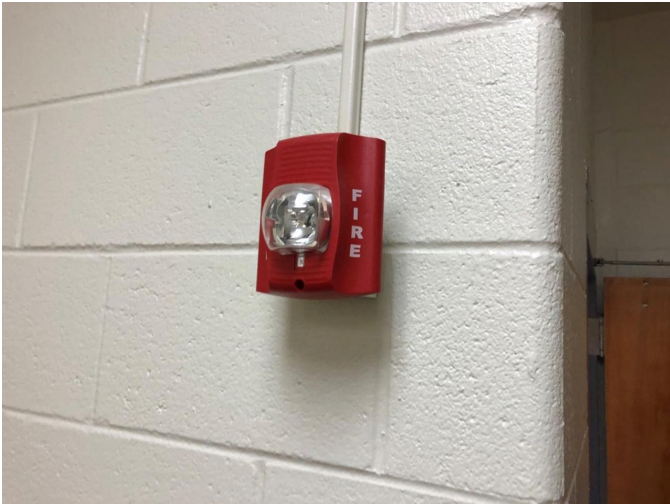
System: D5030910 - Fire Alarm Systems

The security system is beyond its expected service life and upgrades are warranted.

Location: Throughout Building
Distress: Beyond Expected Life
Category: Deferred Maintenance
Priority: 3 - Necessary (Years 2-5)
Correction: Renew System
Qty: 21,980.00
Unit of Measure: S.F.
Estimate: \$66,248.00
Assessor Name: Homero Guerrero
Date Created: 01/27/2020

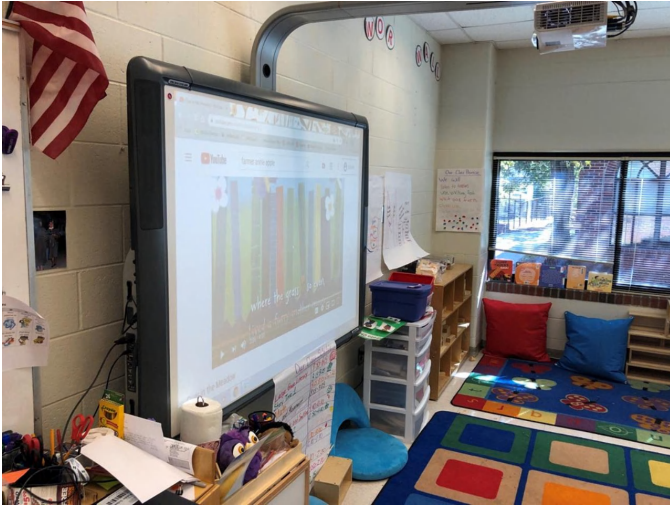
System: E1020 - Institutional Equipment

Location: Throughout Building
Distress: Beyond Expected Life
Category: Deferred Maintenance
Priority: 3 - Necessary (Years 2-5)
Correction: Renew System
Qty: 21,980.00
Unit of Measure: S.F.
Estimate: \$2,418.00
Assessor Name: Homero Guerrero
Date Created: 09/17/2015

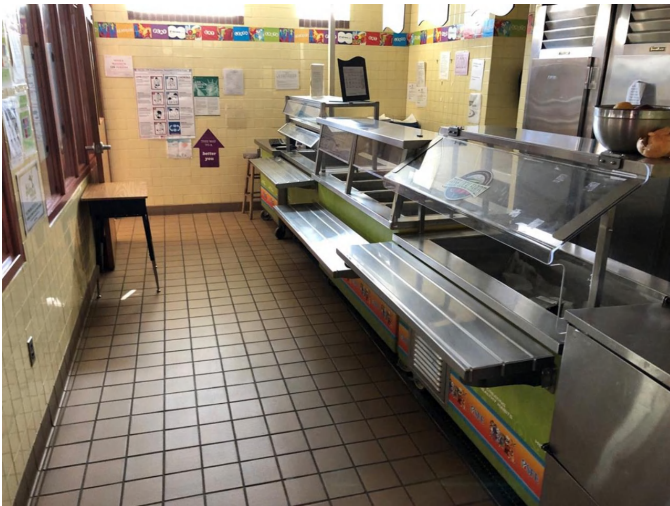
System: E1090 - Other Equipment

Location: Kitchen
Distress: Beyond Expected Life
Category: Deferred Maintenance
Priority: 3 - Necessary (Years 2-5)
Correction: Renew System
Qty: 21,980.00
Unit of Measure: S.F.
Estimate: \$21,035.00
Assessor Name: Homero Guerrero
Date Created: 09/17/2015

The kitchen equipment is beyond its expected service life and upgrades are warranted.

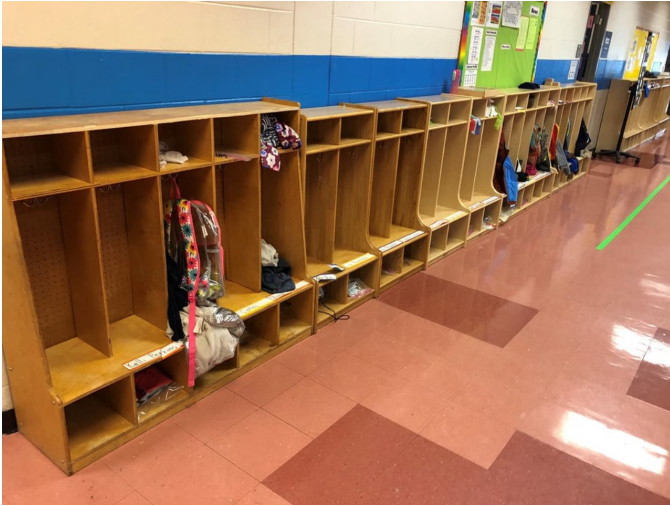
System: E2010 - Fixed Furnishings

Location: Throughout Building
Distress: Beyond Expected Life
Category: Deferred Maintenance
Priority: 3 - Necessary (Years 2-5)
Correction: Renew System
Qty: 21,980.00
Unit of Measure: S.F.
Estimate: \$51,983.00
Assessor Name: Homero Guerrero
Date Created: 09/17/2015

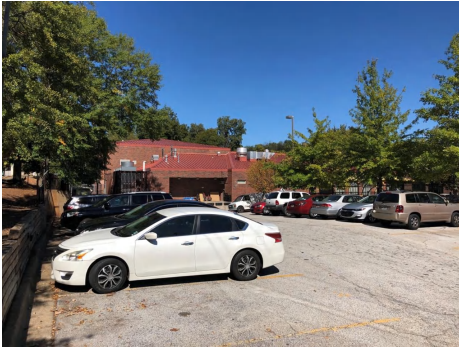
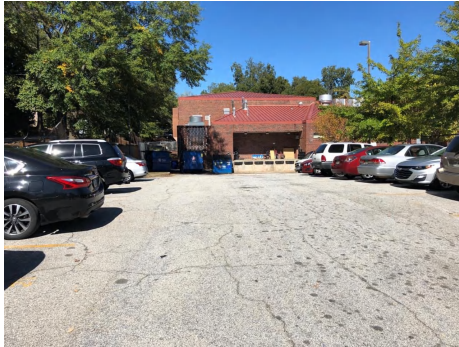
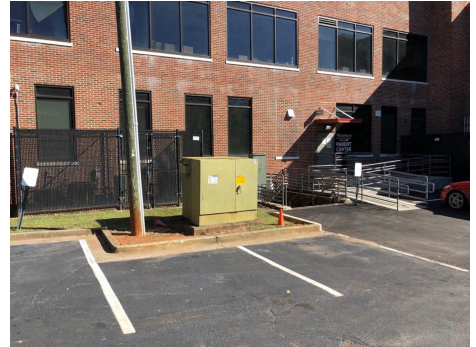
System: G2020 - Parking Lots

Notes: Asphalt pavement is worn and parking stripes wearing.

Location: Site
Distress: Damaged
Category: Deferred Maintenance
Priority: 3 - Necessary (Years 2-5)
Correction: Replace parking lot stripping and curb markings
Qty: 12,000.00
Unit of Measure: S.F.
Estimate: \$5,434.68
Assessor Name: Hayden Collins
Date Created: 08/05/2013
