Atlanta Public Schools/ Jackson Cluster

Burgess-Peterson Elementary School

School Assessment Report

November 10, 2020

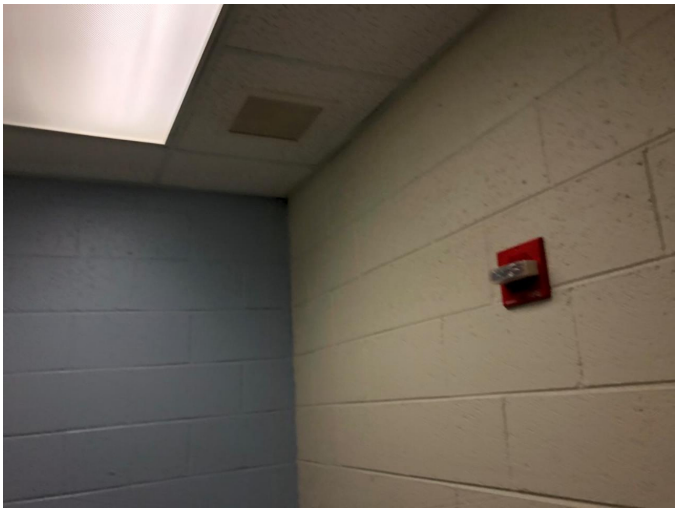
System: D5030910 - Fire Alarm Systems

Location: Throughout Building
Distress: Beyond Expected Life
Category: Deferred Maintenance
Priority: 3 - Necessary (Years 2-5)
Correction: Renew System
Qty: 11,049.00
Unit of Measure: S.F.
Estimate: $33,302.00
Assessor Name: Eduardo Lopez
Date Created: 01/15/2020

Notes: The Fire Alarm system is in good condition. However, it has approached the end of its expected service life and should be scheduled for replacement or upgrade.
