Atlanta Public Schools/ S. Atlanta Cluster

Cleveland Avenue Elementary School

School Assessment Report

November 10, 2020

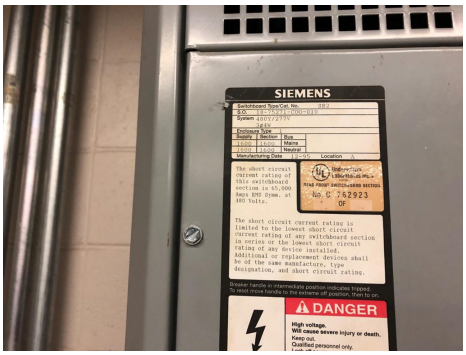
System: D5010 - Electrical Service/Distribution

Notes: The electrical services and distribution system consist of an interior distribution system and branch panels with conduit and wiring to the lighting system. This system is beyond its expected life and universal upgrades are recommended.

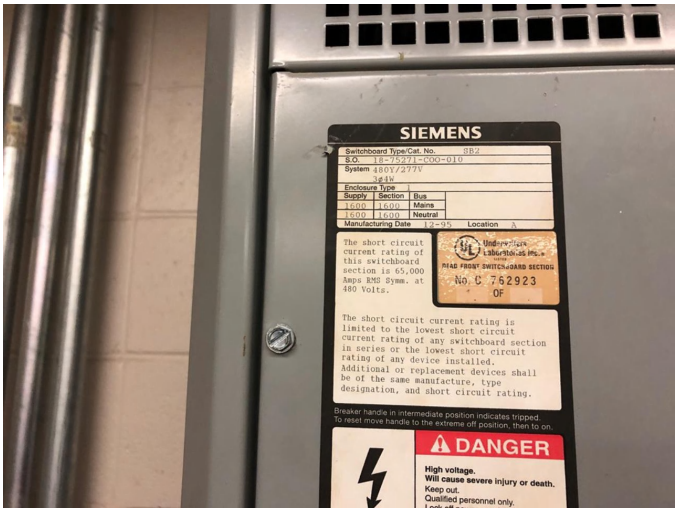
System: D5010 - Electrical Service/Distribution

Location: Electrical Room
Distress: Beyond Expected Life
Category: Deferred Maintenance
Priority: 3 - Necessary (Years 2-5)
Correction: Renew System
Qty: 75,286.00
Unit of Measure: S.F.
Estimate: $211,177.00
Assessor Name: Hayden Collins
Date Created: 09/27/2019

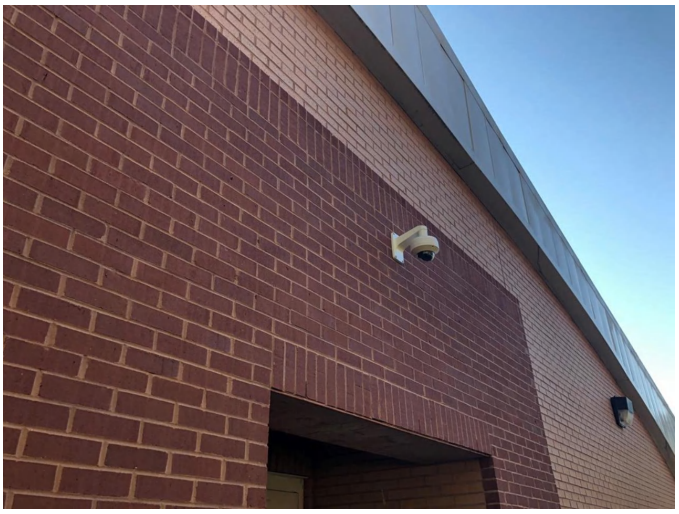
System: G4030 - Site Communication and Security

Location: Site
Distress: Beyond Expected Life
Category: Deferred Maintenance
Priority: 3 - Necessary (Years 2-5)
Correction: Renew System
Qty: 75,286.00
Unit of Measure: S.F.
Estimate: $106,003.00
Assessor Name: Jejuan Hall
Date Created: 02/22/2020

Notes:
Principal reported that on several occasions site Security System has failed resulting in property loss and raising anxiety level of students and staff.
