Atlanta Public Schools/ S. Atlanta Cluster

Dobbs Elementary School

School Assessment Report

November 10, 2020

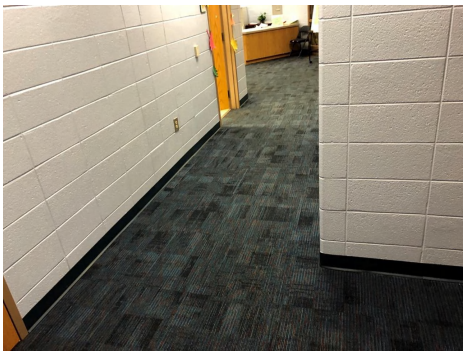
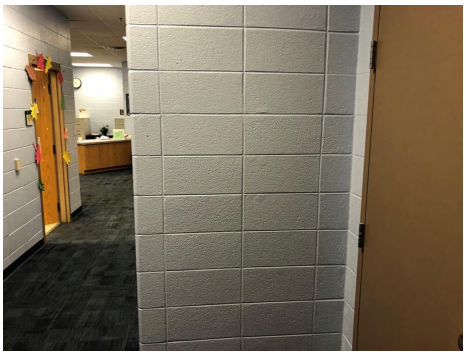
System: C3020901 - Carpet

Notes:
The carpet floor finish is beyond its expected service life, worn and damaged, and is recommended for replacement.

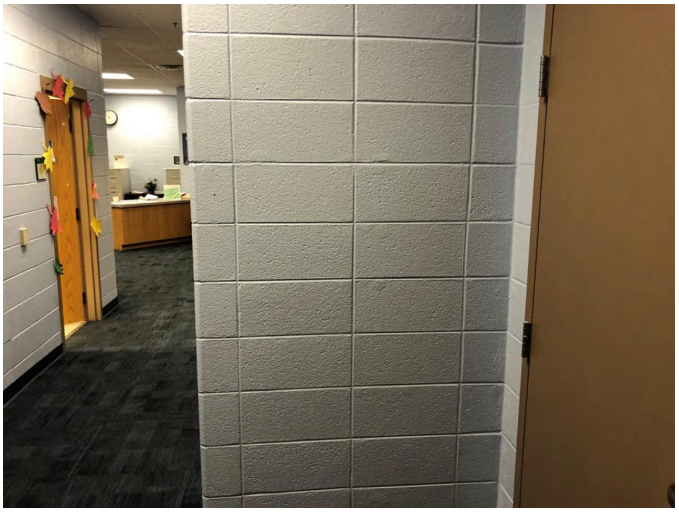
System: C3020901 - Carpet

Location: Media Center
Distress: Beyond Expected Life
Category: Deferred Maintenance
Priority: 3 - Necessary (Years 2-5)
Correction: Renew System
Qty: 4,000.00
Unit of Measure: S.F.
Estimate: $33,000.00
Assessor Name: Hayden Collins
Date Created: 02/14/2020
