Atlanta Public Schools/ Therrell Cluster

Kimberly Elementary School

School Assessment Report

November 10, 2020

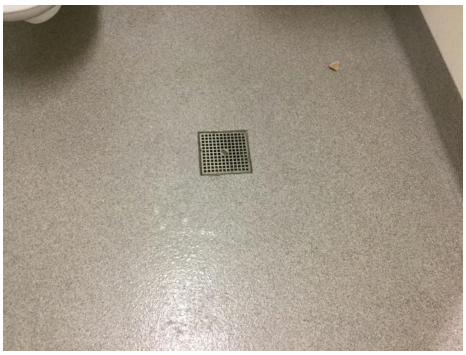
System: C3020405 - Epoxy

Notes: The epoxy floor finish is worn and deteriorating and should be replaced.

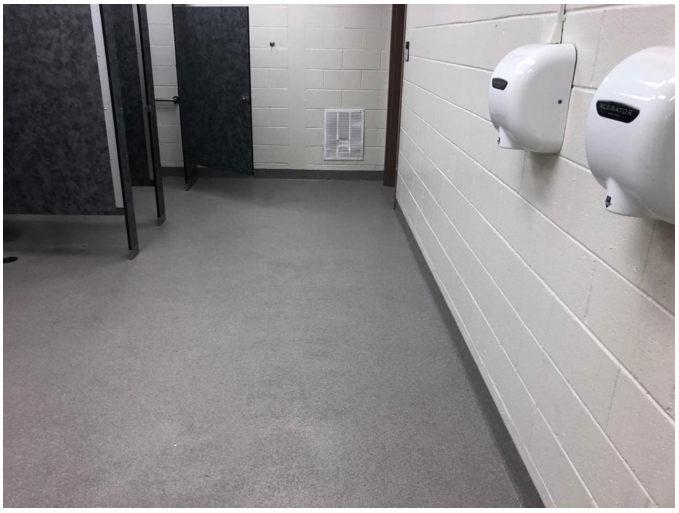
System: C3020999 - Epoxy

Location: Restrooms
Distress: Beyond Expected Life
Category: Deferred Maintenance
Priority: 3 - Necessary (Years 2-5)
Correction: Renew System
Qty: 1,057.00
Unit of Measure: S.F.
Estimate: $20,115.00
Assessor Name: Jejuan Hall
Date Created: 02/07/2020

Notes: The epoxy floor finish is worn and deteriorating and should be replaced.
