Atlanta Public Schools/ Jackson Cluster

Toomer Elementary School

School Assessment Report

November 10, 2020

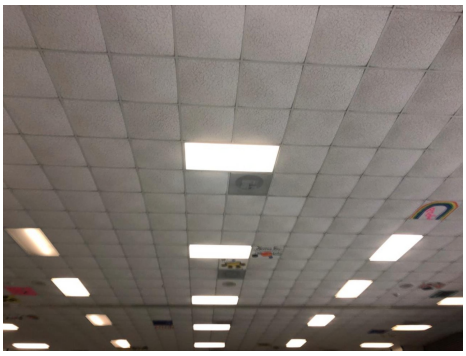
System: C3030 - Ceiling Finishes

Notes: The applied ceiling finish is beyond its expected life cycle and should be replaced.

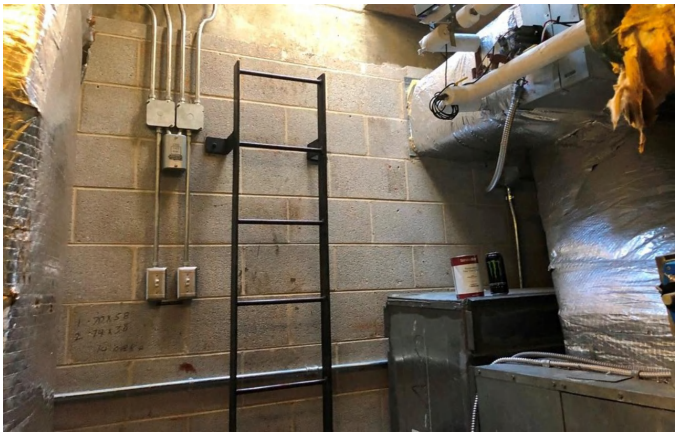
System: D5020 - Branch Wiring

Location: Throughout Building
Distress: Beyond Expected Life
Category: Deferred Maintenance
Priority: 3 - Necessary (Years 2-5)
Correction: Renew System
Qty: 51,209.00
Unit of Measure: S.F.
Estimate: $274,890.00
Assessor Name: Jejuan Hall
Date Created: 08/13/2014

Notes: The branch wiring system is operational but beyond its expected service life and should be replaced.

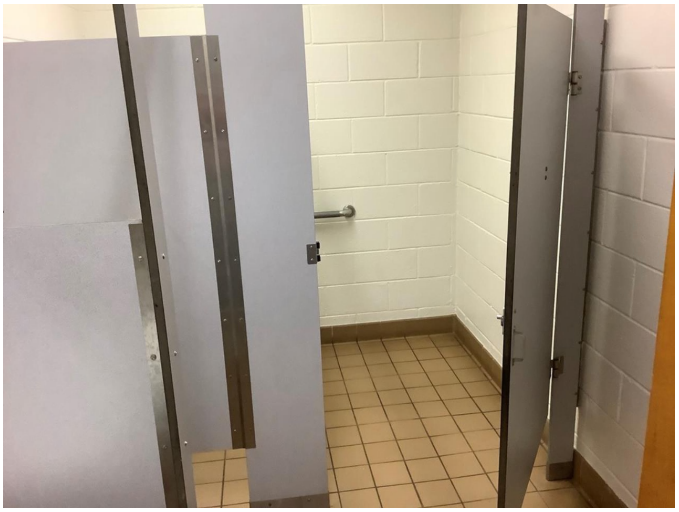
System: C1030 - Fittings

Location: Throughout Building
Distress: Beyond Expected Life
Category: ADA Compliance
Priority: 3 - Necessary (Years 2-5)
Correction: Renew System
Qty: 18,803.00
Unit of Measure: S.F.
Estimate: $66,807.00
Assessor Name: Jejuan Hall
Date Created: 09/27/2019

Notes: Fittings, such as toilet partitions, signage and railing, are beyond their expected service life, outdated and should be replaced and upgraded for compliance with ADA standards.

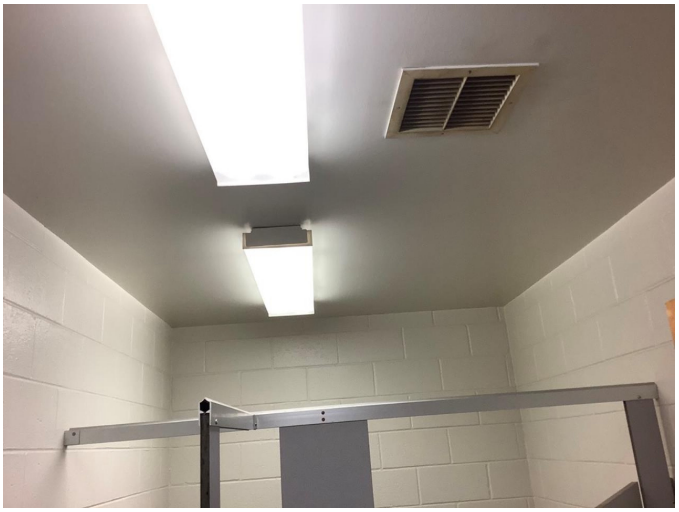
System: D5020 - Lighting

Location: Throughout Building
Distress: Beyond Expected Life
Category: Deferred Maintenance
Priority: 3 - Necessary (Years 2-5)
Correction: Renew System
Qty: 18,803.00
Unit of Measure: S.F.
Estimate: $179,738.00
Assessor Name: Jejuan Hall
Date Created: 01/27/2020

Notes: TThe lighting system is operational but beyond its expected service life and should be replaced.
