Atlanta Public Schools/Charter Schools

# Archer High School (Westside Atlanta Charter)

## School Assessment Report

November 10, 2020

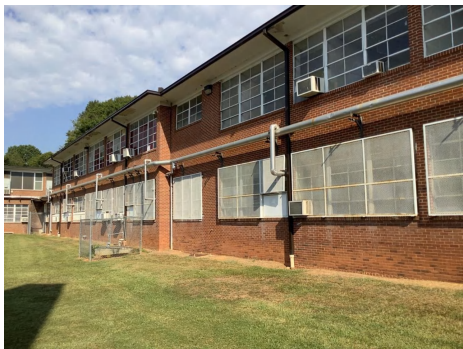
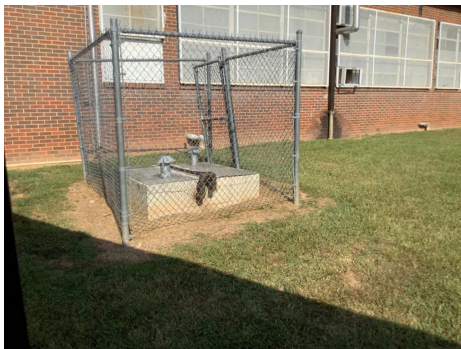
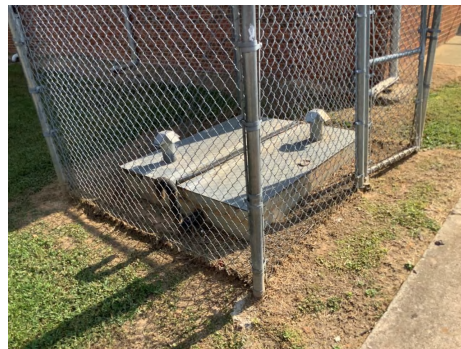
**System:** G3010 - Water Supply

**Notes:** The system is beyond its expected service life and should be scheduled for replacement. Water supply system is aged, and should be replaced.

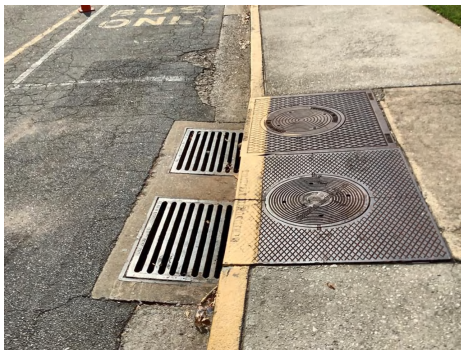
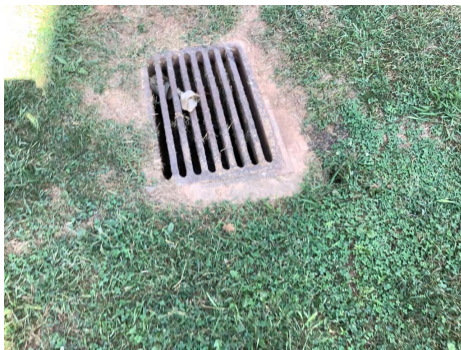
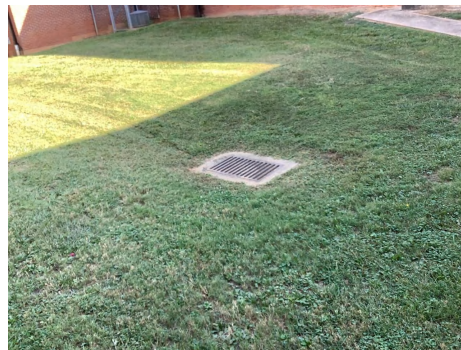
**System:** G3030 - Storm Sewer

**Notes:** The system is beyond its expected service life and should be scheduled for replacement. Storm sewer system is aged, and should be replaced.
