Atlanta Public Schools/ Jackson Cluster

Benteen Elementary School

School Assessment Report

November 10, 2020

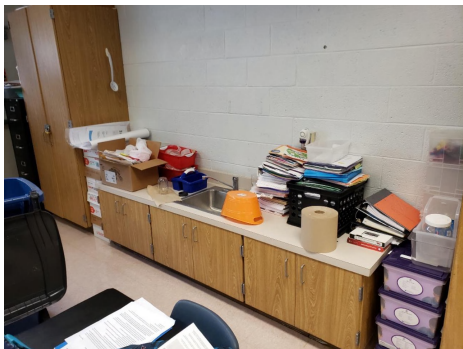
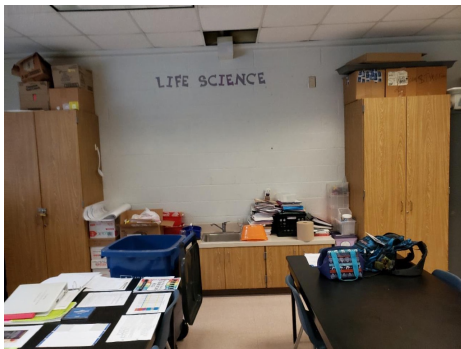
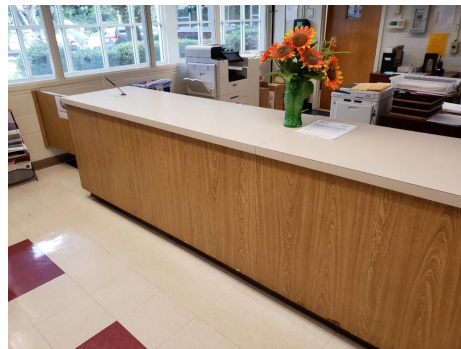
System: E2010 - Fixed Furnishings

Notes: Fixed Furnishings are beyond their service life and should be scheduled for replacement.

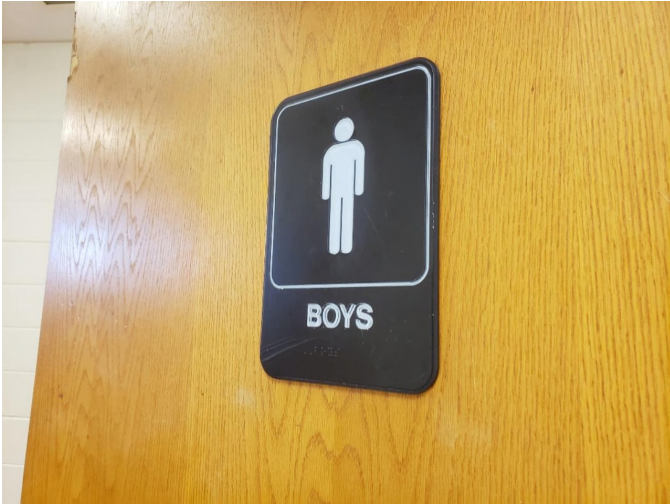
System: C1030 - Fittings

Location: Throughout Building
Distress: Beyond Expected Life
Category: ADA Compliance
Priority: 3 - Necessary (Years 2-5)
Correction: Renew System
Qty: 13,199.00
Unit of Measure: S.F.
Estimate: \$36,442.00
Assessor Name: Jejuan Hall
Date Created: 01/22/2020

Notes: The fittings are beyond their expected life and are recommended for upgrades or replacement.

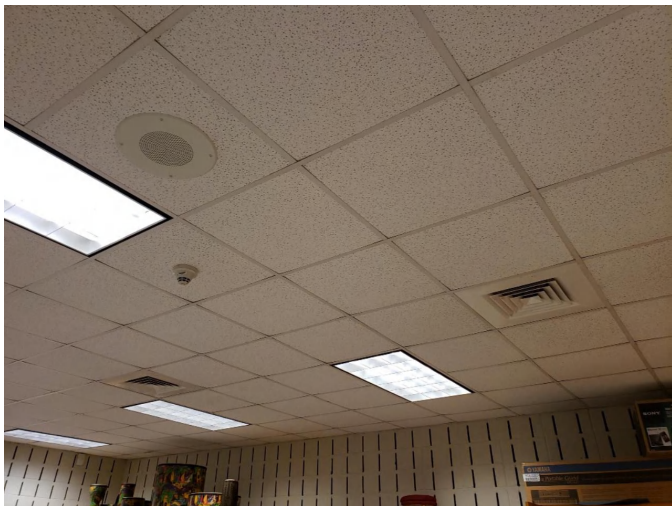
System: D3040 - Distribution Systems

Location: Throughout Building
Distress: Beyond Expected Life
Category: Deferred Maintenance
Priority: 3 - Necessary (Years 2-5)
Correction: Renew System
Qty: 13,199.00
Unit of Measure: S.F.
Estimate: \$150,706.00
Assessor Name: Jejuan Hall
Date Created: 01/22/2020

Notes: The exhaust system is from original construction. This system is beyond the expected life cycle for this application. Upgrades are warranted.

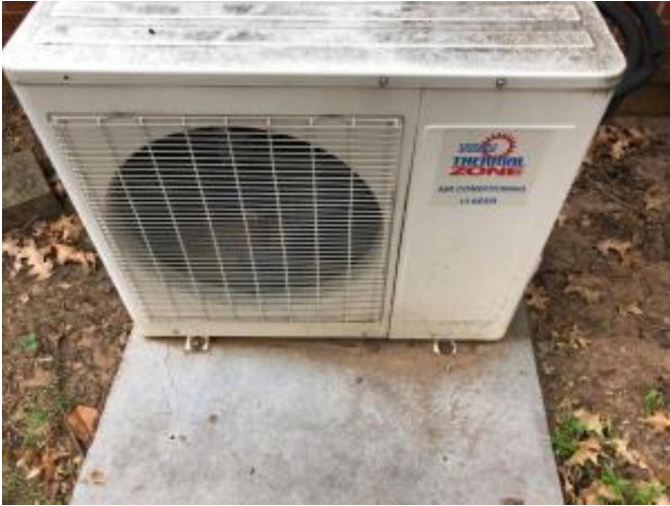
System: D3050 - Terminal & Package Units

Location: outside of building and inside of building
Distress: Beyond Expected Life
Category: Deferred Maintenance
Priority: 3 - Necessary (Years 2-5)
Correction: Renew System
Qty: 13,199.00
Unit of Measure: S.F.
Estimate: \$272,810.00
Assessor Name: Jejuan Hall
Date Created: 07/29/2013

Notes: Terminal and Package Units are beyond their expected service life. Replacing the units are recommended.

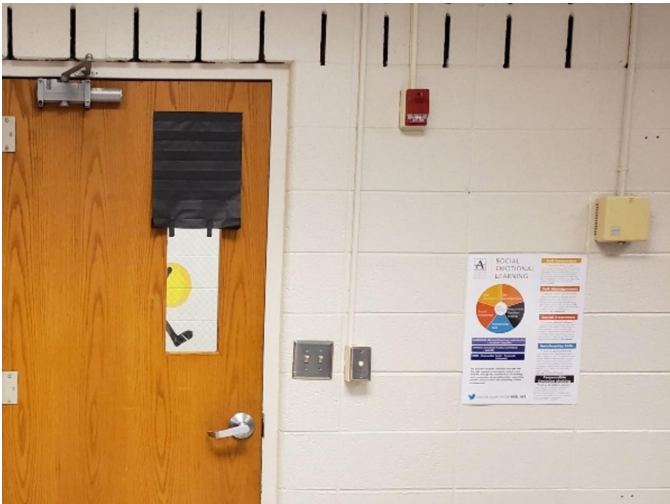
System: D3060 - Controls & Instrumentation

Location: Throughout Building
Distress: Beyond Expected Life
Category: Deferred Maintenance
Priority: 3 - Necessary (Years 2-5)
Correction: Renew System
Qty: 13,199.00
Unit of Measure: S.F.
Estimate: \$31,361.00
Assessor Name: Jejuan Hall
Date Created: 07/29/2013

Notes: HVAC Controls and Instrumentation are beyond their expected service life. Upgrades or replacing the controls are warranted.

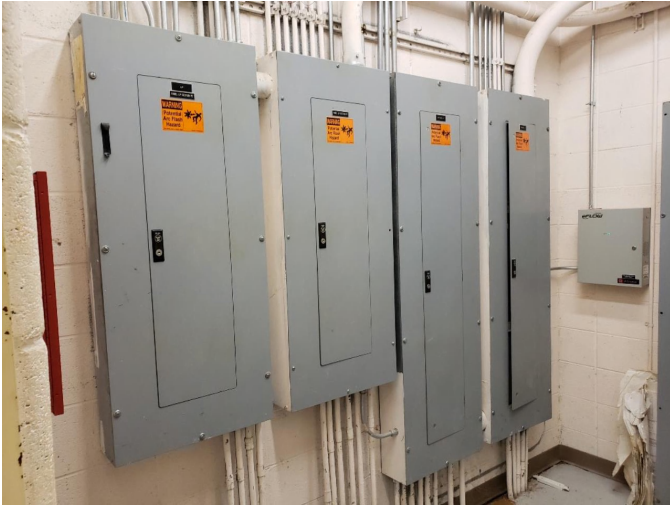
System: D5010 - Electrical Service/Distribution

Location: Electrical Room
Distress: Beyond Expected Life
Category: Deferred Maintenance
Priority: 3 - Necessary (Years 2-5)
Correction: Renew System
Qty: 13,199.00
Unit of Measure: S.F.
Estimate: \$31,796.00
Assessor Name: Jejuan Hall
Date Created: 08/13/2014

Notes: The electrical service/distribution system is aged and should be replaced and upgraded for compliance with current code requirements.

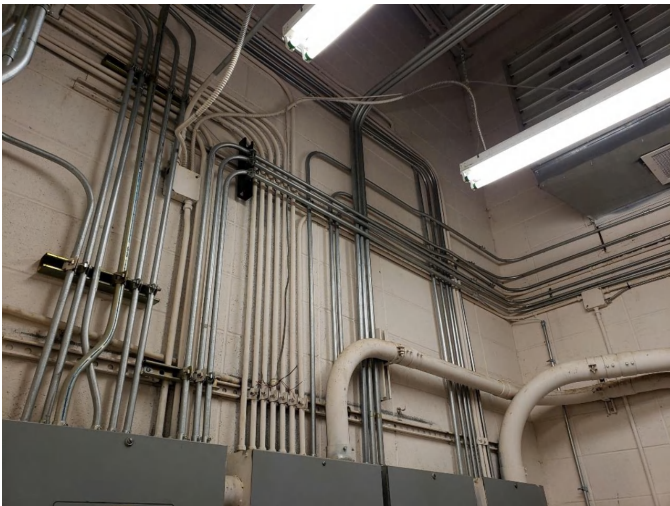
System: D5020 - Branch Wiring

Location: Throughout Building
Distress: Beyond Expected Life
Category: Deferred Maintenance
Priority: 3 - Necessary (Years 2-5)
Correction: Renew System
Qty: 13,199.00
Unit of Measure: S.F.
Estimate: \$65,625.00
Assessor Name: Jejuan Hall
Date Created: 01/22/2020

Notes: The electrical services and distribution system consist of an interior distribution system and branch panels with conduit and wiring. This system is beyond its expected life and universal upgrades are recommended.

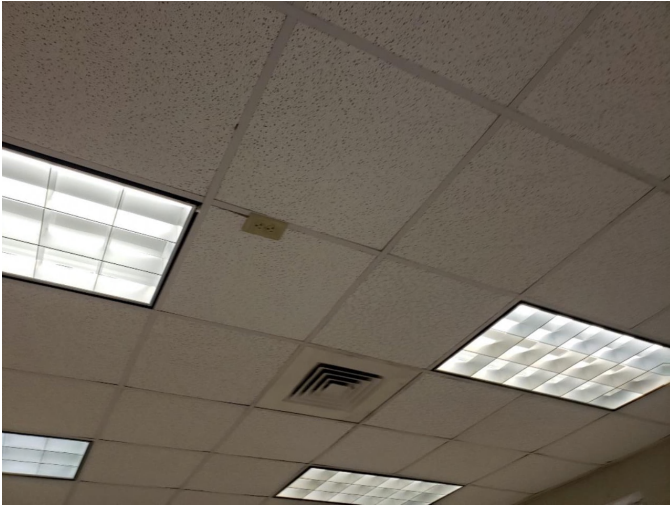
System: D5020 - Lighting

Location: Throughout Building
Distress: Beyond Expected Life
Category: Deferred Maintenance
Priority: 3 - Necessary (Years 2-5)
Correction: Renew System
Qty: 13,199.00
Unit of Measure: S.F.
Estimate: \$98,293.00
Assessor Name: Jejuan Hall
Date Created: 01/22/2020

Notes: The lighting system is beyond its expected life cycle. Replacement or upgrades are recommended.

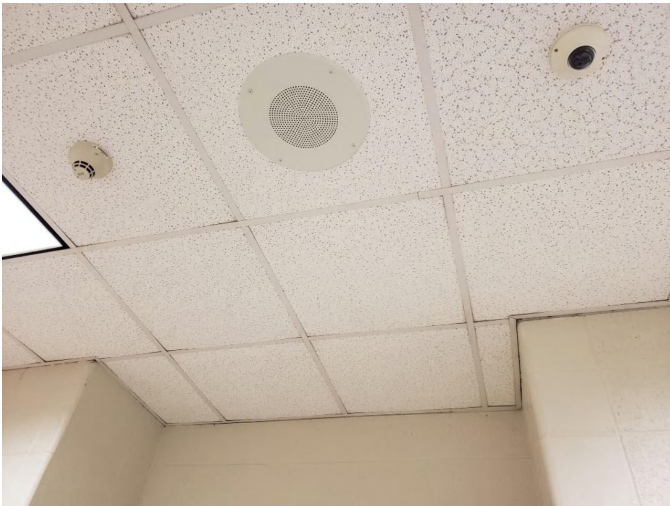
System: D5030810 - Security & Detection Systems

Location: Throughout Building
Distress: Beyond Expected Life
Category: Deferred Maintenance
Priority: 3 - Necessary (Years 2-5)
Correction: Renew System
Qty: 13,199.00
Unit of Measure: S.F.
Estimate: \$21,924.00
Assessor Name: Jejuan Hall
Date Created: 01/22/2020

Notes: The security and detection system is beyond its expected life and needs to be upgraded or replaced.

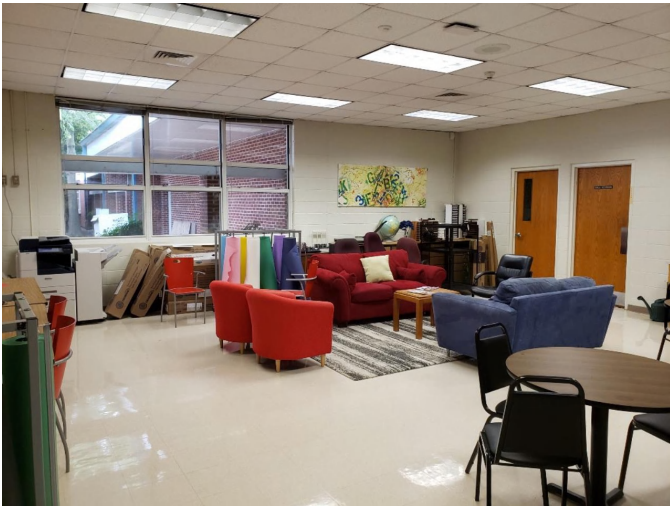
System: E1090 - Other Equipment

Location: Teachers Lounge
Distress: Beyond Expected Life
Category: Deferred Maintenance
Priority: 3 - Necessary (Years 2-5)
Correction: Renew System
Qty: 13,199.00
Unit of Measure: S.F.
Estimate: \$12,196.00
Assessor Name: Jejuan Hall
Date Created: 01/22/2020

Notes: Residential equipment is beyond its expected life and should be scheduled for replacement.

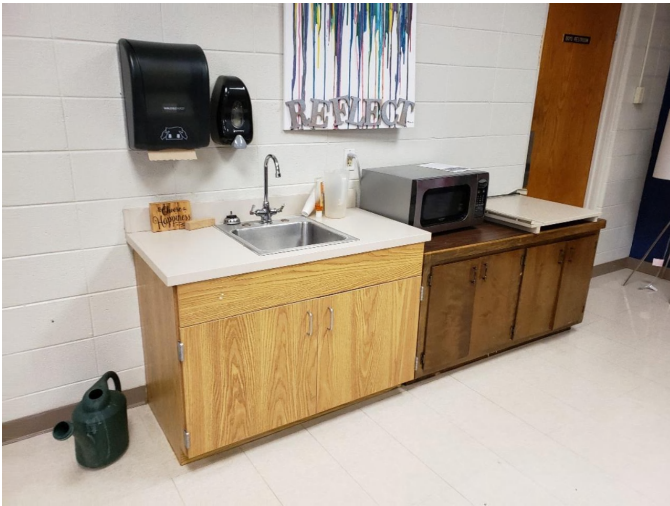
System: E2010 - Fixed Furnishings

Location: Throughout Building
Distress: Beyond Expected Life
Category: Deferred Maintenance
Priority: 3 - Necessary (Years 2-5)
Correction: Renew System
Qty: 13,199.00
Unit of Measure: S.F.
Estimate: \$30,780.00
Assessor Name: Jejuan Hall
Date Created: 01/22/2020

Notes: Fixed furnishings are aged and beyond its expected life and should be scheduled for replacement.

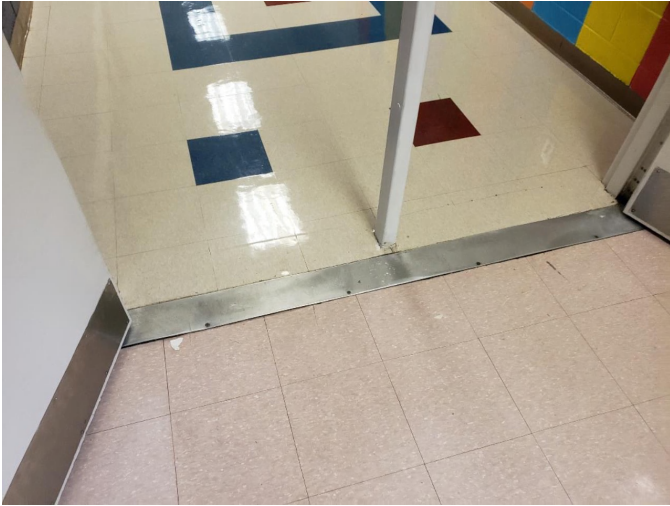
System: C3020903 - VCT

Location: Throughout Building
Distress: Beyond Expected Life
Category: Deferred Maintenance
Priority: 3 - Necessary (Years 2-5)
Correction: Renew System
Qty: 10,175.00
Unit of Measure: S.F.
Estimate: \$54,884.00
Assessor Name: Eduardo Lopez
Date Created: 01/22/2020

Notes: The VCT floor finish is beyond its expected service life, faded and stained, and should be replaced.

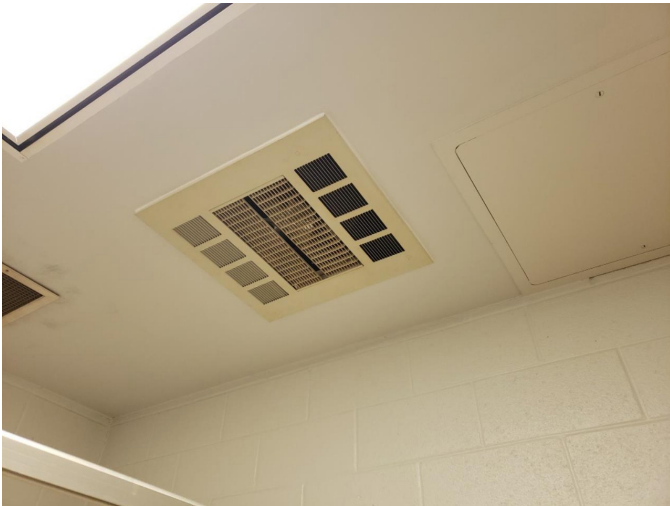
System: D3040 - Distribution Systems

Location: Throughout Building
Distress: Beyond Expected Life
Category: Deferred Maintenance
Priority: 3 - Necessary (Years 2-5)
Correction: Renew System
Qty: 10,777.00
Unit of Measure: S.F.
Estimate: \$123,052.00
Assessor Name: Eduardo Lopez
Date Created: 10/06/2020

Notes: The distribution system is beyond service life and should be scheduled for replacement.

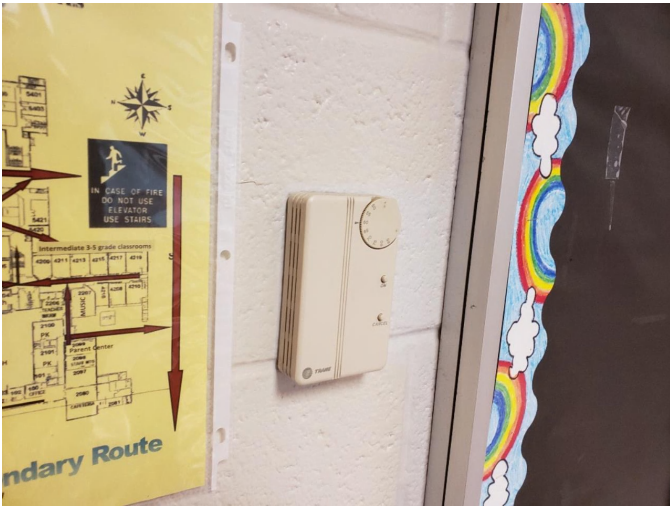
System: D3060 - Controls & Instrumentation

Location: Throughout Building
Distress: Beyond Expected Life
Category: Deferred Maintenance
Priority: 3 - Necessary (Years 2-5)
Correction: Renew System
Qty: 10,777.00
Unit of Measure: S.F.
Estimate: \$25,606.00
Assessor Name: Eduardo Lopez
Date Created: 01/22/2020

Notes: HVAC Controls and Instrumentation are beyond their expected service life. Upgrades or replacing the controls are warranted.

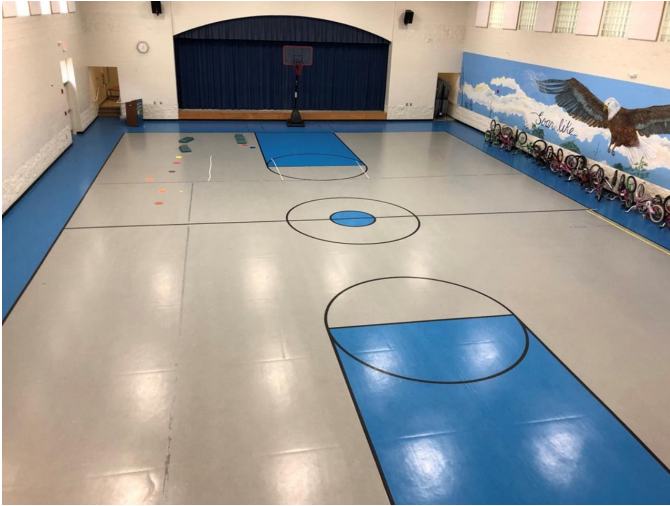
System: C3020999 - Other - Rubber or Neoprene

Location: Multi-purpose room
Distress: Beyond Expected Life
Category: Deferred Maintenance
Priority: 3 - Necessary (Years 2-5)
Correction: Renew System
Qty: 5,086.00
Unit of Measure: S.F.
Estimate: \$149,208.00
Assessor Name: Eduardo Lopez
Date Created: 01/22/2020

Notes: The Neoprene floor finish is beyond its expected service life, faded and stained, and should be replaced.

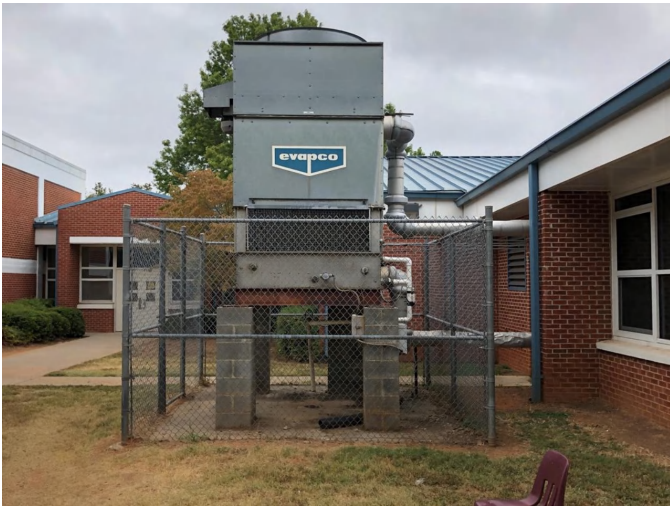
System: D3030 - Cooling Generating Systems

Location: Site
Distress: Beyond Expected Life
Category: Deferred Maintenance
Priority: 3 - Necessary (Years 2-5)
Correction: Renew System
Qty: 31,790.00
Unit of Measure: S.F.
Estimate: \$188,833.00
Assessor Name: Eduardo Lopez
Date Created: 10/06/2020

Notes: The cooling generating system is beyond service life and should be scheduled for replacement.

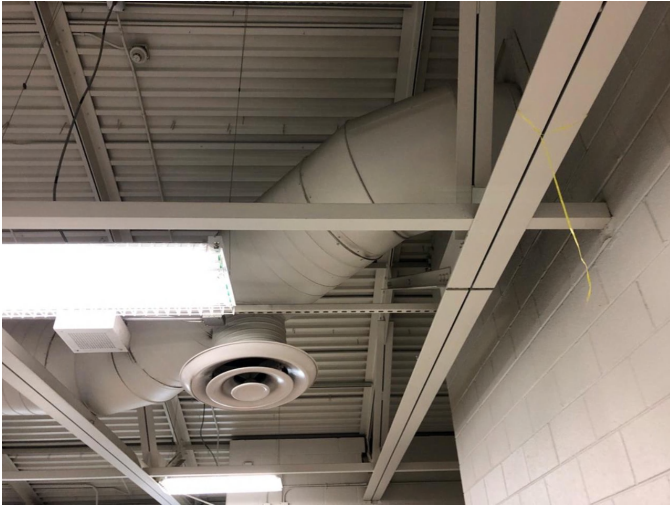
System: D3040 - Distribution Systems

Location: Throughout Building
Distress: Beyond Expected Life
Category: Deferred Maintenance
Priority: 3 - Necessary (Years 2-5)
Correction: Renew System
Qty: 31,790.00
Unit of Measure: S.F.
Estimate: \$328,359.00
Assessor Name: Eduardo Lopez
Date Created: 10/06/2020

Notes: The distribution system is beyond service life and should be scheduled for replacement.

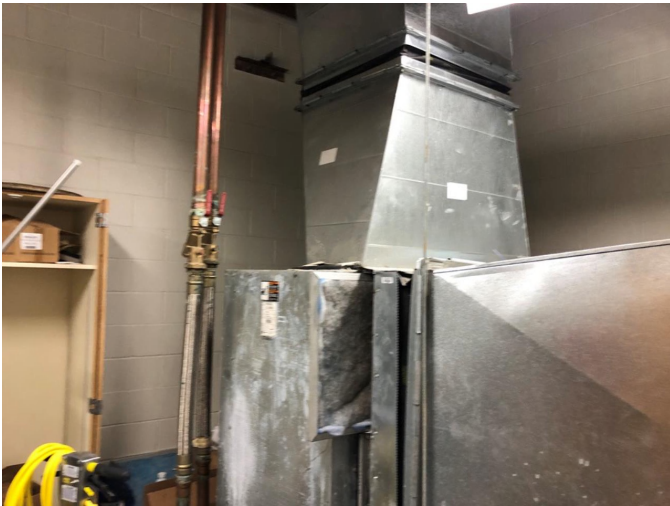
System: D3050 - Terminal & Package Units

Location: Throughout Building
Distress: Beyond Expected Life
Category: Deferred Maintenance
Priority: 3 - Necessary (Years 2-5)
Correction: Renew System
Qty: 31,790.00
Unit of Measure: S.F.
Estimate: \$833,661.00
Assessor Name: Eduardo Lopez
Date Created: 10/06/2020

Notes: The terminal and package units are beyond service life and should be scheduled for replacement.

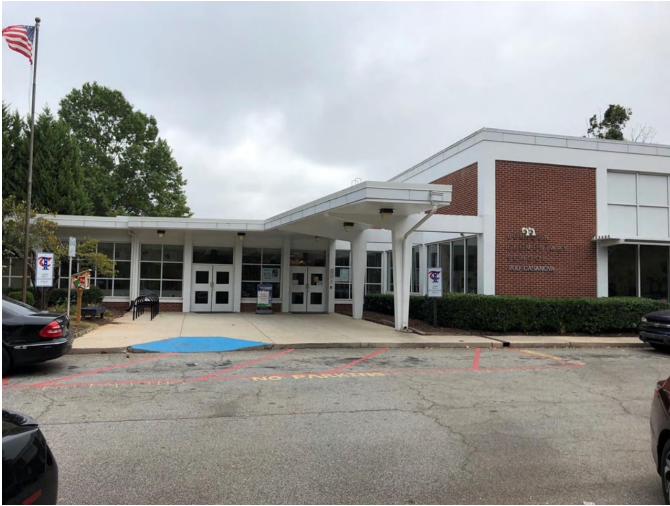
System: G3030 - Storm Sewer

Location: Bldg 1957
Distress: Missing
Category: Deferred Maintenance
Priority: 2 - Trending Critical (Year 1)
Correction: Renew System
Qty: 79,633.00
Unit of Measure: S.F.
Estimate: \$104,240.00
Assessor Name: Jejuan Hall
Date Created: 07/29/2013

Notes: Although storm sewers were installed with building additions, original facility lacks site drainage. Site area South of original facility and West of 2000 addition does not drain properly.

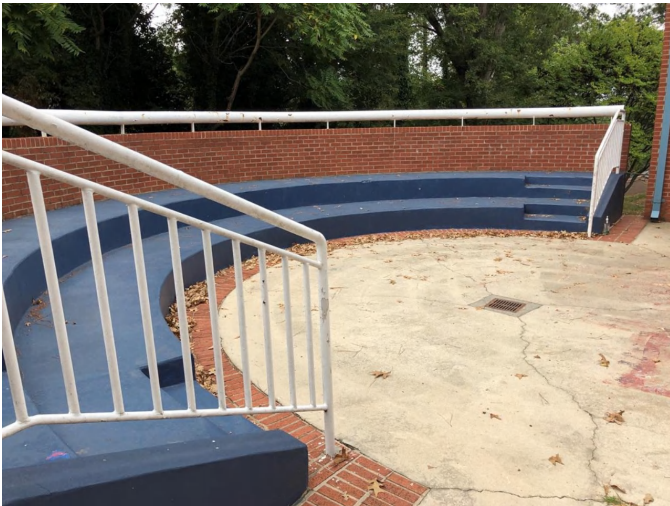
System: G2040950 - Hard Surface Play Area

Location: North side of building 2020
Distress: Beyond Expected Life
Category: Deferred Maintenance
Priority: 3 - Necessary (Years 2-5)
Correction: Renew System
Qty: 79,633.00
Unit of Measure: S.F.
Estimate: \$62,193.00
Assessor Name: Jejuan Hall
Date Created: 01/22/2020

Notes: The Hard Surface play area is beyond its expected life cycle and upgrades are warranted.

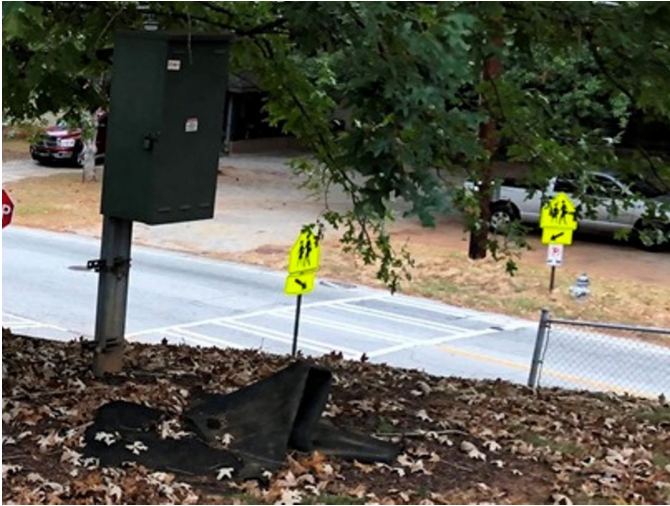
System: G3010 - Water Supply

Location: Across the street from school
Distress: Beyond Expected Life
Category: Deferred Maintenance
Priority: 3 - Necessary (Years 2-5)
Correction: Renew System
Qty: 79,633.00
Unit of Measure: S.F.
Estimate: \$89,348.00
Assessor Name: Jejuan Hall
Date Created: 01/22/2020

Notes: The original domestic water distribution system components consist of galvanized and copper pipes, valves and domestic water supply. Water supply control valves should be accessible for easy operation. Valves located in various areas on the site should be protected and easily accessible during a fire. All valves should be clearly marked and identifiable with exterior signs showing the locations of each valve. These valves should be marked with information indicating the areas and locations covered by their water source. The only water source located at this site is the fire hydrant across the street from the school.

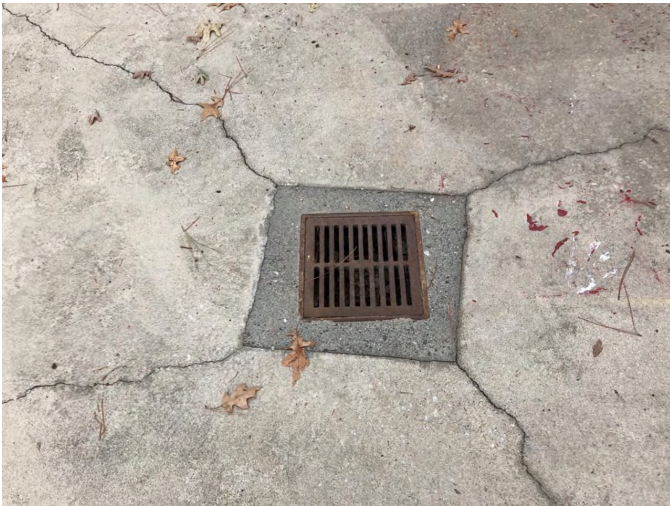
System: G3020 - Sanitary Sewer

Location: outside of building
Distress: Beyond Expected Life
Category: Deferred Maintenance
Priority: 3 - Necessary (Years 2-5)
Correction: Renew System
Qty: 79,633.00
Unit of Measure: S.F.
Estimate: \$183,952.00
Assessor Name: Jejuan Hall
Date Created: 01/22/2020

Notes: The sanitary system is original and beyond the expected life cycle. Upgrades to the existing sanitary sewer system are considered necessary.
