Atlanta Public Schools/Relocation Sites

Bethune ES (Barack and Michelle Obama Academy relocation site)

School Assessment Report

November 10, 2020

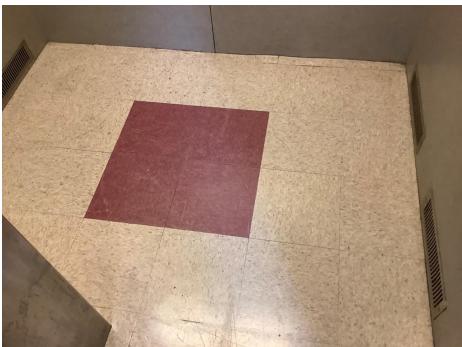
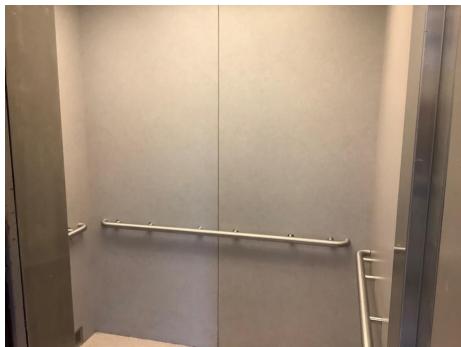
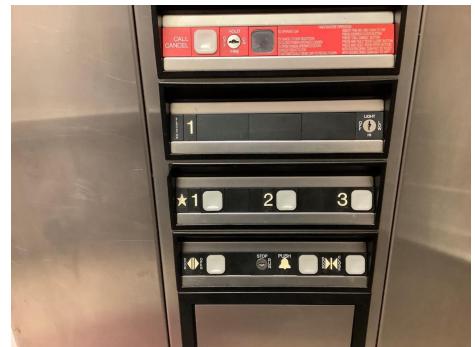
System: D1010 - Elevators and Lifts

Note: Building contains one elevator that serves the entire school, and one lift that serves the stage.

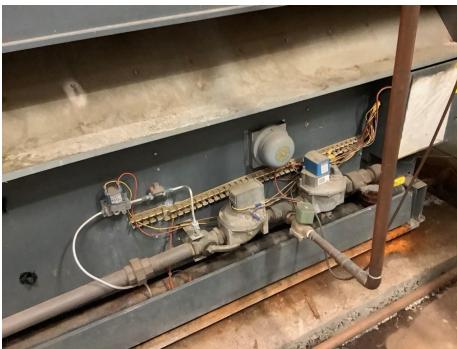
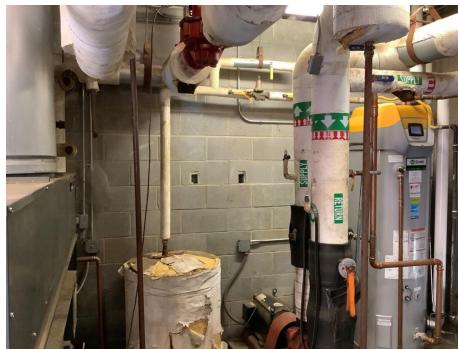
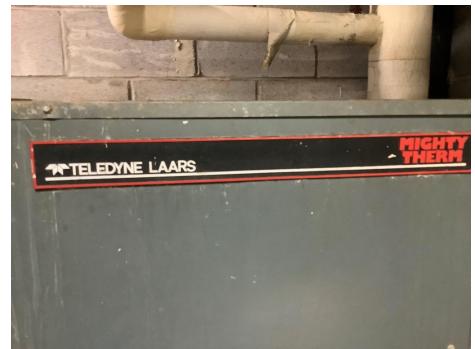
**Note:****System:** D3020 - Heat Generating Systems

Note: Heating hot water boiler is located in Bldg 2011.

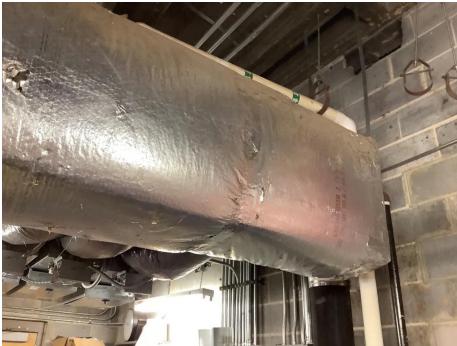
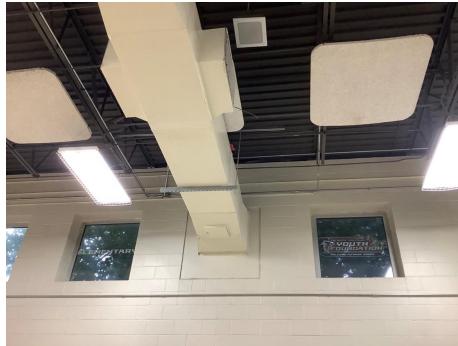
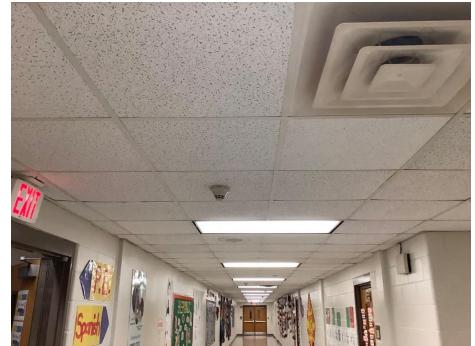
System: D3040 - Distribution Systems

Note: New VAV units and ductwork system installed 2005. Fan coil units serving classrooms installed 1999.

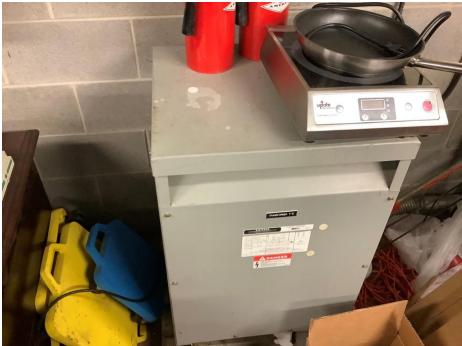
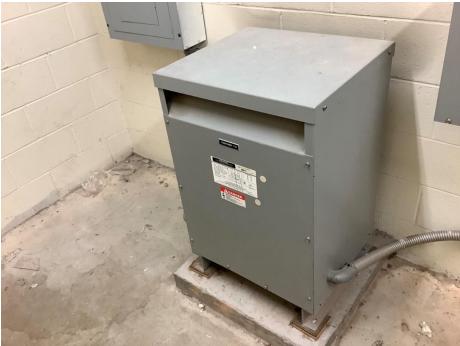
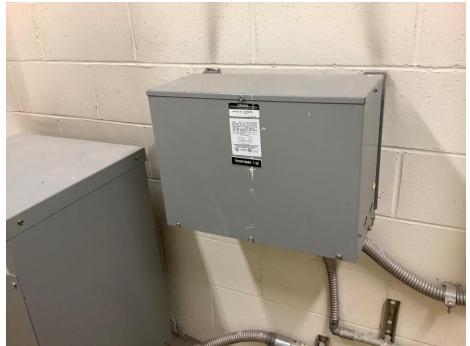
System: D5010 - Electrical Service/Distribution

Notes: The electrical service/distribution system is beyond its expected service life and should be scheduled for replacement.

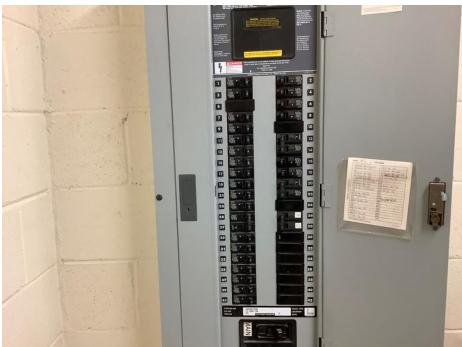
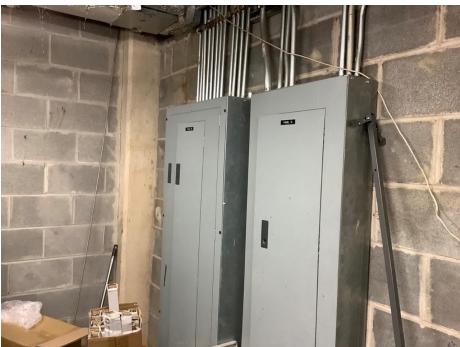
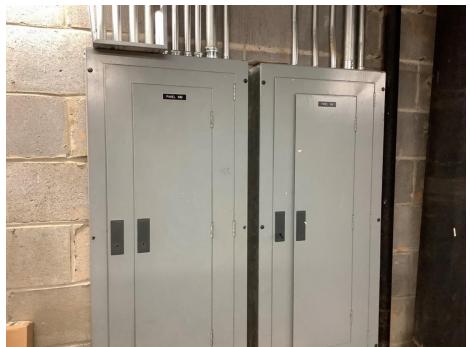
System: D5020 - Branch Wiring

Notes: Most of the branch wire system appears to be from the original construction. The age and environmental conditions warrants upgrades. Upgrades are recommended.

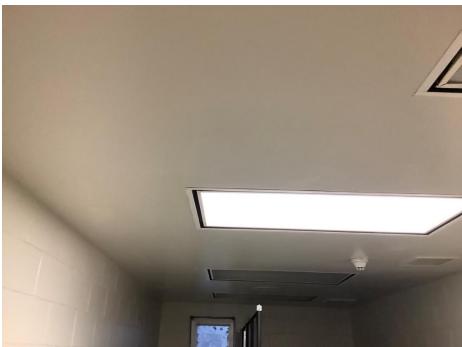
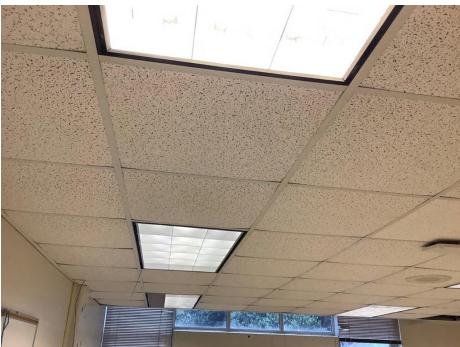
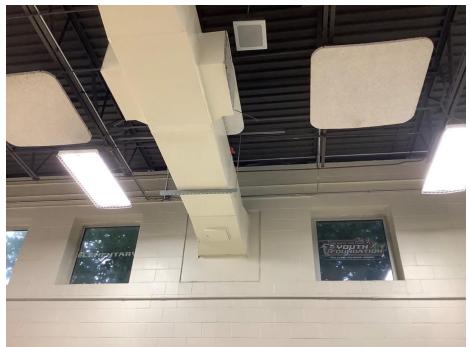
System: D5020 - Lighting

Notes: Most of the lighting system appears to be from the original construction. The age and environmental conditions warrants upgrades. Universal upgrades are recommended.

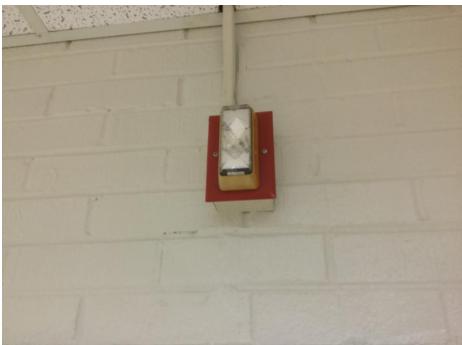
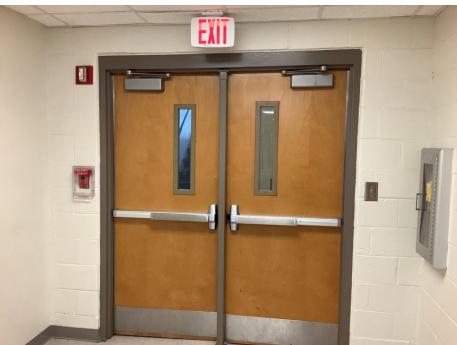
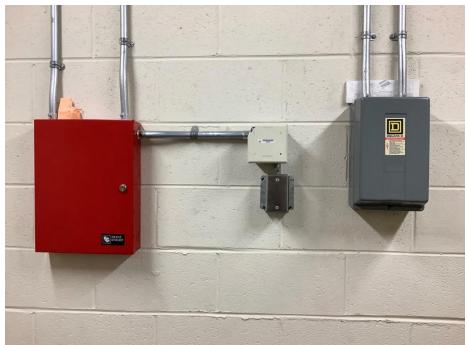
System: D5030910 - Fire Alarm Systems

Notes: The Silent Knight fire alarm system appears to be from original construction. There are components such as push stations, lights and alarm bells installed to support the fire life safety for this building. This system is nearing the end of its expected life and upgrades are warranted. This deficiency provides a budgetary consideration for universal upgrades to the fire alarm system.

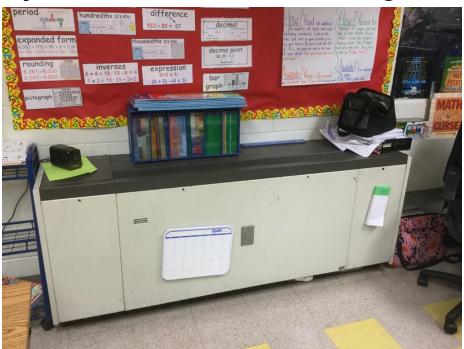
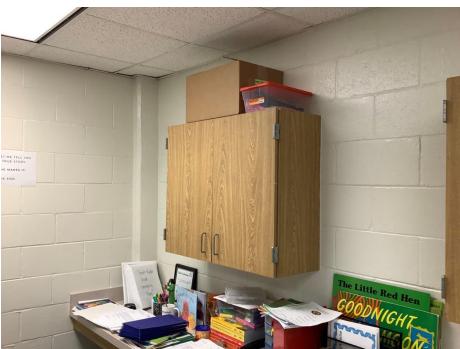
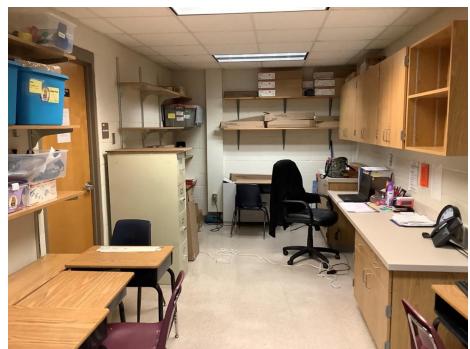
System: E2010 - Fixed Furnishings

Notes: The fixed artwork and casework for this facility is from original construction. This deficiency provides a budgetary consideration for upgrades based on life cycle conditions.

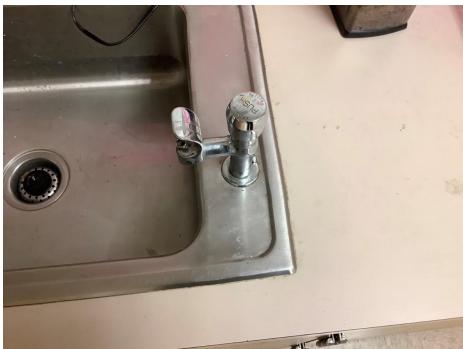
System: D2020 - Domestic Water Distribution

Note: New water heater serving the Kitchen was installed in 2013.

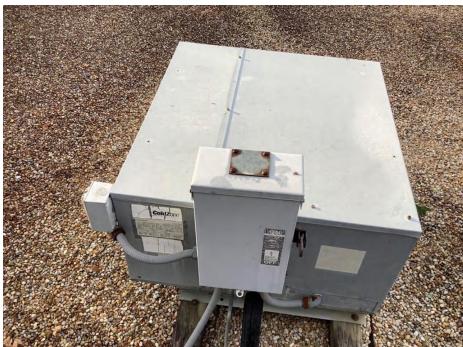
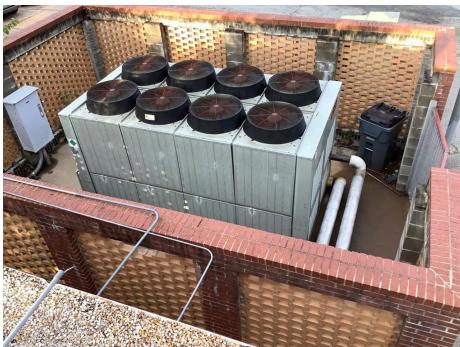
System: D3030 - Cooling Generating Systems

Note: Air cooled chiller is located in Building 2011 but serves the entire school.

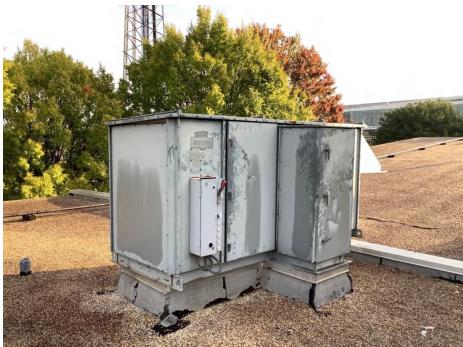
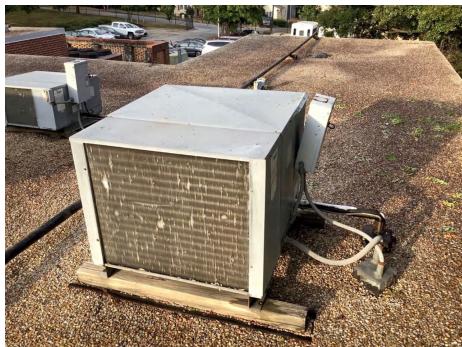
System: D3050 - Terminal & Package Units

Notes: The terminal and package units are beyond expected service life and should be scheduled for replacement.

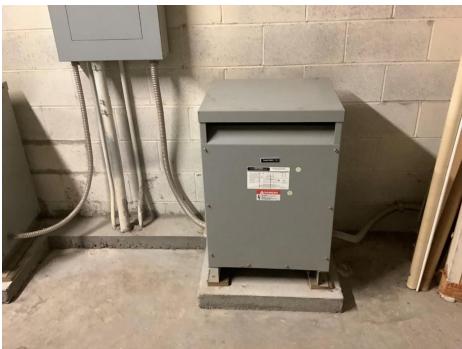
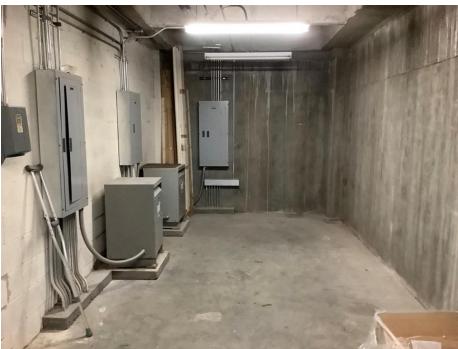
System: D5010 - Electrical Service/Distribution

Notes: The electrical service/distribution system is beyond its expected service life and should be scheduled for replacement.

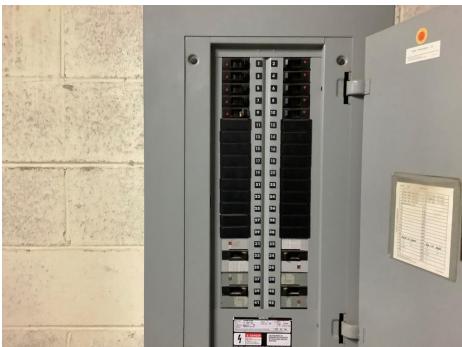
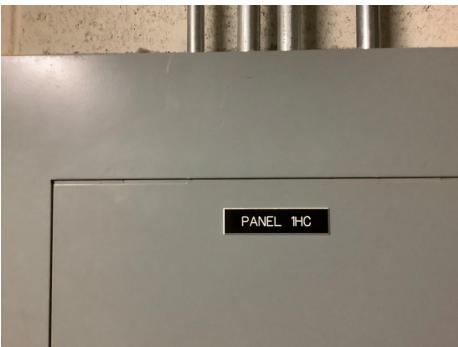
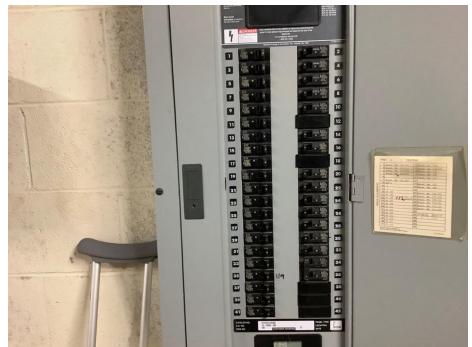
System: D5020 - Branch Wiring

Notes: Most of the branch wire system appears to be from the original construction. The age and environmental conditions warrants upgrades. Universal upgrades are recommended.

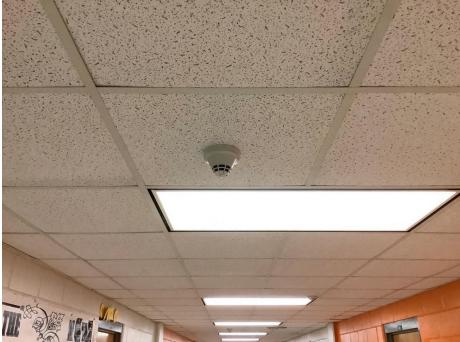
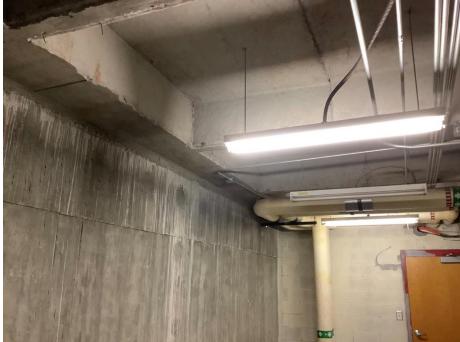
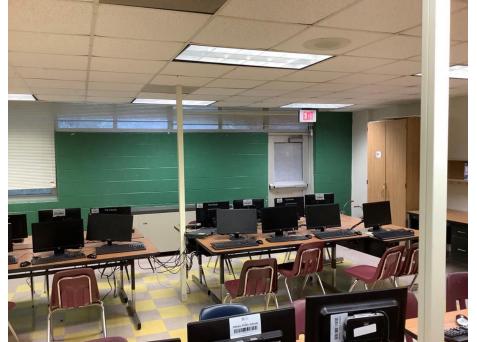
System: D5020 - Lighting

Notes: Most of the lighting system appears to be from the original construction. The age and environmental conditions warrants upgrades. Universal upgrades are recommended.

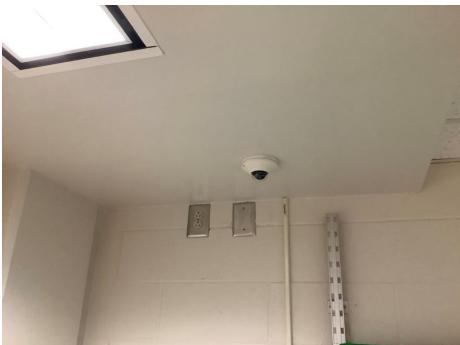
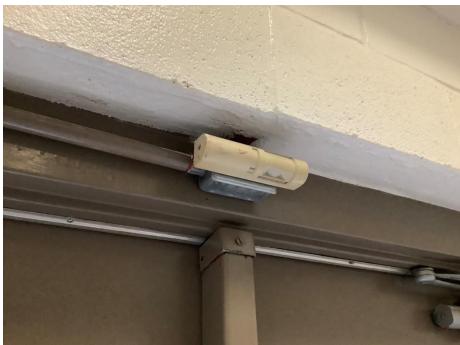
System: D5030810 - Security & Detection Systems

Notes: This deficiency provides a budgetary consideration to improve the alarm and security system.

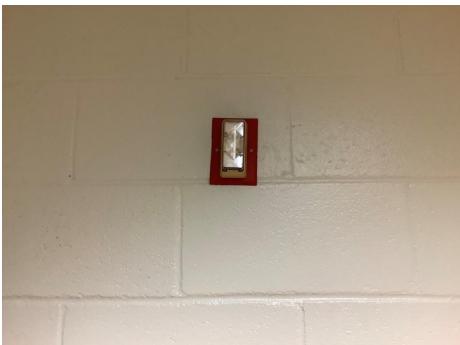
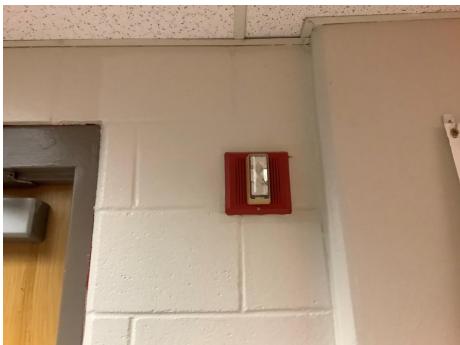
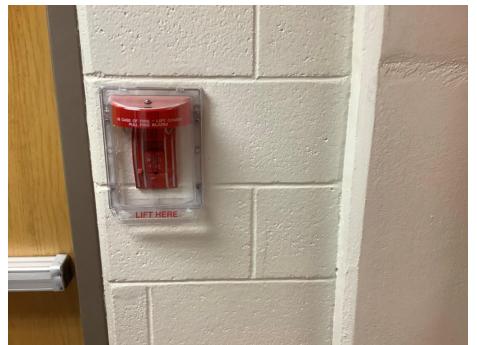
System: D5030910 - Fire Alarm Systems

Notes: The Silent Knight fire alarm system appears to be from original construction. There are components such as push stations, lights and alarm bells installed to support the fire life safety for this building. This system is nearing the end of its expected life and upgrades are warranted. This deficiency provides a budgetary consideration for universal upgrades to the fire alarm system.

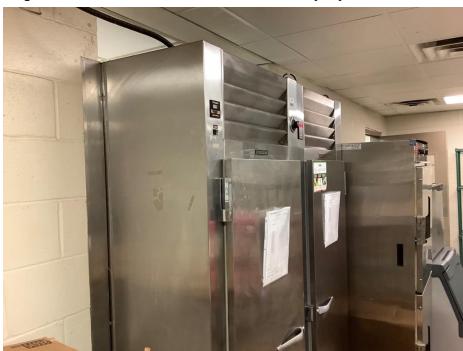
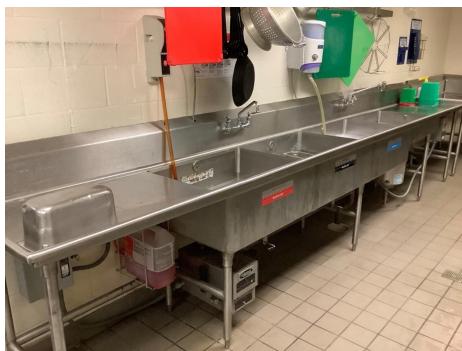
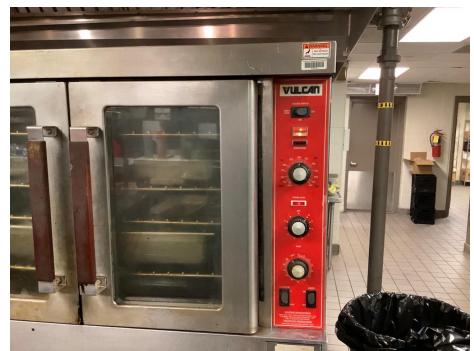
System: E1090 - Other Equipment

Notes: The Food Service Equipment equipment appears to be from the original construction of the school. The equipment is well maintained however is showing signs of age related to a high level of usage. This deficiency provides a budgetary consideration for a universal upgrade to these systems.

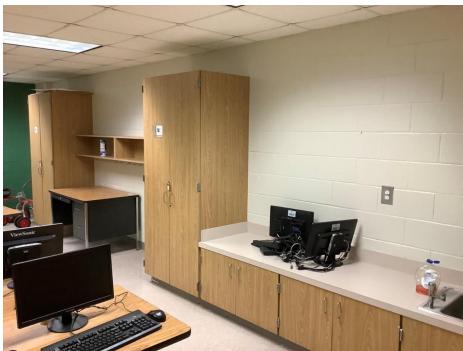
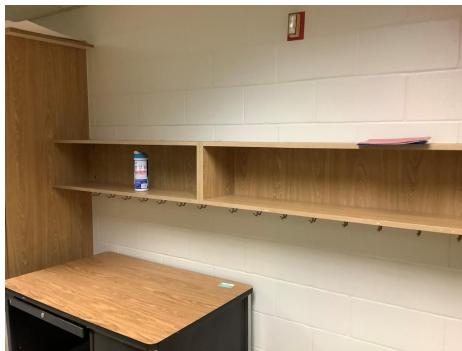
System: E2010 - Fixed Furnishings

Notes: The fixed artwork and casework for this facility is from original construction. This deficiency provides a budgetary consideration for universal upgrades based on life cycle conditions.
