Atlanta Public Schools/ N. Atlanta Cluster

Brandon Elementary School

School Assessment Report

November 10, 2020

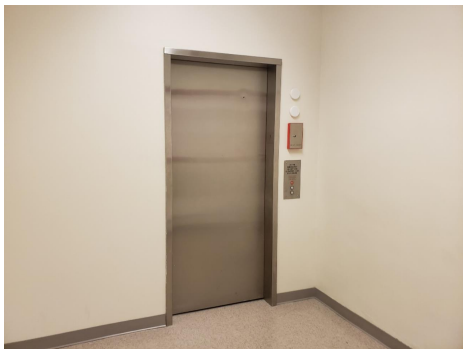
System: D1010 - Elevators and Lifts

Note: Elevator in Bldg 2010 serves Buildings 2010, 2011, 2012, and 2015.

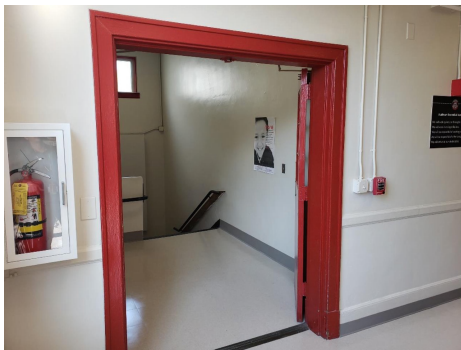
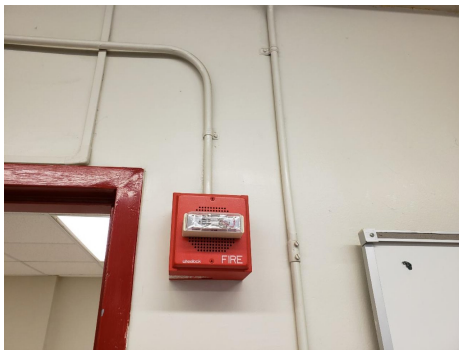
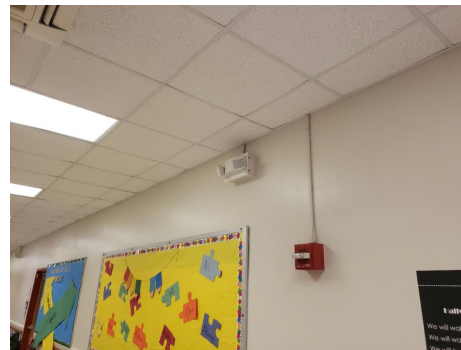
System: D5030910 - Fire Alarm Systems

Notes: The Fire Alarm Systems has exceeded its expected life cycle and is recommended for upgrade.

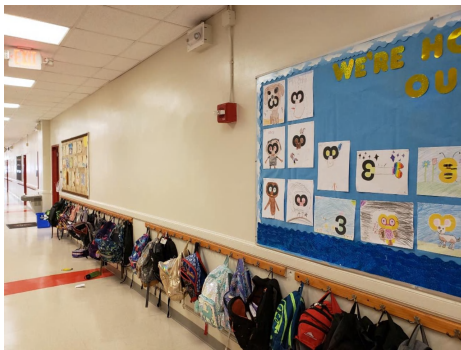
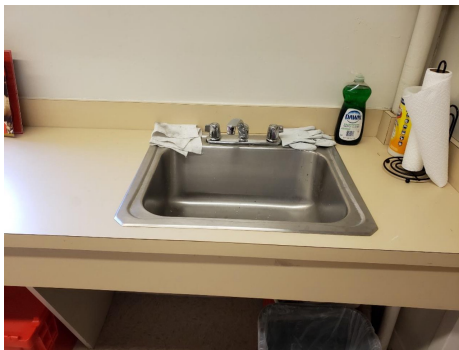
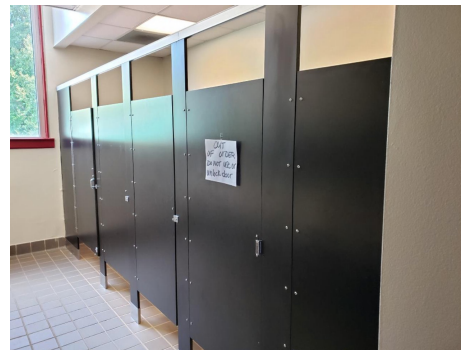
System: E2010 - Fixed Furnishings

Notes: Fixed furnishings are aged, worn and damaged, and should be scheduled for replacement.

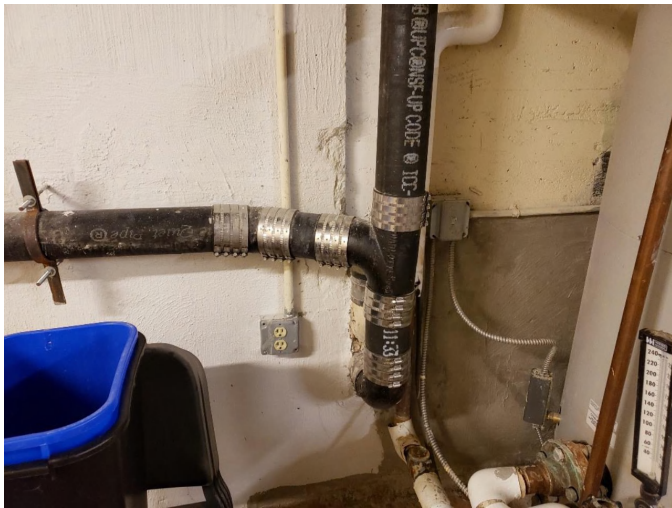
System: D2040 - Rain Water Drainage

Distress: Beyond Expected Life

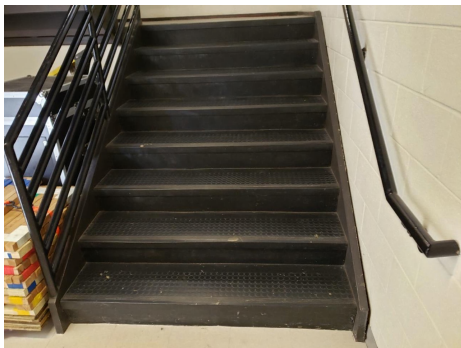
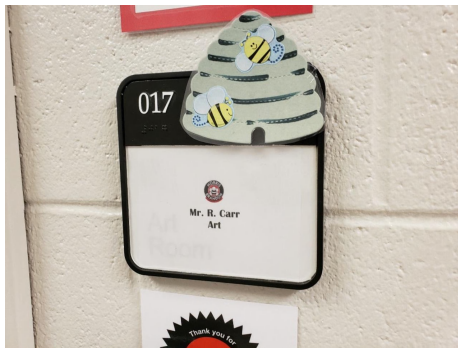
System: C1030 - Fittings

Notes: The signage, lockers and storage shelving is from original construction and beyond the expected life for this application. The system is outdated recommended for upgrades.

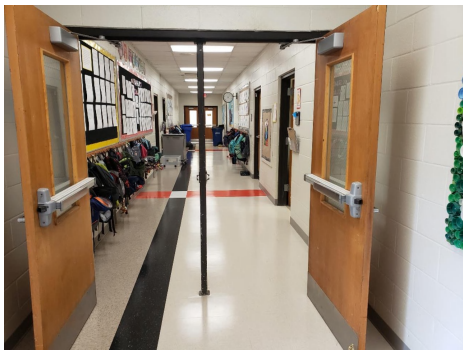
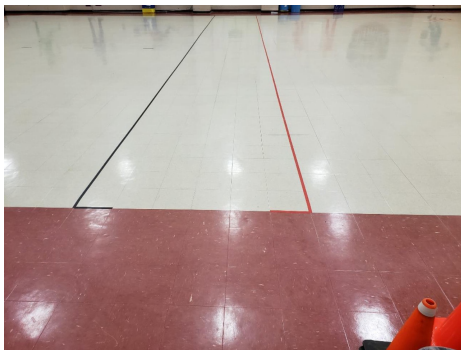
System: C3020903 - VCT

Notes: The VCT floor finish is beyond its expected service life, worn and damaged, and is recommended for replacement.

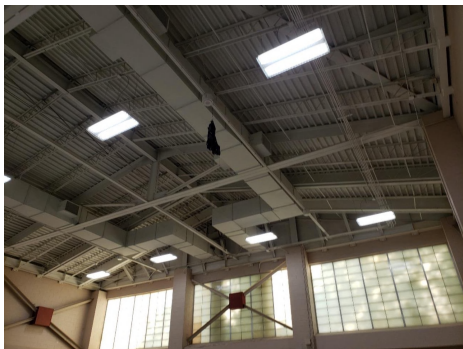
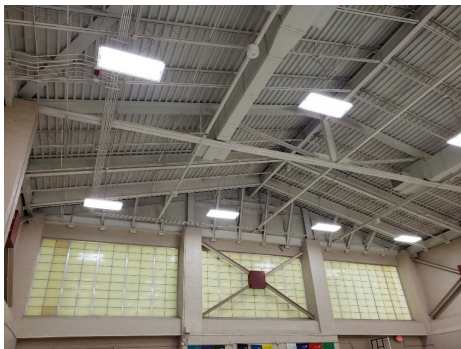
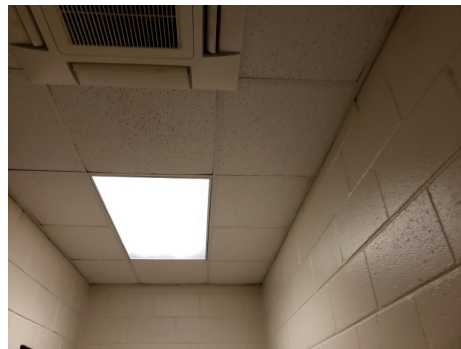
System: C3030 - Ceiling Finishes

Notes: The applied ceiling finish is beyond its expected life cycle and should be replaced.

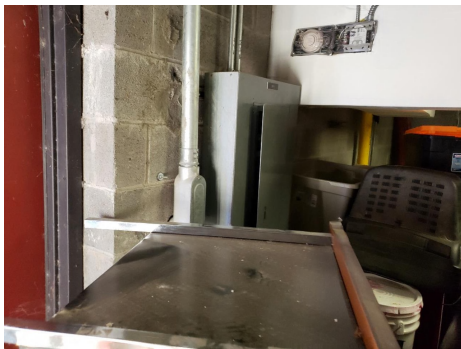
System: D5020 - Branch Wiring

Notes: Most of the branch wire system appears to be from the original construction. The age and environmental conditions warrants upgrades.

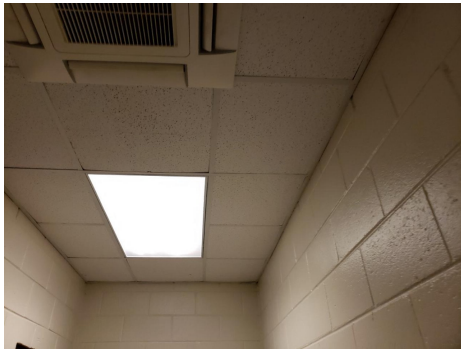
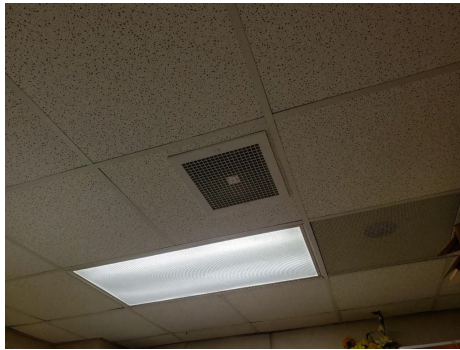
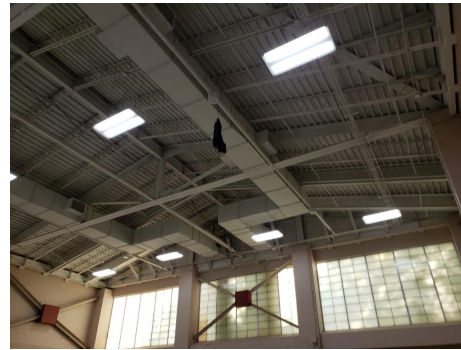
System: D5020 - Lighting

Notes: Most of the lighting system appears to be from the original construction. The age and environmental conditions warrants upgrades.

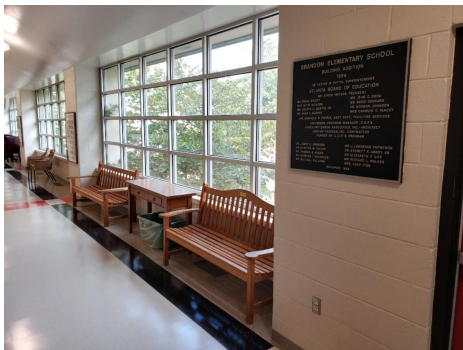
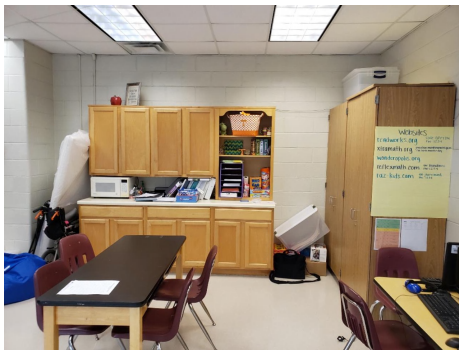
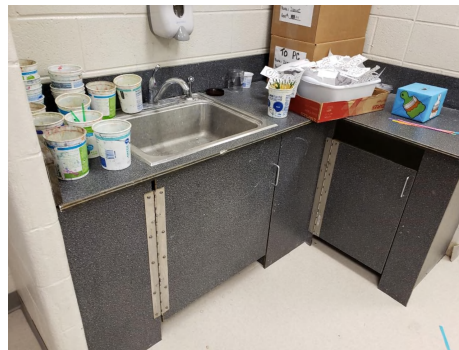
System: E2010 - Fixed Furnishings

Notes: Fixed furnishings are aged, worn and damaged, and should be scheduled for replacement.
