Atlanta Public Schools/ Washington Cluster

# Brown Middle School

## School Assessment Report

November 10, 2020

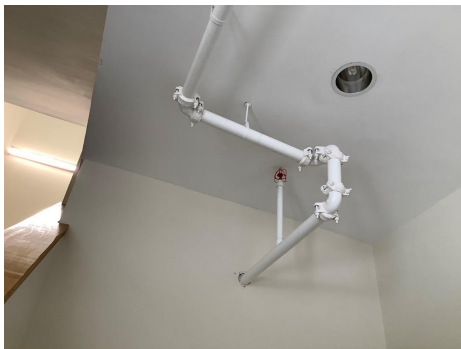
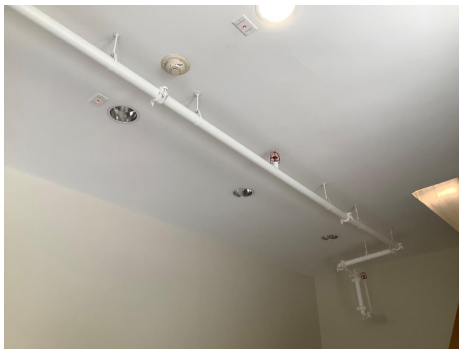
**System:** D4010 - Sprinklers Auditorium

**Note:** Added Fire sprinkler system to existing system to encompass the entire auditorium. Installed new sprinkler system through-out the gymnasium space.

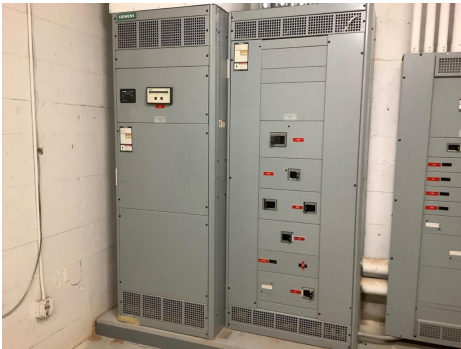
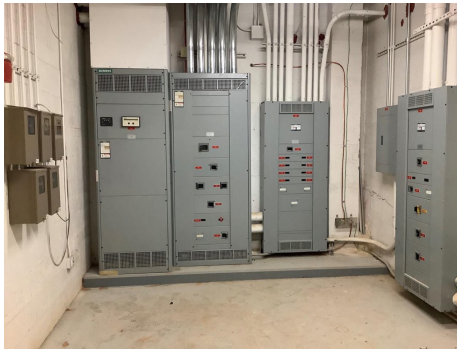
**System:** D5010 - Electrical Service/Distribution

**Note:** Electrical panels in Building 502.3 are expired (original to building 1949).
