Atlanta Public Schools/Relocation Sites

Campbell Building

School Assessment Report

November 10, 2020

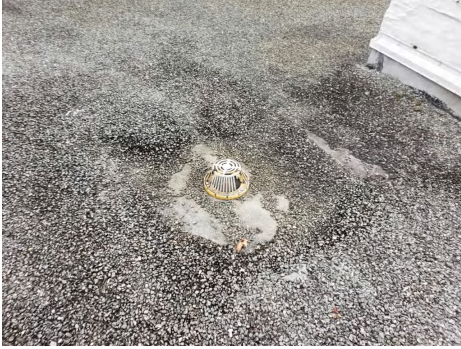
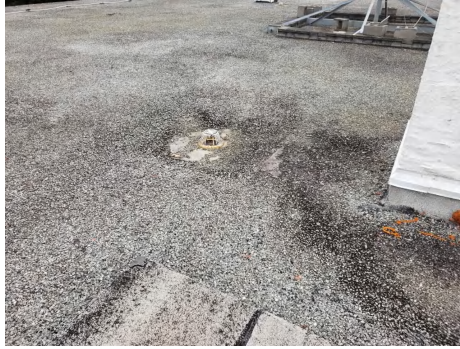
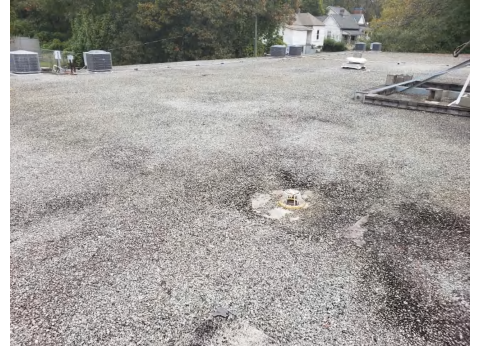
System: D2040 - Rain Water Drainage

Notes: The rainwater drainage system is aged, in marginal condition, and should be replaced.

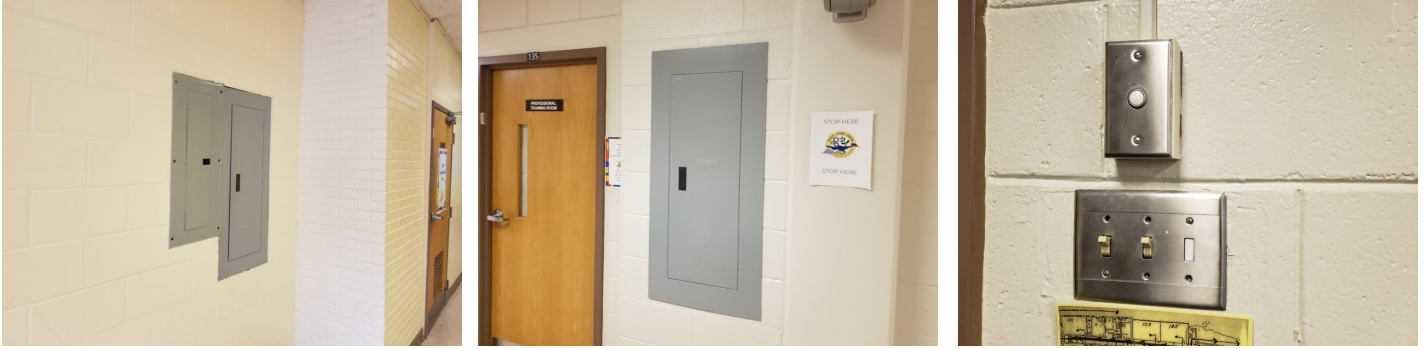
System: D5020 - Branch Wiring

Notes: The branch wiring system is operating, but is aged, in poor condition, and should be replaced.

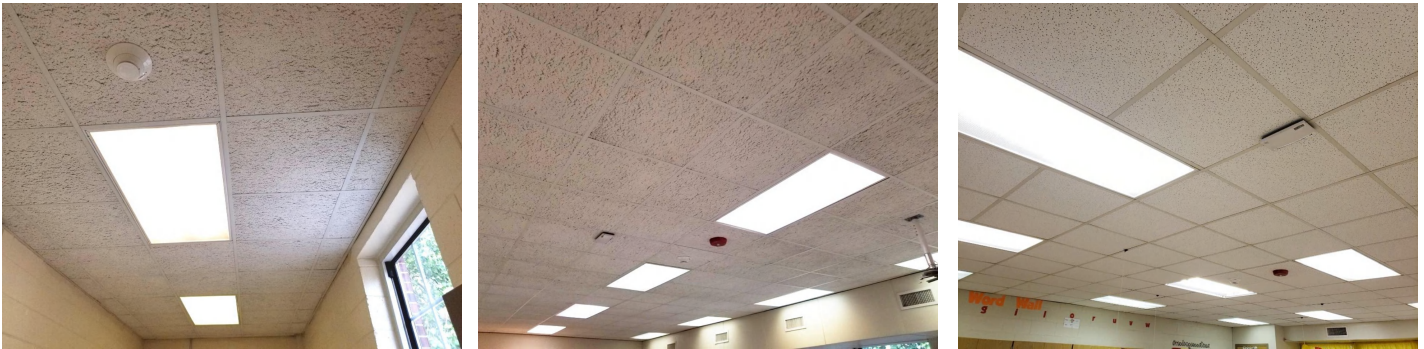
System: D5020 - Lighting

Notes: The lighting system is operating, but is aged, in poor condition, and should be replaced.

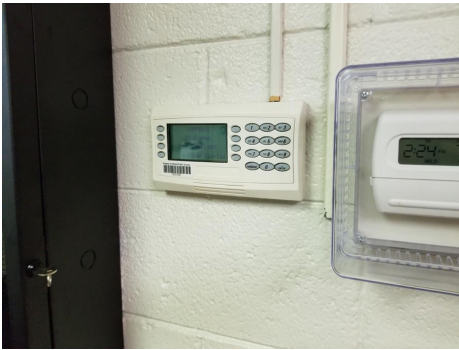
System: D5030810 - Security & Detection Systems

Notes: The security system is beyond its expected service life and should be scheduled for replacement.

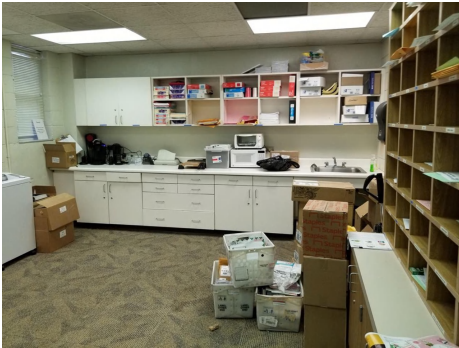
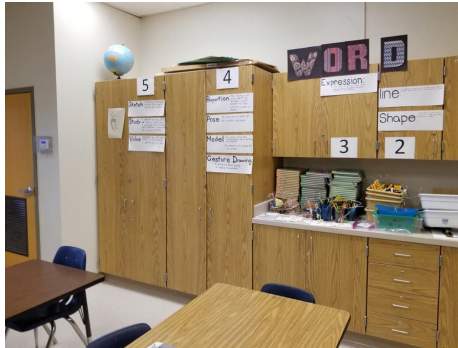
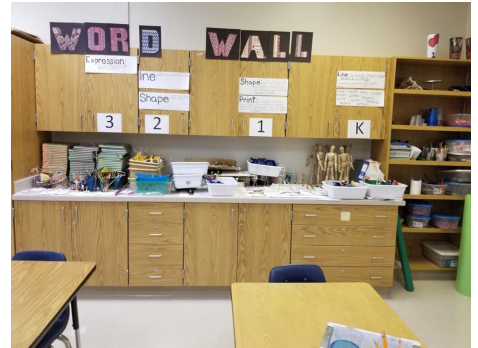
System: E2010 - Fixed Furnishings

Notes: The fixed furnishings are aged, and should be replaced.

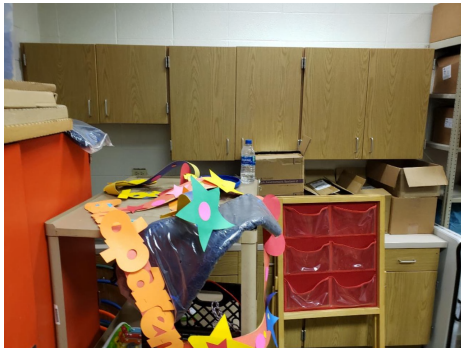
System: D2010 - Plumbing Fixtures

Note: Hand sink was not accessible.

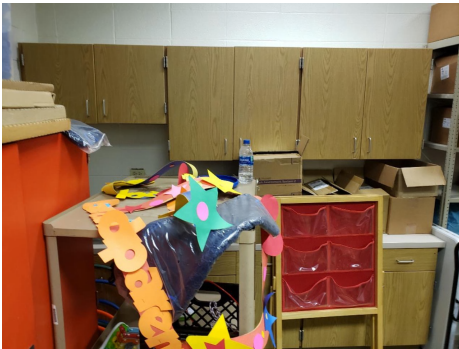
System: D2030 - Sanitary Waste

Note: Hand sink was not accessible.

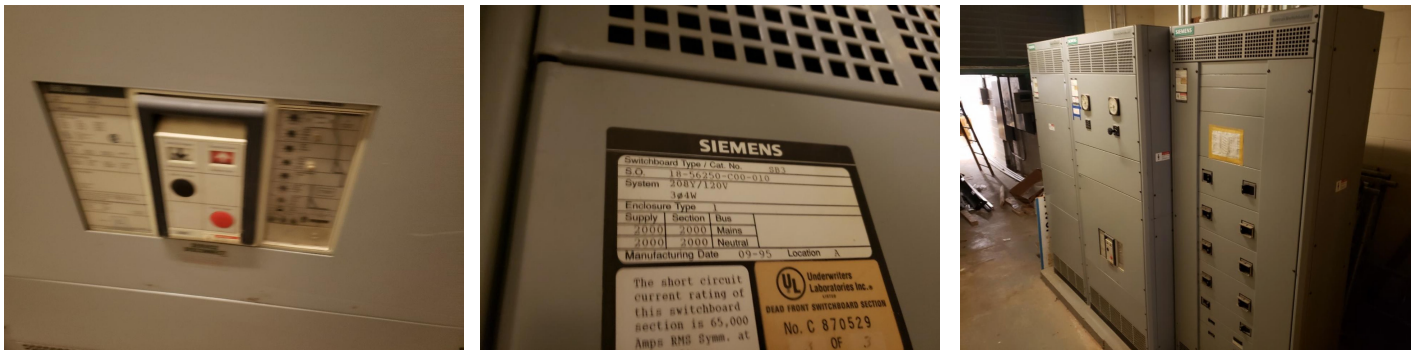
System: D5010 - Electrical Service/Distribution

Notes: The original electrical service is operating but is in marginal condition and should be replaced.

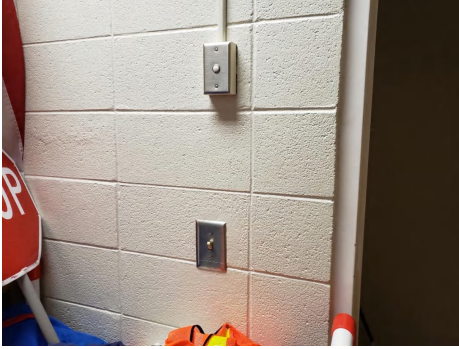
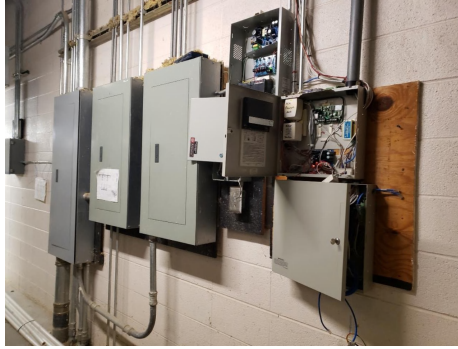
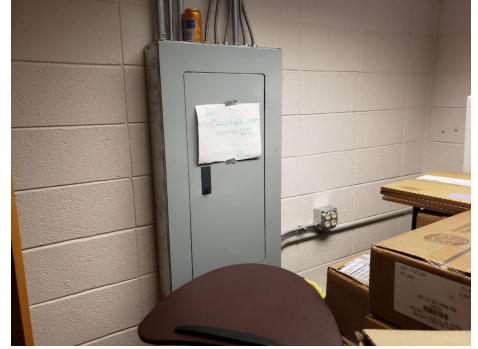
System: D5020 - Branch Wiring

Notes: The original branch wiring system is operating, but is aged, in poor condition, and should be replaced.

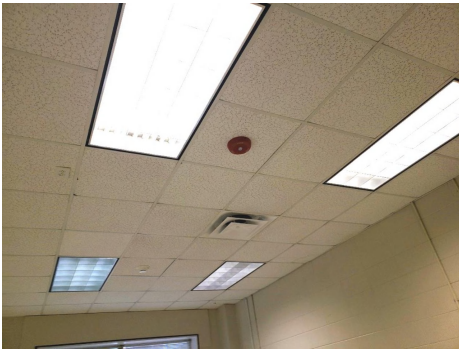
System: D5020 - Lighting

Notes: The original lighting system is operating, but is aged, in poor condition, and should be replaced.

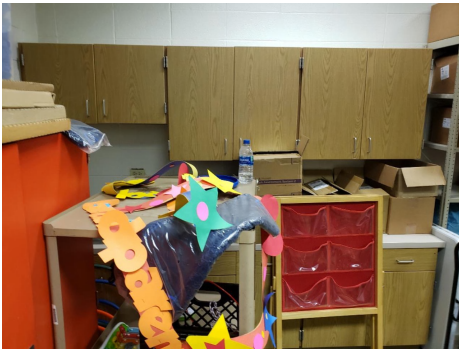
System: E2010 - Fixed Furnishings

Notes: The fixed furnishings are aged, and should be replaced.
