Atlanta Public Schools/Relocation Sites

# Capitol View Elementary School

## School Assessment Report

November 10, 2020

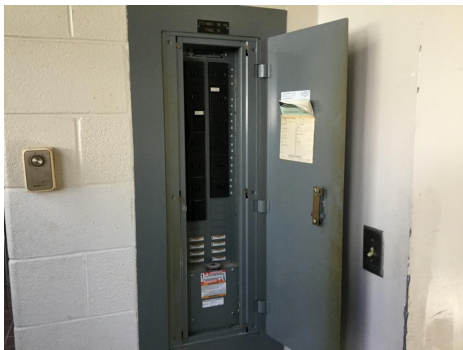
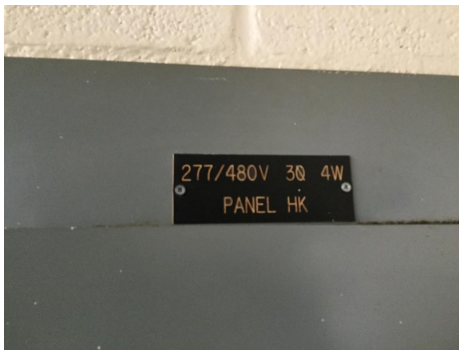
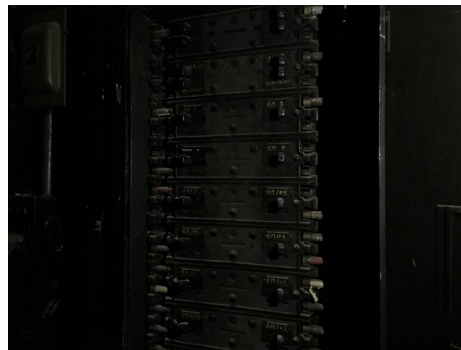
**System:** D5020 - Branch Wiring

**Notes:** The branch wiring systems are on stand-by, out of service or not functioning as designed. Considering the current status of the school this deficiency provides a budgetary consideration for system renewal prior to the school reopening.

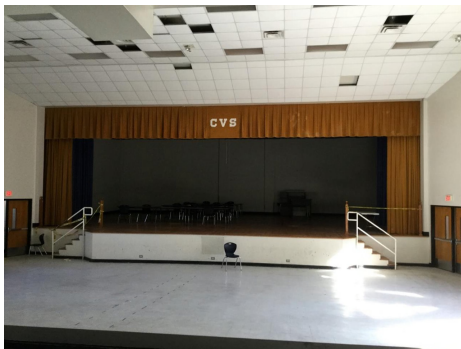
**System:** E1020 - Institutional Equipment

**Notes:** The institutional equipment has been removed throughout the school. This deficiency provides a budgetary consideration for the renewal of the system prior to occupancy.

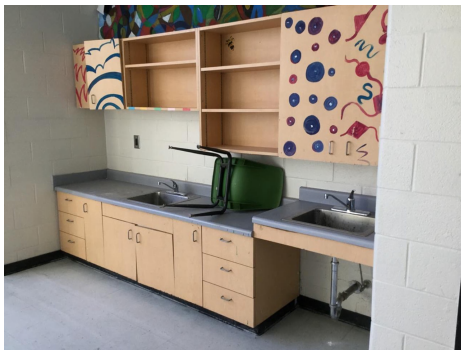
**System:** E2010 - Fixed Furnishings

**Notes:** The fixed furnishings system should be scheduled for replacement. This school is abandoned and most systems are recommended for replacement. This deficiency is expected to be completed as part of an overall effort to renew the interior finishes.

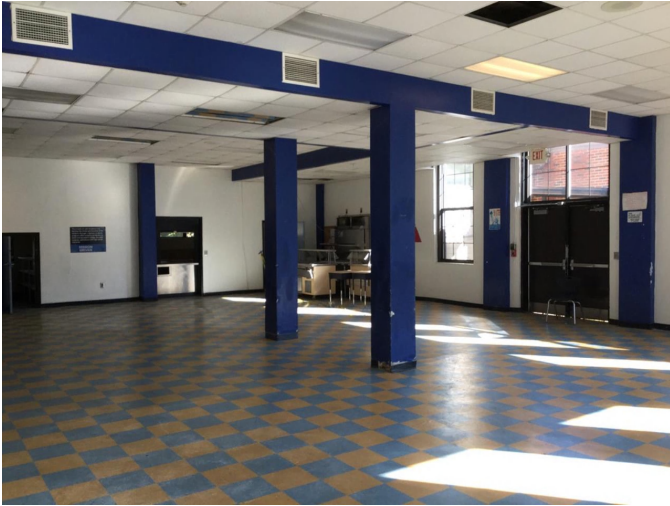
**System: C3030 - Ceiling Finishes**

**Location:** Throughout building  
**Distress:** Beyond Expected Life  
**Category:** Deferred Maintenance  
**Priority:** 3 - Necessary (Years 2-5)  
**Correction:** Renew System  
**Qty:** 49,075.00  
**Unit of Measure:** S.F.  
**Estimate:** \$485,843.00  
**Assessor Name:** Hayden Collins  
**Date Created:** 02/21/2020

The acoustic ceilings are aged and stained and should be scheduled for replacement. This school is abandoned, and the ceilings are recommended for replacement. This deficiency is expected to be completed as part of an overall effort to renew the interior finishes.

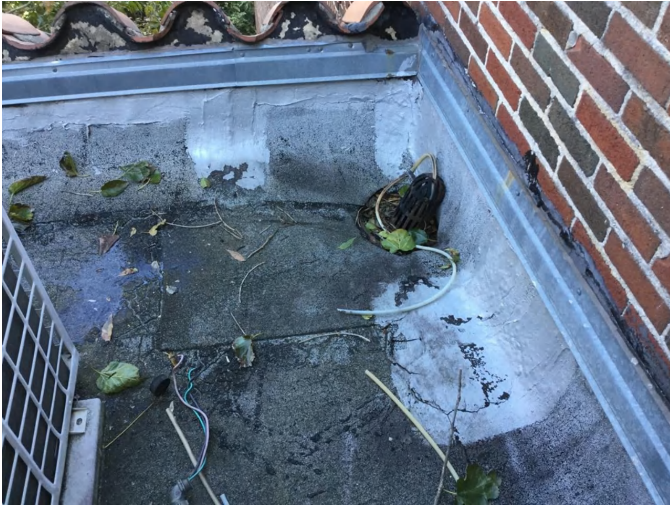
**System: D2040 - Rain Water Drainage**

**Location:** Roof  
**Distress:** Beyond Expected Life  
**Category:** Deferred Maintenance  
**Priority:** 3 - Necessary (Years 2-5)  
**Correction:** Renew System  
**Qty:** 49,075.00  
**Unit of Measure:** S.F.  
**Estimate:** \$21,593.00  
**Assessor Name:** Hayden Collins  
**Date Created:** 02/21/2020

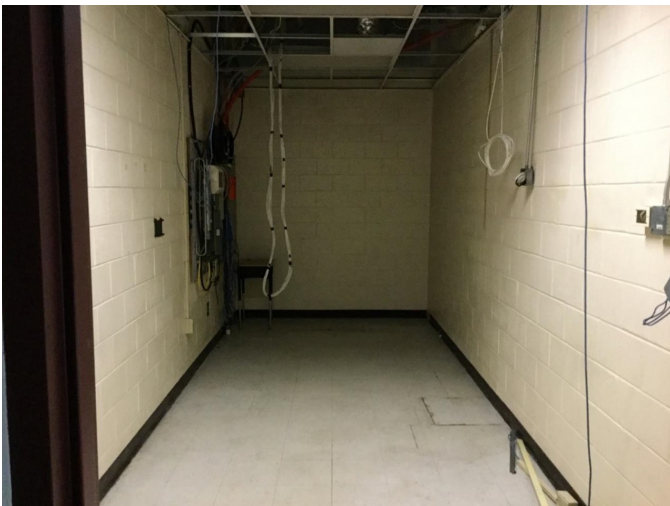
### **System: C3020903 - VCT**

**Location:** Throughout building  
**Distress:** Beyond Expected Life  
**Category:** Deferred Maintenance  
**Priority:** 3 - Necessary (Years 2-5)  
**Correction:** Renew System  
**Qty:** 7,000.00  
**Unit of Measure:** S.F.  
**Estimate:** \$37,758.00  
**Assessor Name:** Hayden Collins  
**Date Created:** 02/11/2020

This VCT floor system should be scheduled for replacement. This school is abandoned and most systems are recommended for replacement. This deficiency is expected to be completed as part of an overall effort to renew the school.

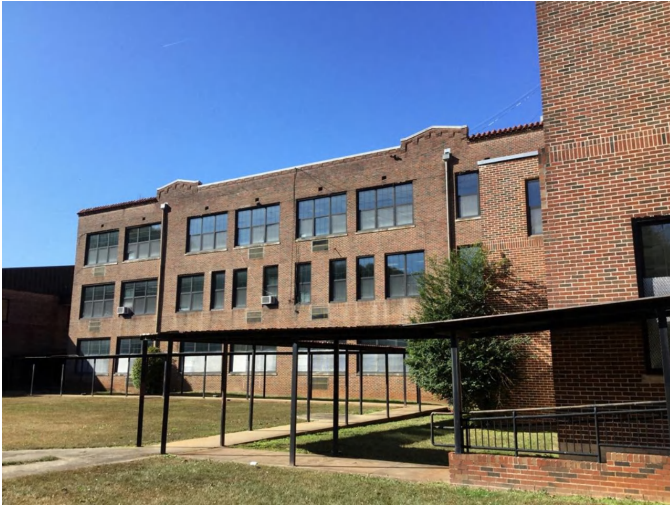
#### System: G2030 - Pedestrian Paving

**Location:** Site  
**Distress:** Beyond Expected Life  
**Category:** ADA Compliance  
**Priority:** 3 - Necessary (Years 2-5)  
**Correction:** Renew System  
**Qty:** 60,509.00  
**Unit of Measure:** S.F.  
**Estimate:** \$155,085.00  
**Assessor Name:** Jejuan Hall  
**Date Created:** 02/21/2020

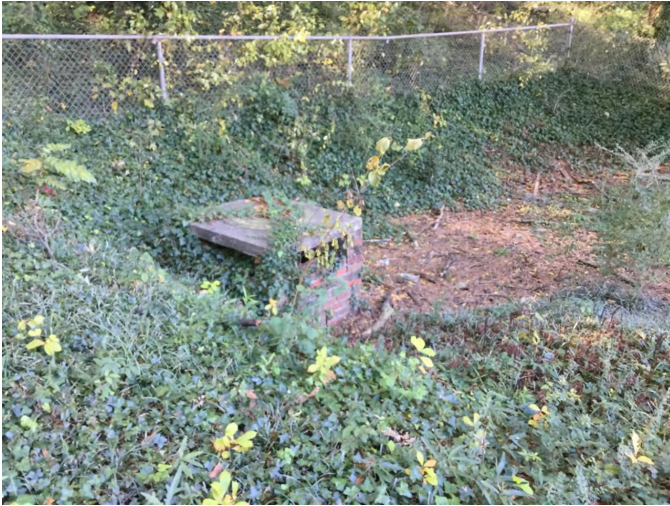
### **System: G3030 - Storm Sewer**

**Location:** Site  
**Distress:** Beyond Expected Life  
**Category:** Deferred Maintenance  
**Priority:** 3 - Necessary (Years 2-5)  
**Correction:** Renew System  
**Qty:** 60,509.00  
**Unit of Measure:** S.F.  
**Estimate:** \$83,200.00  
**Assessor Name:** Hayden Collins  
**Date Created:** 02/21/2020

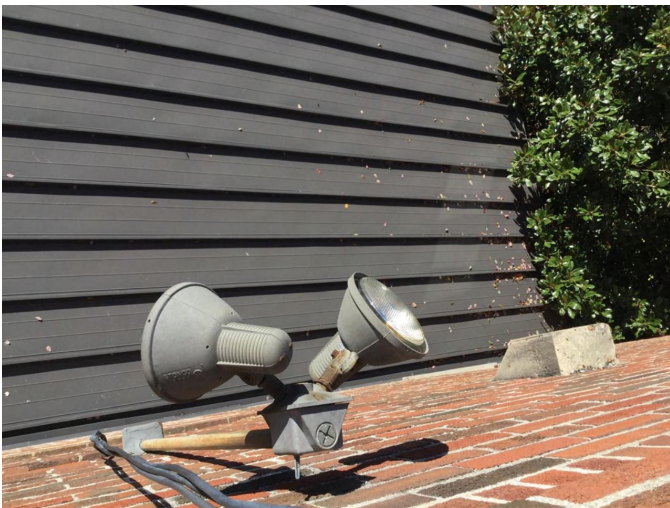
### **System: G4020 - Site Lighting**

**Location:** Site  
**Distress:** Beyond Expected Life  
**Category:** Deferred Maintenance  
**Priority:** 3 - Necessary (Years 2-5)  
**Correction:** Renew System  
**Qty:** 60,509.00  
**Unit of Measure:** S.F.  
**Estimate:** \$198,349.00  
**Assessor Name:** Hayden Collins  
**Date Created:** 02/21/2020
