Atlanta Public Schools/ Mays Cluster

Cascade Elementary School

School Assessment Report

November 10, 2020

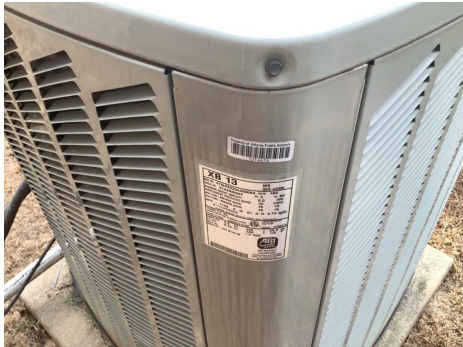
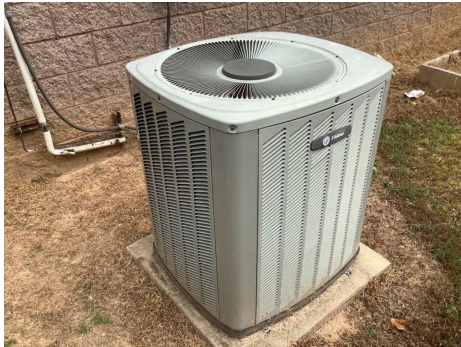
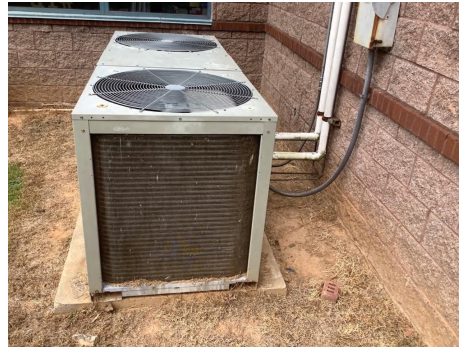
System: D3050 - Terminal & Package Units

Notes: The terminal and package units are beyond expected service life and should be scheduled for replacement.
