Atlanta Public Schools/ Douglass Cluster

Douglass High School

School Assessment Report

November 10, 2020

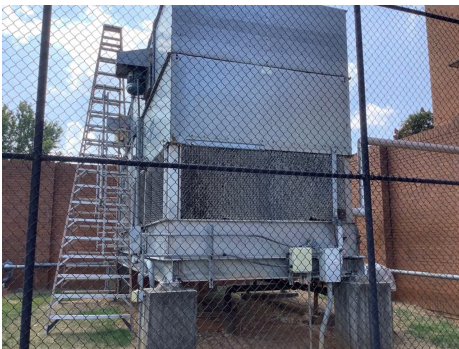
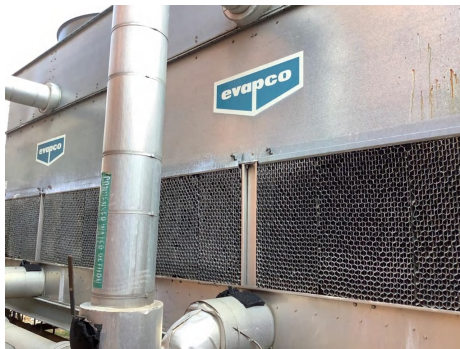
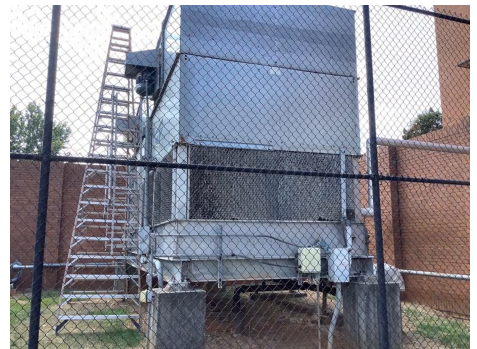
System: D3030 - Cooling Generating Systems

Notes: The cooling generating system is beyond its expected service life and should be scheduled for replacement.

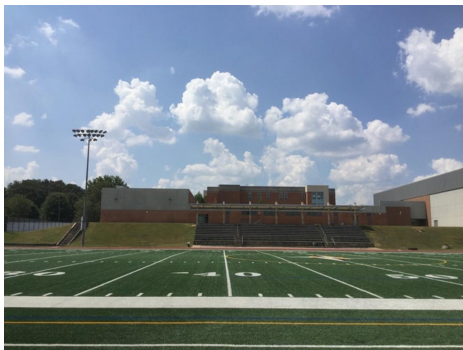
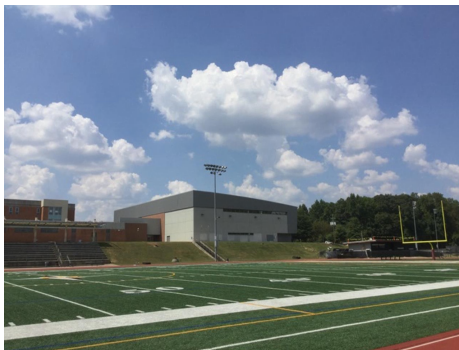
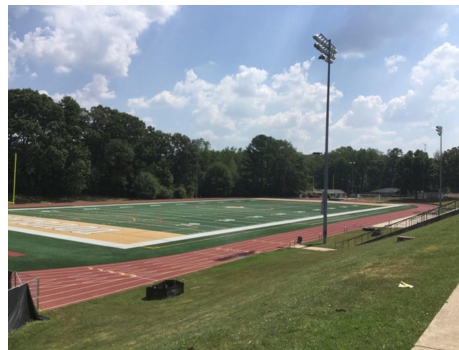
System: G2040950 - Other Site Development, Football

Notes: Current legislation related to accessibility requires that access be equitable. The school sports complex is limited by several sets of concrete stairs and moderate elevation changes between the access point and general seating. To comply with the intent of this legislation, it is recommended that a new handrails and guard rails be installed on the existing stair systems.

Location: Sports Access Sidewalks and Stairs
Distress: Inadequate
Category: ADA Compliance
Priority: 2 - Trending Critical (Year 1)
Correction: Add handicap ramp with railings
Qty: 100.00
Unit of Measure: L.F.
Estimate: \$50,460.79
Assessor Name: Hayden Collins
Date Created: 10/29/2019
