Atlanta Public Schools/Other Facilities

Facilities Service Center

Support Campus Assessment Report

November 10, 2020

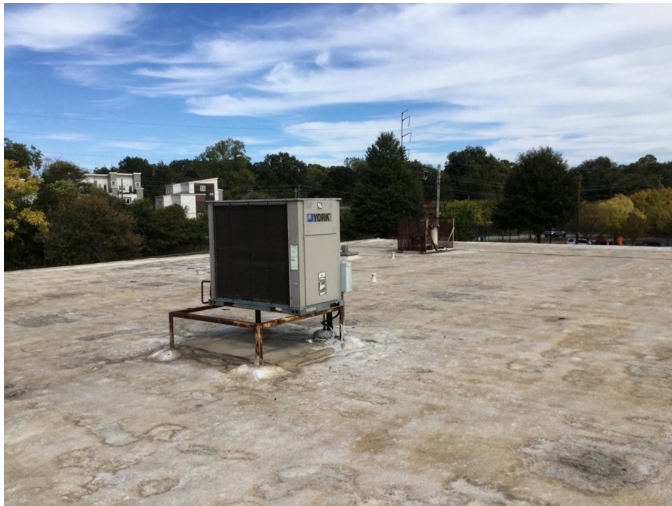
System: D3050 - Terminal & Package Units

Location: Roof
Distress: Beyond Expected Life
Category: Deferred Maintenance
Priority: 2 - Trending Critical (Year 1)
Correction: Renew System
Qty: 40,950.00
Unit of Measure: S.F.
Estimate: \$481,982.00
Assessor Name: Eduardo Lopez
Date Created: 09/17/2015

Notes: The terminal and package units are at the end of their useful life. The system is functional however upgrades are warranted.

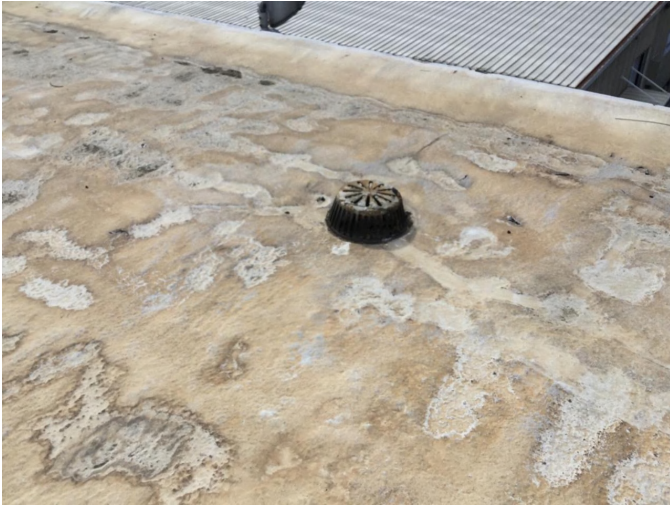
System: D2040 - Rain Water Drainage

Location: Roof
Distress: Beyond Expected Life
Category: Deferred Maintenance
Priority: 3 - Necessary (Years 2-5)
Correction: Renew System
Qty: 163,800.00
Unit of Measure: S.F.
Estimate: \$118,919.00
Assessor Name: Eduardo Lopez
Date Created: 02/21/2020

The roof drains, insulation and fittings that support the water run off from this roof are in poor condition. The insulation is damaged from leaks and the drains have developed leaks. This deficiency provides a budgetary consideration for a new rainwater drainage system. This is expected to be completed as part of an overall effort to upgrade the roof and should be completed as part of the recommended roof upgrade also in this report.

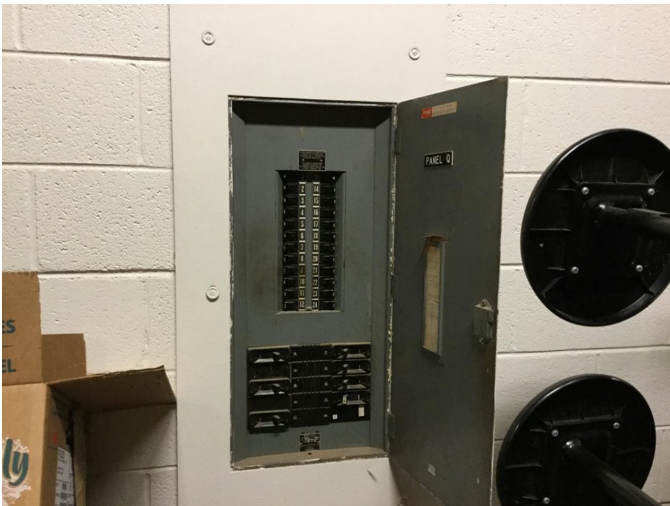
System: D5020 - Branch Wiring

Location: Throughout building
Distress: Beyond Expected Life
Category: Deferred Maintenance
Priority: 3 - Necessary (Years 2-5)
Correction: Renew System
Qty: 163,800.00
Unit of Measure: S.F.
Estimate: \$1,610,809.00
Assessor Name: Eduardo Lopez
Date Created: 01/09/2020

Notes: The original branch wiring system is operational but is aged and should be replaced with an energy efficient system.

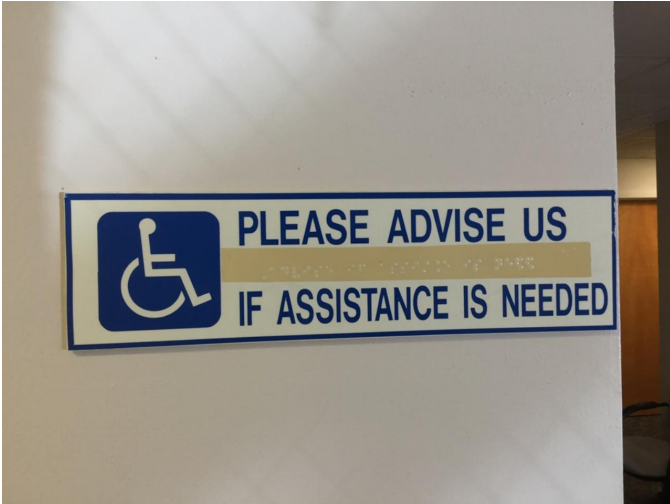
System: C1030 - Fittings

Location: Throughout building
Distress: Beyond Expected Life
Category: ADA Compliance
Priority: 3 - Necessary (Years 2-5)
Correction: Renew System
Qty: 9,000.00
Unit of Measure: S.F.
Estimate: \$44,055.00
Assessor Name: Eduardo Lopez
Date Created: 01/10/2020

Notes: Fittings, such as toilet partitions, lockers, signage and railing, are beyond their expected service life, outdated and missing in areas, and should be replaced and upgraded for compliance with ADA standards.

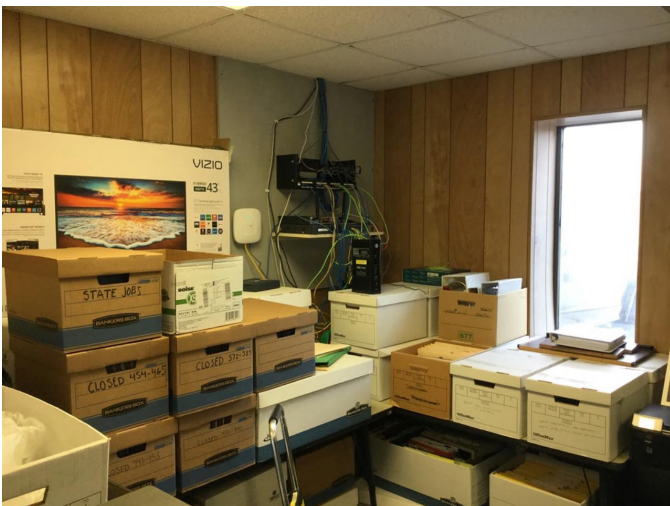
System: C3010902 - Wood Paneling

Location: Support Office
Distress: Beyond Expected Life
Category: Deferred Maintenance
Priority: 3 - Necessary (Years 2-5)
Correction: Renew System
Qty: 1,000.00
Unit of Measure: S.F.
Estimate: \$8,258.00
Assessor Name: Eduardo Lopez
Date Created: 01/10/2020

Notes: The wood panel system is aged and should be replaced and upgraded.

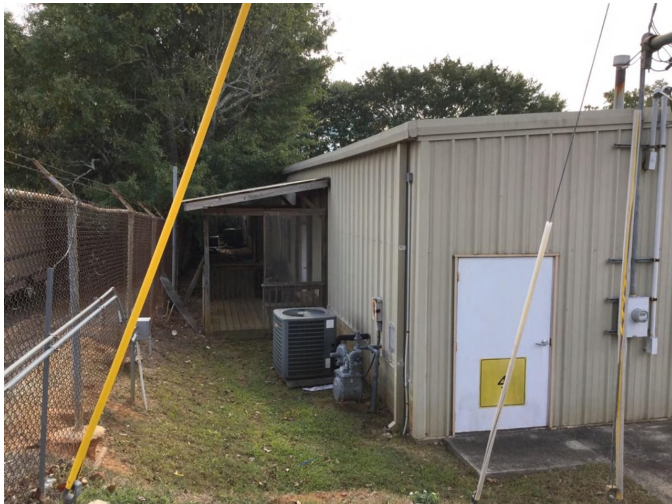
System: D3050 - Terminal & Package Units

Location: Throughout building
Distress: Beyond Expected Life
Category: Deferred Maintenance
Priority: 3 - Necessary (Years 2-5)
Correction: Renew System
Qty: 9,000.00
Unit of Measure: S.F.
Estimate: \$173,646.00
Assessor Name: Eduardo Lopez
Date Created: 09/17/2015

Notes: The terminal and package units are nearing the end of their useful life. The system is functional however upgrades are warranted.

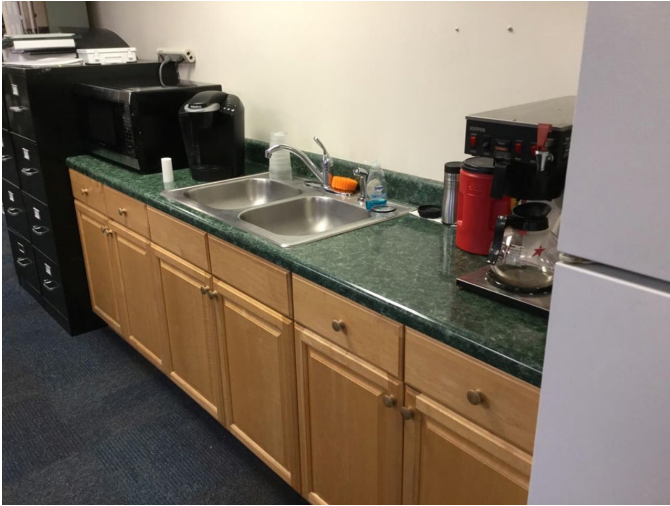
System: E2010 - Fixed Furnishings

Location: Throughout building
Distress: Beyond Expected Life
Category: Deferred Maintenance
Priority: 3 - Necessary (Years 2-5)
Correction: Renew System
Qty: 9,000.00
Unit of Measure: S.F.
Estimate: \$103,158.00
Assessor Name: Eduardo Lopez
Date Created: 01/10/2020

Notes: Fixed furnishings are aged, worn and damaged, and should be scheduled for replacement.

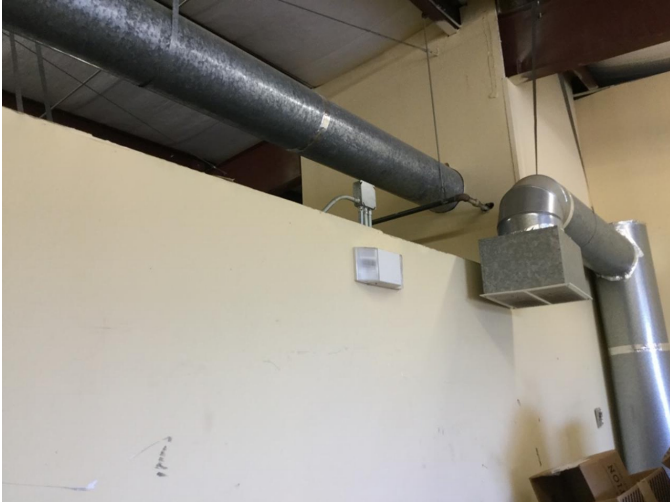
System: D3040 - Distribution Systems

Location: Throughout building
Distress: Beyond Expected Life
Category: Deferred Maintenance
Priority: 4 - Recommended (Years 6-10)
Correction: Renew System
Qty: 9,000.00
Unit of Measure: S.F.
Estimate: \$58,905.00
Assessor Name: Eduardo Lopez
Date Created: 01/10/2020

Notes: The HVAC Distribution System is nearing the end of useful life. Internal and external age and damage warrant upgrades.

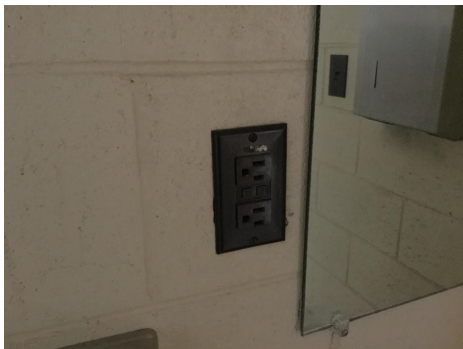
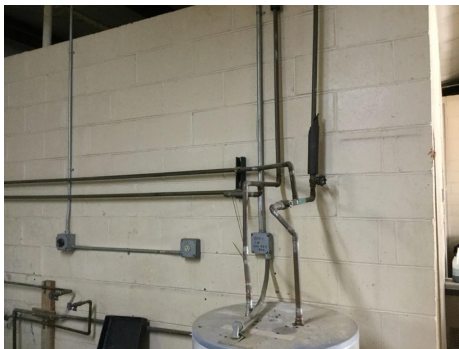
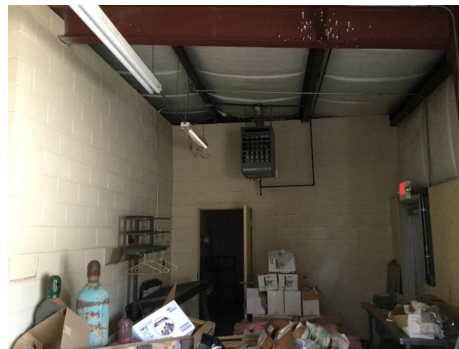
System: C3010230 - Paint & Covering

Notes: The applied interior wall finish is aged and stained and should be replaced with a more resilient finish.

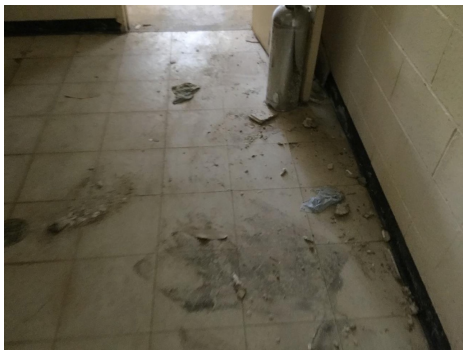
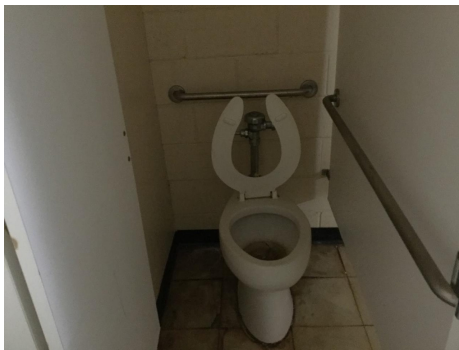
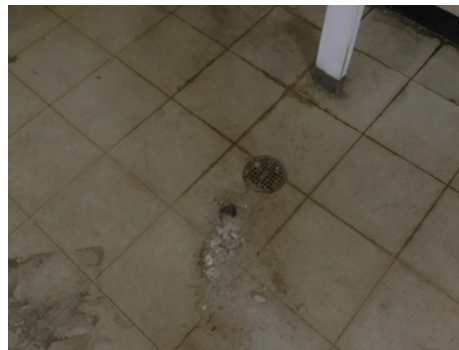
System: C3020903 - VCT

Notes: The VCT floor finish is beyond its expected service life, worn and damaged, and is recommended for replacement.

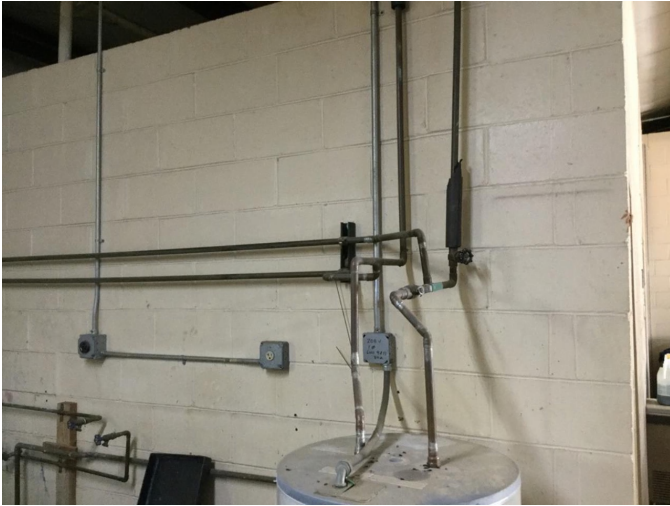
System: C3010230 - Paint & Covering

Location: Throughout building
Distress: Beyond Expected Life
Category: Deferred Maintenance
Priority: 3 - Necessary (Years 2-5)
Correction: Renew System
Qty: 5,100.00
Unit of Measure: S.F.
Estimate: \$8,247.00
Assessor Name: Homero Guerrero
Date Created: 01/10/2020

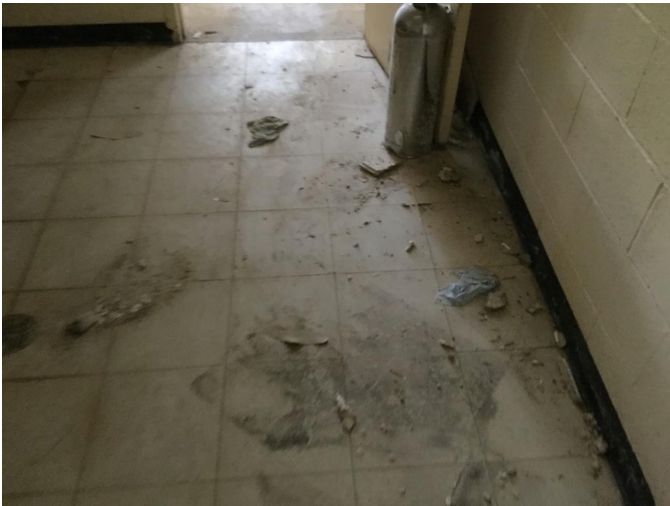
System: C3020903 - VCT

Location: Restroom
Distress: Beyond Expected Life
Category: Deferred Maintenance
Priority: 3 - Necessary (Years 2-5)
Correction: Renew System
Qty: 500.00
Unit of Measure: S.F.
Estimate: \$2,697.00
Assessor Name: Homero Guerrero
Date Created: 01/10/2020

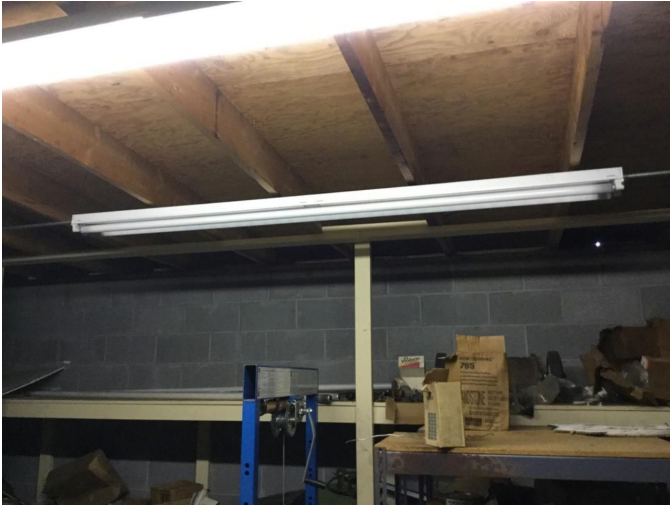
System: C3030 - Ceiling Finishes

Location: Throughout building
Distress: Beyond Expected Life
Category: Deferred Maintenance
Priority: 3 - Necessary (Years 2-5)
Correction: Renew System
Qty: 5,100.00
Unit of Measure: S.F.
Estimate: \$195,121.00
Assessor Name: Homero Guerrero
Date Created: 01/10/2020

Notes: The ceiling finish is beyond its expected service life and is recommended for replacement in conjunction with other recommended renovations.

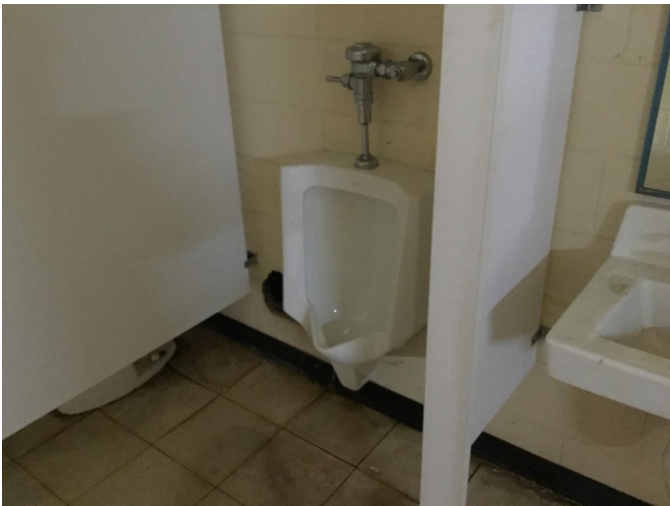
System: D2010 - Plumbing Fixtures

Location: Throughout building
Distress: Beyond Expected Life
Category: ADA Compliance
Priority: 3 - Necessary (Years 2-5)
Correction: Renew System
Qty: 5,100.00
Unit of Measure: S.F.
Estimate: \$22,496.00
Assessor Name: Jejuan Hall
Date Created: 09/17/2015

Notes: The plumbing fixtures are from original construction with few exceptions. The system is beyond its expected life cycle and upgrades are warranted for ADA compliance.

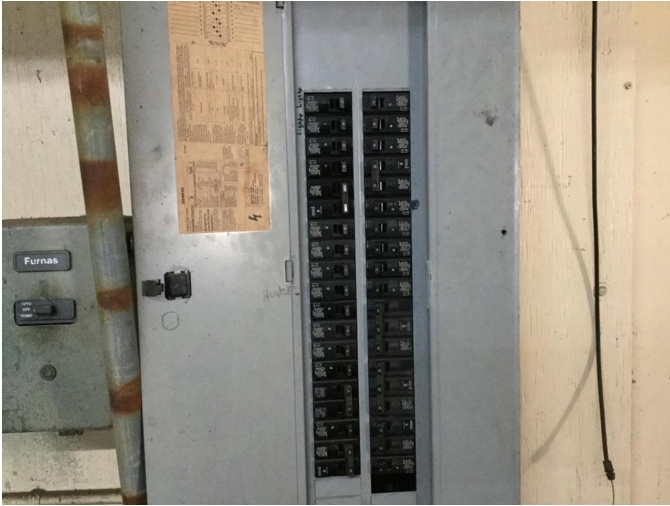
System: D5020 - Branch Wiring

Location: Throughout building
Distress: Beyond Expected Life
Category: Deferred Maintenance
Priority: 3 - Necessary (Years 2-5)
Correction: Renew System
Qty: 5,100.00
Unit of Measure: S.F.
Estimate: \$33,920.00
Assessor Name: Homero Guerrero
Date Created: 01/10/2020

Notes: The electrical service and distribution system consist of a service disconnect, primary main rated at 200 amps, breaker system, switch box, and conduit and wiring to equipment, interior and exterior lights. This system is a mix of the old and new. Some of the system was recently upgraded; however, a majority of the system is original. Upgrades are warranted.

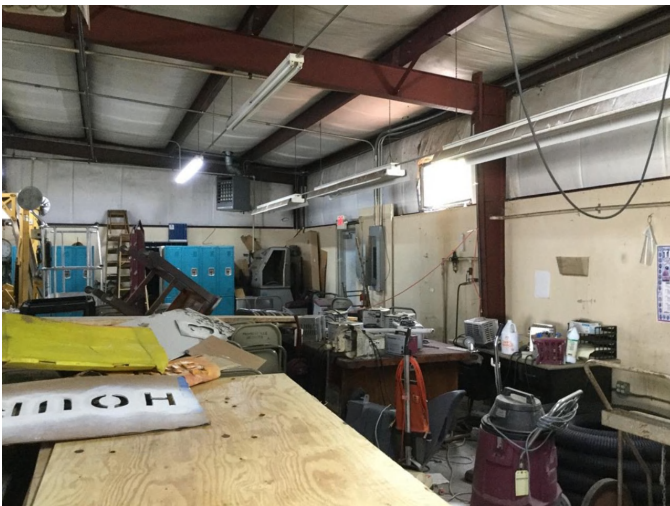
System: D5020 - Lighting

Location: Throughout building
Distress: Beyond Expected Life
Category: Deferred Maintenance
Priority: 3 - Necessary (Years 2-5)
Correction: Renew System
Qty: 5,100.00
Unit of Measure: S.F.
Estimate: \$50,123.00
Assessor Name: Homero Guerrero
Date Created: 09/17/2015

Notes: Most of the lighting system appears to be from the original construction. The system is showing signs of age and should be scheduled for replacement and upgrade in conjunction with other recommended renovations.

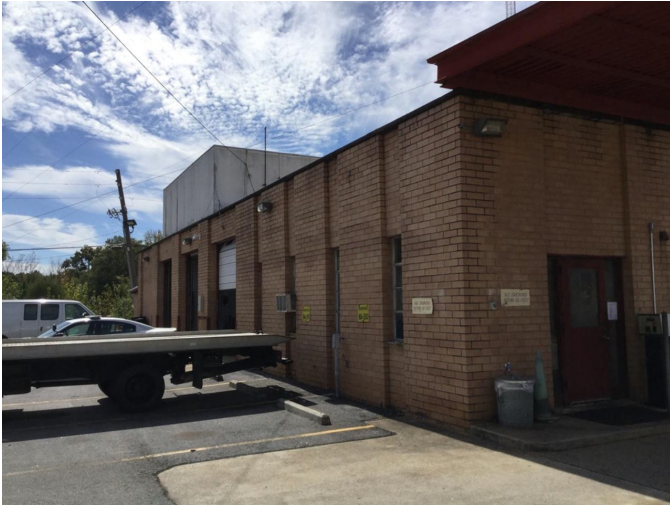
System: B2020 - Exterior Windows

Location: Throughout building
Distress: Beyond Expected Life
Category: Deferred Maintenance
Priority: 3 - Necessary (Years 2-5)
Correction: Renew System
Qty: 4,427.00
Unit of Measure: S.F.
Estimate: \$8,230.00
Assessor Name: Eduardo Lopez
Date Created: 02/21/2020

The exterior windows are original to the building's construction with few exceptions. The window system is beyond its expected life cycle, worn and damaged, and should be replaced and upgraded.

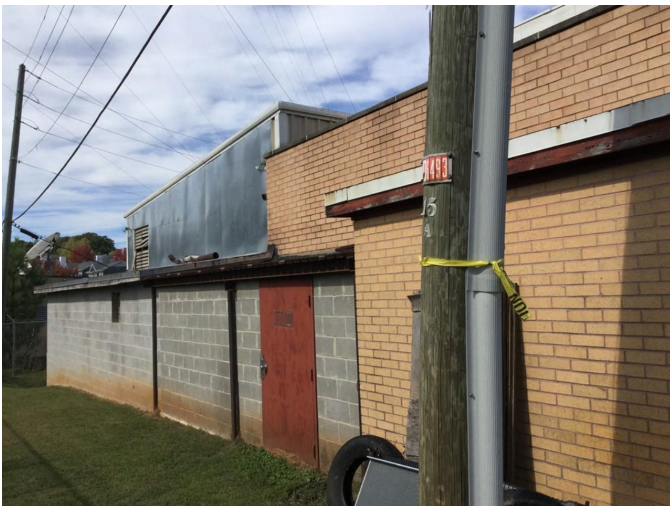
System: B2030 - Exterior Doors

Location: Throughout building
Distress: Beyond Expected Life
Category: ADA Compliance
Priority: 3 - Necessary (Years 2-5)
Correction: Renew System
Qty: 4,427.00
Unit of Measure: S.F.
Estimate: \$8,522.00
Assessor Name: Eduardo Lopez
Date Created: 02/21/2020

Notes: The glazed metal exterior doors are original to the building's construction with few exceptions. The door system is beyond its expected life cycle, worn and damaged, and should be replaced and upgraded for ADA compliance.

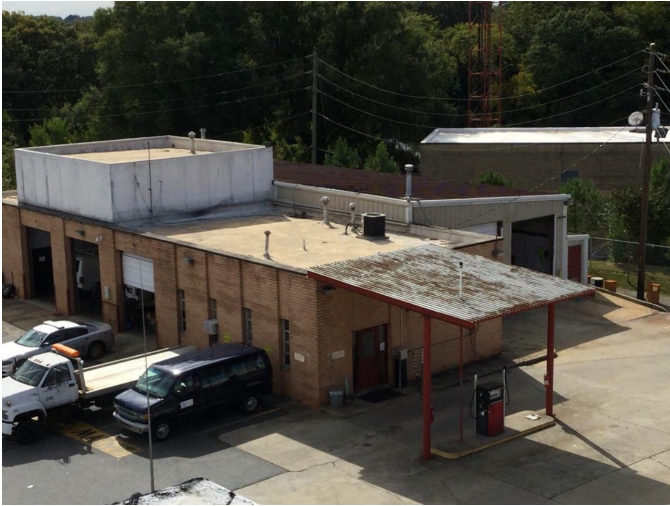
System: B3010130 - Preformed Metal Roofing

Location: Roof
Distress: Beyond Expected Life
Category: Deferred Maintenance
Priority: 3 - Necessary (Years 2-5)
Correction: Renew System
Qty: 2,482.00
Unit of Measure: S.F.
Estimate: \$23,207.00
Assessor Name: Eduardo Lopez
Date Created: 01/10/2020

Notes: The metal roof covering is original and beyond its service life and should be scheduled for replacement.

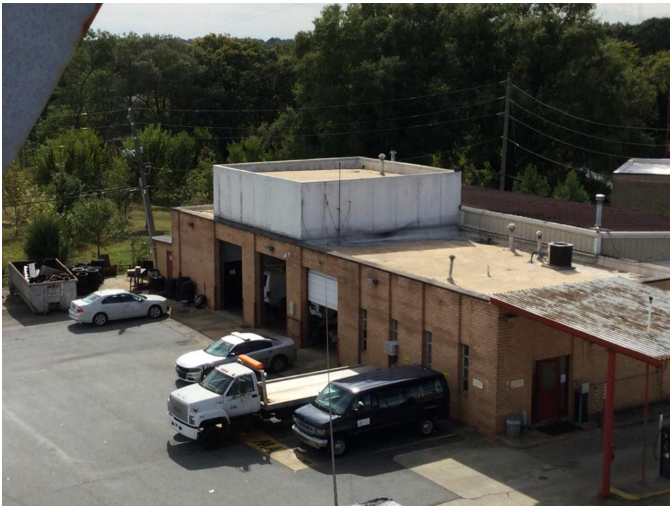
System: B3010999 - Other - Foam and Coat over Single Ply

Location: Roof
Distress: Beyond Expected Life
Category: Deferred Maintenance
Priority: 3 - Necessary (Years 2-5)
Correction: Renew System
Qty: 1,945.00
Unit of Measure: S.F.
Estimate: \$11,489.00
Assessor Name: Eduardo Lopez
Date Created: 01/10/2020

Notes: The roofing system is not expected to outlast the purview of this analysis. Future budgetary consideration should include provision for the renewal of the foam and coat roofing system and install a new Single-Ply roof.

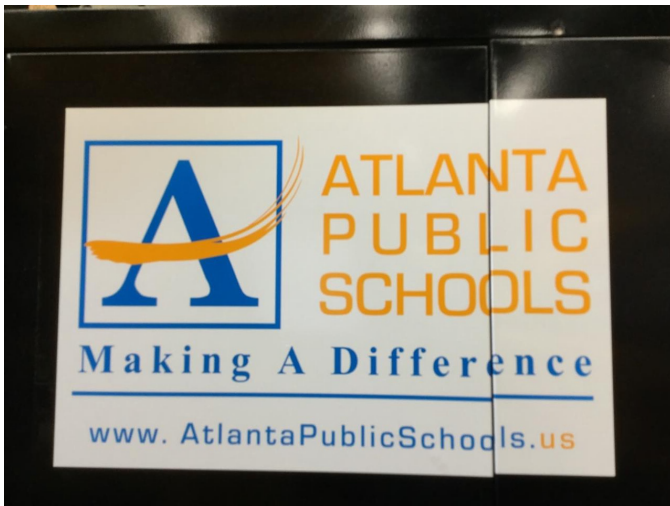
System: C1030 - Fittings

Location: Throughout building
Distress: Beyond Expected Life
Category: ADA Compliance
Priority: 3 - Necessary (Years 2-5)
Correction: Renew System
Qty: 4,427.00
Unit of Measure: S.F.
Estimate: \$26,296.00
Assessor Name: Eduardo Lopez
Date Created: 02/21/2020

Fittings, such as toilet partitions, lockers, signage and railing, are beyond their expected service life, worn and damaged in areas, and should be replaced and upgraded for compliance with ADA standards.

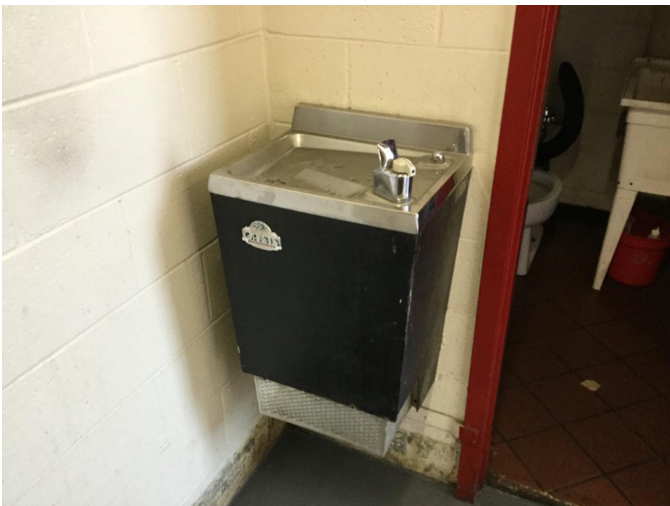
System: C3020420 - Ceramic Tile

Location: Restroom
Distress: Beyond Expected Life
Category: Deferred Maintenance
Priority: 3 - Necessary (Years 2-5)
Correction: Renew System
Qty: 247.00
Unit of Measure: S.F.
Estimate: \$6,202.00
Assessor Name: Eduardo Lopez
Date Created: 01/13/2020

Notes: The ceramic tile floor finish is beyond its expected service life and should be replaced in conjunction with other recommended renovations.

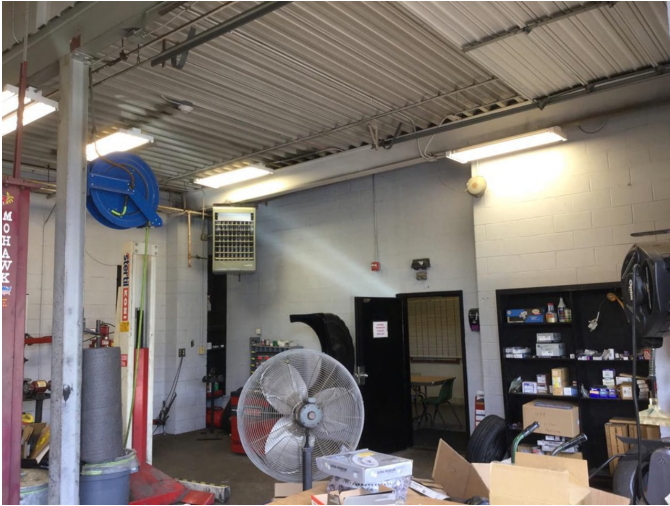
System: C3020999 - Other - Concrete Finish w/Sealer

Location: Throughout building
Distress: Beyond Expected Life
Category: Deferred Maintenance
Priority: 3 - Necessary (Years 2-5)
Correction: Renew System
Qty: 4,200.00
Unit of Measure: S.F.
Estimate: \$31,739.00
Assessor Name: Eduardo Lopez
Date Created: 01/31/2020

Notes: The concrete finish is worn and should be resealed.

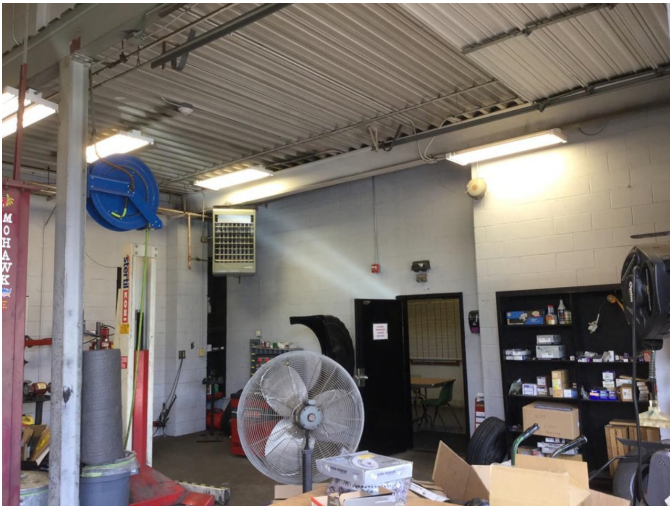
System: C3030 - Ceiling Finishes

Location: Throughout building
Distress: Beyond Expected Life
Category: Deferred Maintenance
Priority: 3 - Necessary (Years 2-5)
Correction: Renew System
Qty: 4,427.00
Unit of Measure: S.F.
Estimate: \$125,103.00
Assessor Name: Eduardo Lopez
Date Created: 02/21/2020

Notes:
The acoustic ceilings are aged and stained and should be scheduled for replacement.

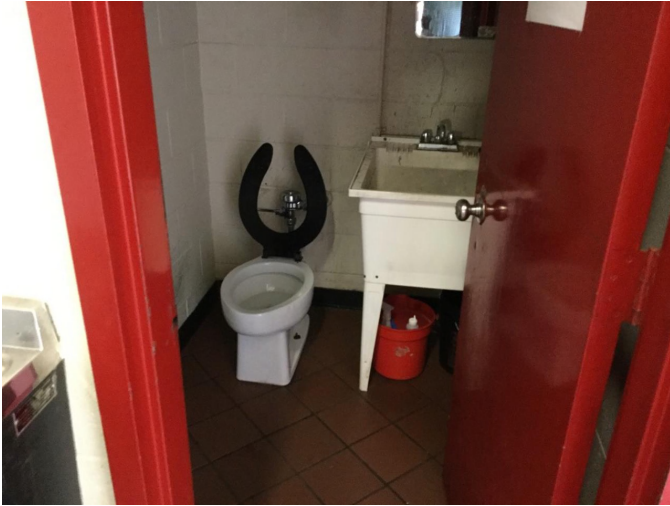
System: D2010 - Plumbing Fixtures

Location: Restroom
Distress: Beyond Expected Life
Category: ADA Compliance
Priority: 3 - Necessary (Years 2-5)
Correction: Renew System
Qty: 4,427.00
Unit of Measure: S.F.
Estimate: \$38,373.00
Assessor Name: Eduardo Lopez
Date Created: 02/21/2020

Plumbing fixtures are beyond their expected service life and should be replaced and upgraded for ADA compliance.

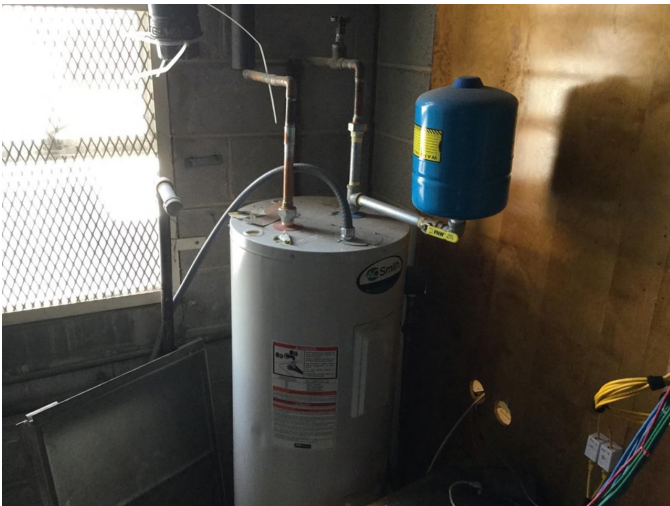
System: D2020 - Domestic Water Distribution

Location: Throughout building
Distress: Beyond Expected Life
Category: Deferred Maintenance
Priority: 3 - Necessary (Years 2-5)
Correction: Renew System
Qty: 4,427.00
Unit of Measure: S.F.
Estimate: \$7,110.00
Assessor Name: Eduardo Lopez
Date Created: 09/04/2013

Notes: The domestic water distribution system consists of galvanized and copper pipes, valves and domestic water supply. The system is beyond its expected life cycle and upgrades are recommended.

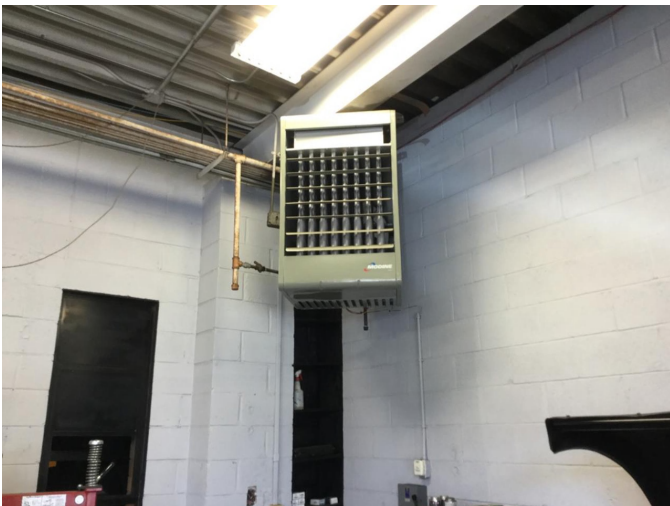
System: D3020 - Heat Generating Systems

Location: Throughout building
Distress: Beyond Expected Life
Category: Deferred Maintenance
Priority: 3 - Necessary (Years 2-5)
Correction: Renew System
Qty: 4,427.00
Unit of Measure: S.F.
Estimate: \$39,493.00
Assessor Name: Eduardo Lopez
Date Created: 09/04/2013

Notes: The heat generation system is original and beyond its expected life cycle. Upgrades to the existing system are considered necessary.

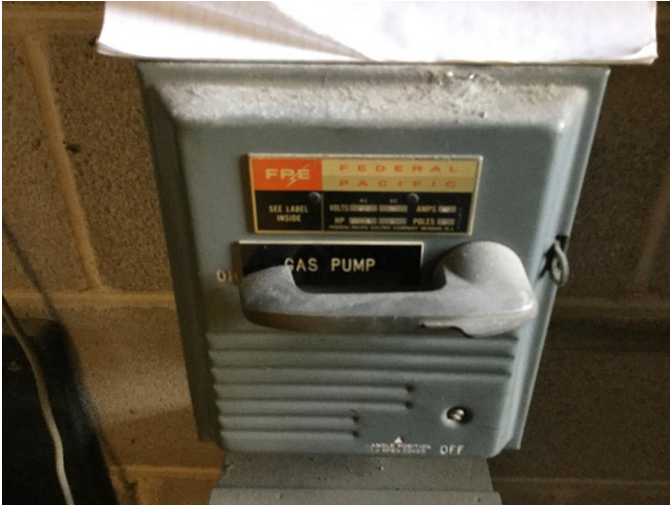
System: D5010 - Electrical Service/Distribution

Location: Throughout building
Distress: Beyond Expected Life
Category: Deferred Maintenance
Priority: 3 - Necessary (Years 2-5)
Correction: Renew System
Qty: 4,427.00
Unit of Measure: S.F.
Estimate: \$22,547.00
Assessor Name: Eduardo Lopez
Date Created: 08/13/2014

Notes: The Federal Pacific electrical service and distribution system consist of a service disconnect, primary main rated at 100 amps, breaker system, switch box, and conduit and wiring to equipment, interior and exterior lights. This system is a mix of the old and new. Some of the system was recently upgraded; however, a majority of the system is original. Upgrades are warranted.

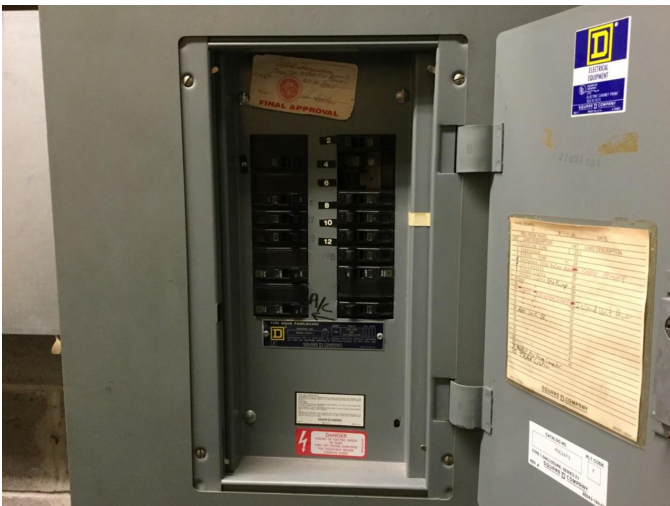
System: D5020 - Branch Wiring

Location: Throughout building
Distress: Beyond Expected Life
Category: Deferred Maintenance
Priority: 3 - Necessary (Years 2-5)
Correction: Renew System
Qty: 4,427.00
Unit of Measure: S.F.
Estimate: \$47,772.00
Assessor Name: Eduardo Lopez
Date Created: 01/13/2020

Notes: The Federal Pacific electrical service/distribution system is no longer supported and is aged and should be replaced and upgraded for compliance with current code requirements.

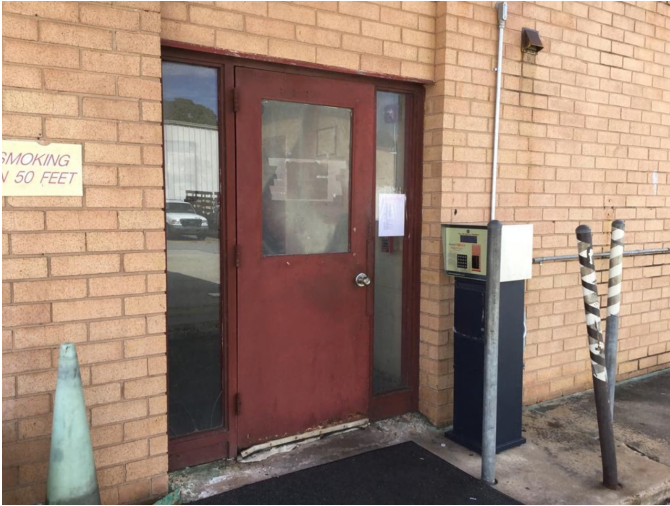
System: D5030810 - Security & Detection Systems

Location: Throughout building
Distress: Beyond Expected Life
Category: Deferred Maintenance
Priority: 3 - Necessary (Years 2-5)
Correction: Renew System
Qty: 4,427.00
Unit of Measure: S.F.
Estimate: \$7,353.00
Assessor Name: Eduardo Lopez
Date Created: 01/13/2020

Notes: This facilities security and alarm system is original. The main entrance is easily accessed and there are no existing barriers to prevent vehicle access. This project provides a budgetary consideration to improve the entrance and upgrade the alarm and security system.

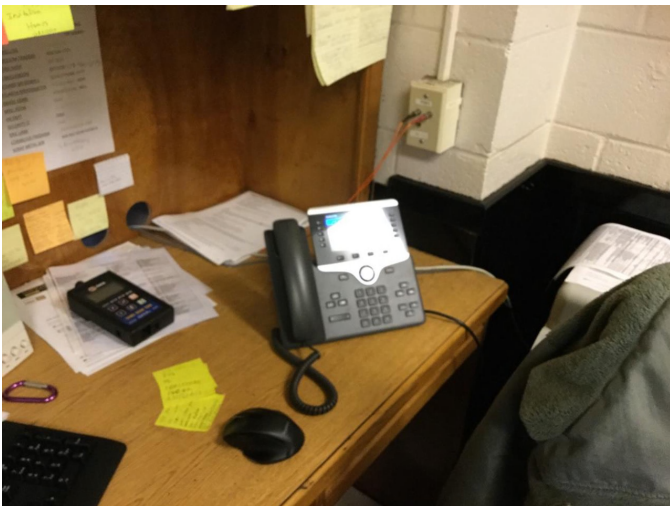
System: D5030920 - Data Communication

Location: Administration Area
Distress: Beyond Expected Life
Category: Deferred Maintenance
Priority: 3 - Necessary (Years 2-5)
Correction: Renew System
Qty: 4,427.00
Unit of Measure: S.F.
Estimate: \$17,336.00
Assessor Name: Eduardo Lopez
Date Created: 01/13/2020

Notes: This facilities original data communications system that provides access to the internet and phone services. The system is aged and a new data system is recommended.

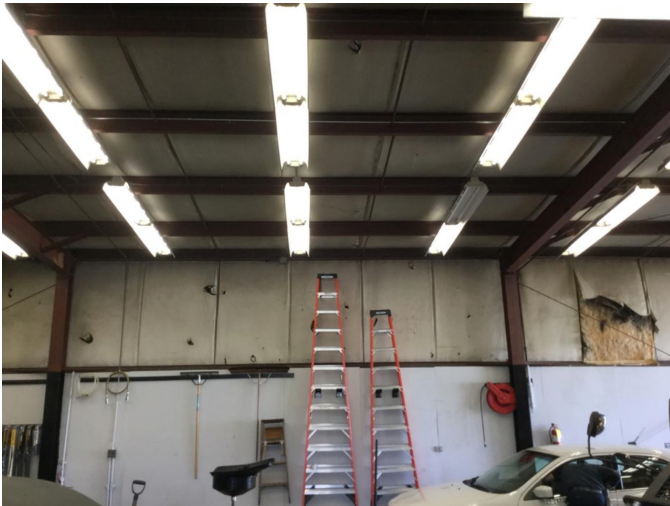
System: D5020 - Lighting

Location: Throughout building
Distress: Beyond Expected Life
Category: Deferred Maintenance
Priority: 4 - Recommended (Years 6-10)
Correction: Renew System
Qty: 4,427.00
Unit of Measure: S.F.
Estimate: \$66,666.00
Assessor Name: Eduardo Lopez
Date Created: 08/13/2014

Notes: The original lighting system is operational but is aged and should be replaced with an energy efficient system.

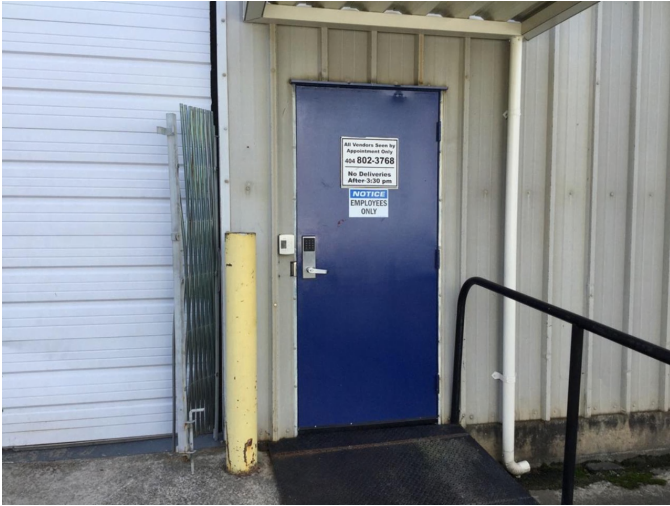
System: B2030 - Exterior Doors

Location: Throughout building
Distress: Beyond Expected Life
Category: ADA Compliance
Priority: 3 - Necessary (Years 2-5)
Correction: Renew System
Qty: 43,000.00
Unit of Measure: S.F.
Estimate: \$159,874.00
Assessor Name: Eduardo Lopez
Date Created: 08/13/2014

Notes: The metal exterior doors are original to the building's construction with few exceptions. The door system is beyond its expected life cycle, worn and should be replaced and upgraded for ADA compliance.

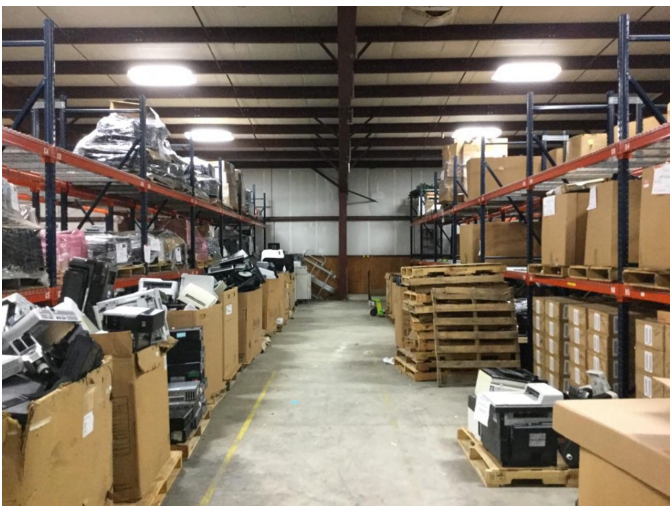
System: C3020999 - Other - Concrete Finish w/Sealer

Location: Throughout building
Distress: Beyond Expected Life
Category: Deferred Maintenance
Priority: 3 - Necessary (Years 2-5)
Correction: Renew System
Qty: 42,000.00
Unit of Measure: S.F.
Estimate: \$317,394.00
Assessor Name: Eduardo Lopez
Date Created: 01/14/2020

Notes: The concrete floor finish for this facility is beyond service life. Re surfacing the concrete finish is the best option for extended life. Surface sealers protect the surface and resist penetration from chemicals, rust, oils, salts, water, and many other stains. This deficiency provides a budgetary consideration for a uniform surface seal and protective coat application.

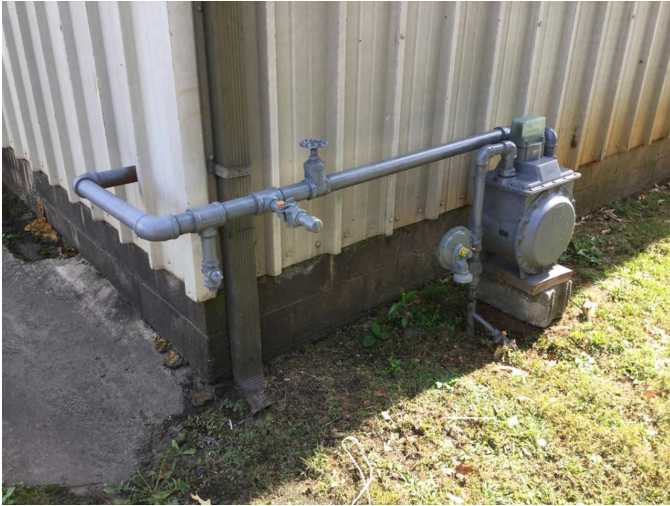
System: D3010 - Energy Supply

Location: Throughout building
Distress: Beyond Expected Life
Category: Deferred Maintenance
Priority: 3 - Necessary (Years 2-5)
Correction: Renew System
Qty: 43,000.00
Unit of Measure: S.F.
Estimate: \$28,853.00
Assessor Name: Eduardo Lopez
Date Created: 01/14/2020

Notes: There were no records to indicate the installation of the gas distribution system. This system appears to be from the the original construction and is beyond the expected life cycle for this application. Upgrades are warranted.

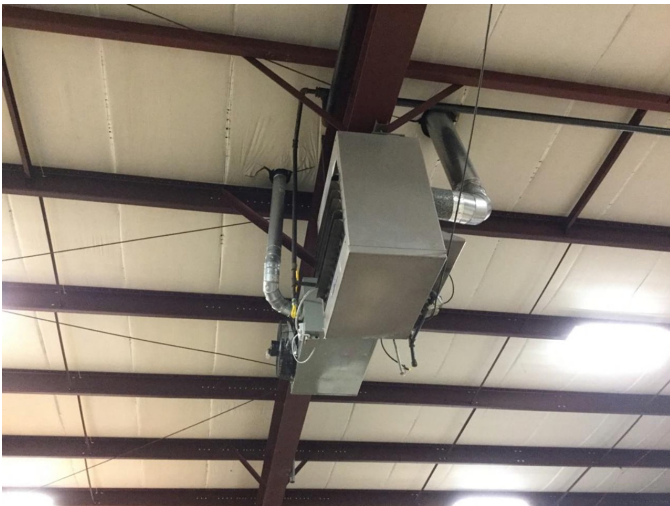
System: D3020 - Heat Generating Systems

Location: Throughout building
Distress: Beyond Expected Life
Category: Deferred Maintenance
Priority: 3 - Necessary (Years 2-5)
Correction: Renew System
Qty: 43,000.00
Unit of Measure: S.F.
Estimate: \$210,958.00
Assessor Name: Eduardo Lopez
Date Created: 02/21/2020

Notes: There were no records to indicate the installation of the heat generation system. This system appears to be from the original construction and is beyond the expected life cycle for this application. Upgrades are warranted.

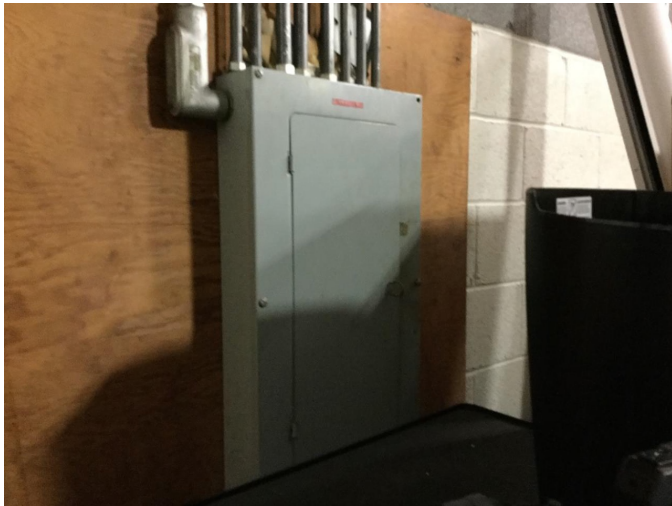
System: D5010 - Electrical Service/Distribution

Location: Throughout building
Distress: Beyond Expected Life
Category: Deferred Maintenance
Priority: 3 - Necessary (Years 2-5)
Correction: Renew System
Qty: 43,000.00
Unit of Measure: S.F.
Estimate: \$44,505.00
Assessor Name: Eduardo Lopez
Date Created: 02/21/2020

The original electrical distribution system is operational but is aged and should be replaced with an energy efficient system.

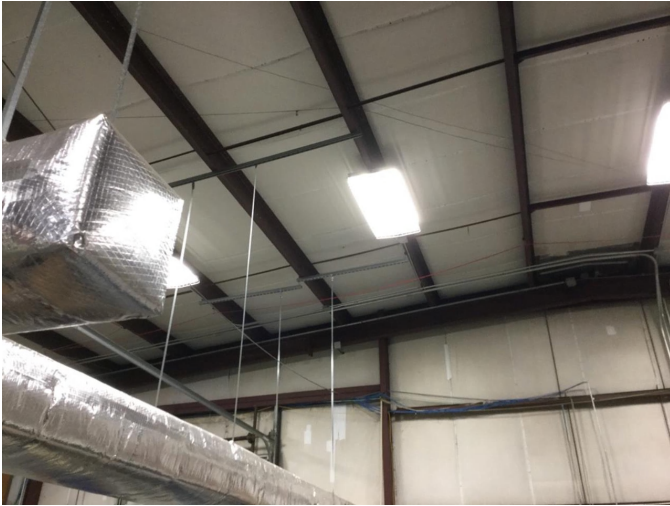
System: D5020 - Lighting

Location: Throughout building
Distress: Beyond Expected Life
Category: Deferred Maintenance
Priority: 3 - Necessary (Years 2-5)
Correction: Renew System
Qty: 43,000.00
Unit of Measure: S.F.
Estimate: \$402,093.00
Assessor Name: Eduardo Lopez
Date Created: 02/21/2020

The original lighting system is operational but is aged and should be replaced with an energy efficient system.

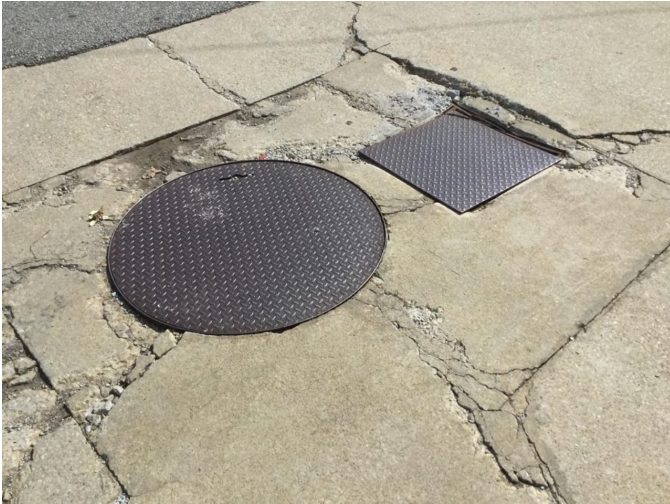
System: G2020 - Parking Lots

Location: Loading dock

Distress: Damaged

Concrete slab at areas of heavy truck use - including loading docks, and ramp to lower area of site - is cracked, broken spalled and significantly deteriorated.

Correction: Remove and replace concrete parking slab.

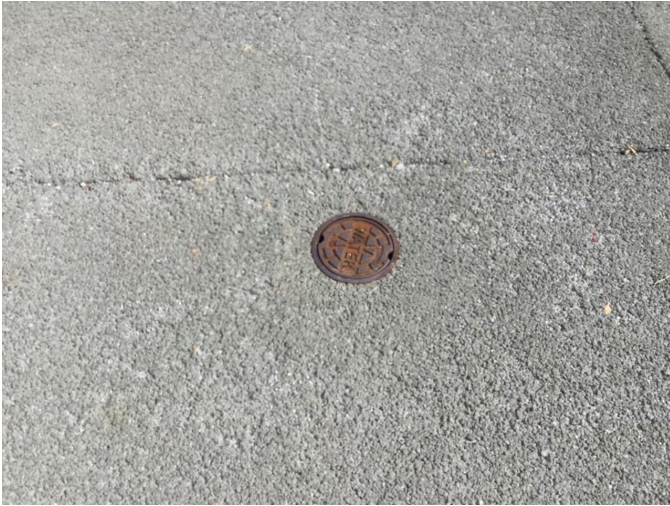
System: G3010 - Water Supply

Location: Site
Distress: Beyond Expected Life
Category: Deferred Maintenance
Priority: 3 - Necessary (Years 2-5)
Correction: Renew System
Qty: 225,327.00
Unit of Measure: S.F.
Estimate: \$270,167.00
Assessor Name: Hayden Collins
Date Created: 09/17/2015

Notes: The original domestic water distribution system components consist of galvanized and copper pipes, valves and domestic water supply. Water supply control valves should be accessible for easy operation. Valves located in various areas on the site should be protected and easily accessible during a fire. All valves should be clearly marked and identifiable with exterior signs showing the locations of each valve. These valves should be marked with information indicating the areas and locations covered by their water source. This deficiency provides a budgetary consideration for universal upgrades to the domestic water distribution system for this site.

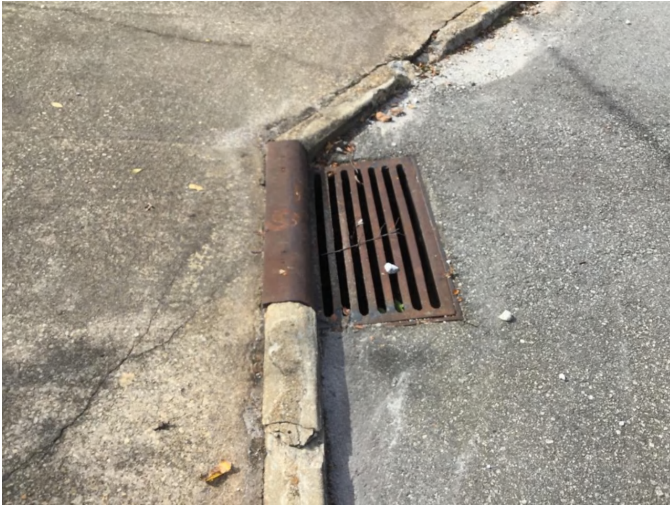
System: G3030 - Storm Sewer

Location: Site
Distress: Beyond Expected Life
Category: Deferred Maintenance
Priority: 3 - Necessary (Years 2-5)
Correction: Renew System
Qty: 225,327.00
Unit of Measure: S.F.
Estimate: \$309,825.00
Assessor Name: Hayden Collins
Date Created: 09/17/2015

Notes: The site storm drains that support the water runoff are functional however, have exceeded the expected life cycle. This deficiency provides a budgetary consideration for a new rainwater drainage system. This is expected to be completed as part of an overall effort to upgrade the site and should be completed as part of the recommended site upgrades also in this report.

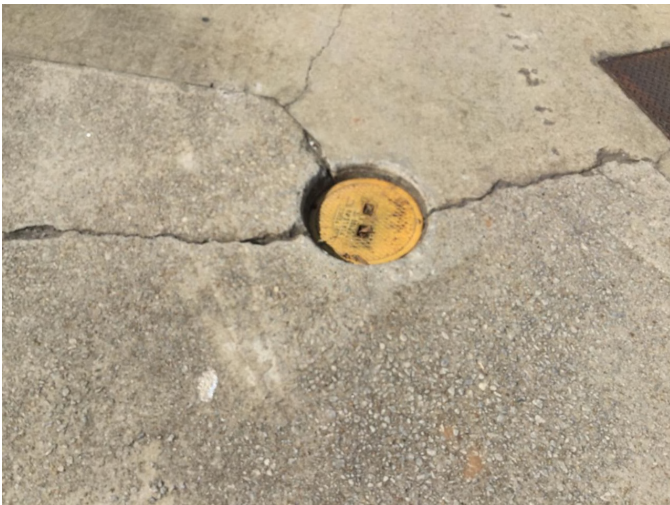
System: G3060110 - Gas Service Piping

Location: Vehicle Service Station
Distress: Beyond Expected Life
Category: Deferred Maintenance
Priority: 3 - Necessary (Years 2-5)
Correction: Renew System
Qty: 1,200.00
Unit of Measure: S.F.
Estimate: \$50,028.00
Assessor Name: Hayden Collins
Date Created: 01/14/2020

Notes: There were no records to indicate the installation of the gasoline distribution system. This system appears to be from the the original construction and is beyond the expected life cycle for this application. Upgrades are warranted.

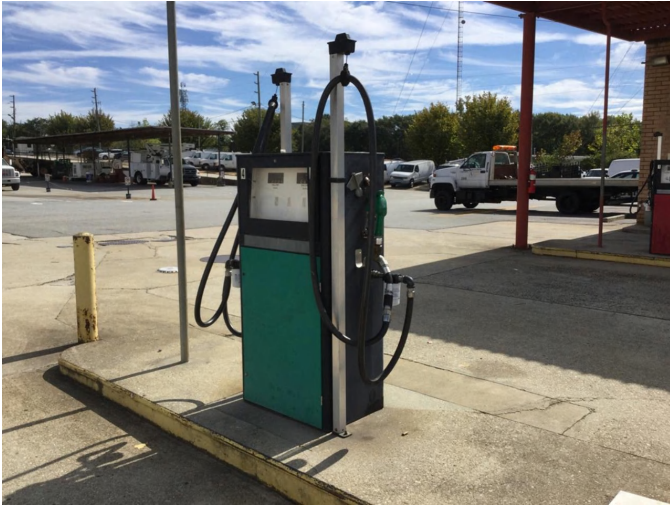
System: G3060320 - Steel Fuel Tank, Double Wall

Location: Vehicle Service Station
Distress: Beyond Expected Life
Category: Deferred Maintenance
Priority: 3 - Necessary (Years 2-5)
Correction: Renew System
Qty: 20,000.00
Unit of Measure: Gal.
Estimate: \$1,420,320.00
Assessor Name: Hayden Collins
Date Created: 01/13/2020

Notes: This site contains an underground storage tanks (USTs). The greatest potential threat from a leaking UST is contamination of groundwater, the source of drinking water. This UST is assumed to be original and beyond its expected useful life. This deficiency provides a budgetary consideration for the removal and replacement of this UST.

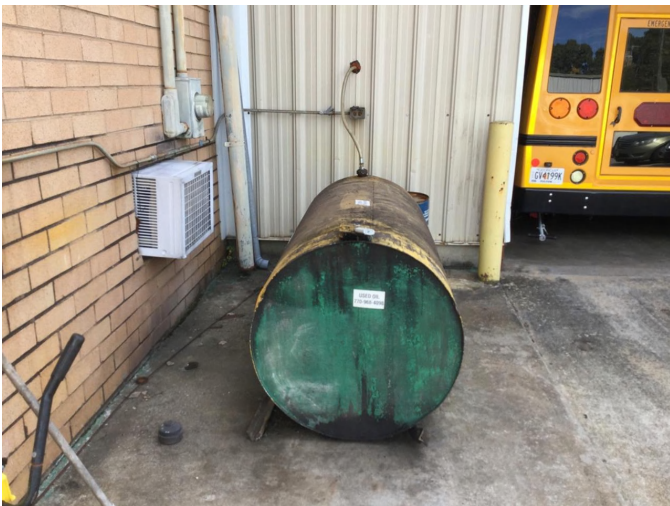
System: G3060325 - Steel Tank, Above Ground, Single Wall

Location: Vehicle Service Station
Distress: Beyond Expected Life
Category: Code Compliance
Priority: 3 - Necessary (Years 2-5)
Correction: Renew System
Qty: 500.00
Unit of Measure: Gal.
Estimate: \$35,508.00
Assessor Name: Hayden Collins
Date Created: 01/13/2020

Notes: Aboveground storage tanks (ASTs) used for the store of petroleum products is regulated primarily under 40 CFR 112. This Fuel Tank Systems is pre-engineered and constructed in place with no safety catch basin. This AST is original and has exceeded its expected life. A new AST designed in accordance with 40 CFR 112 is recommended.

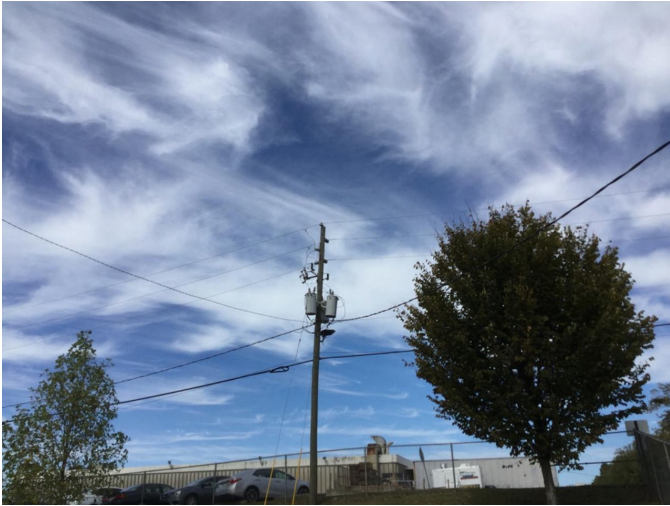
System: G4010 - Electrical Distribution

Location: Site
Distress: Beyond Expected Life
Category: Deferred Maintenance
Priority: 3 - Necessary (Years 2-5)
Correction: Renew System
Qty: 225,327.00
Unit of Measure: S.F.
Estimate: \$632,042.00
Assessor Name: Hayden Collins
Date Created: 02/21/2020

The site electrical services and distribution system consist of pole mounted transformers connecting the facility to the power net. This system has expired and will require upgrades. This deficiency is expected to be completed as part of an overall site upgrade effort.
