Atlanta Public Schools/Relocation Sites

Fain ES (West Manor relocation site)

School Assessment Report

November 10, 2020

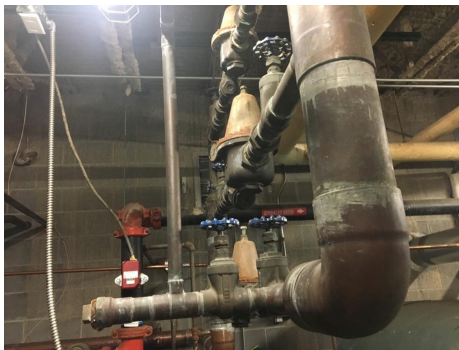
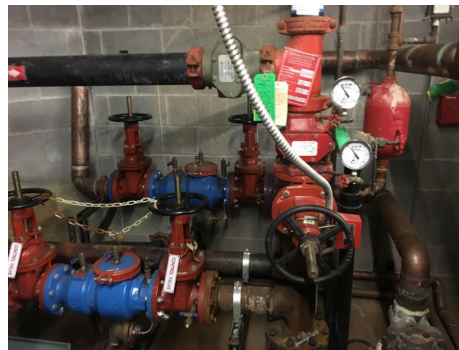
System: D2020 - Domestic Water Distribution

Note: Water heaters are original to building.

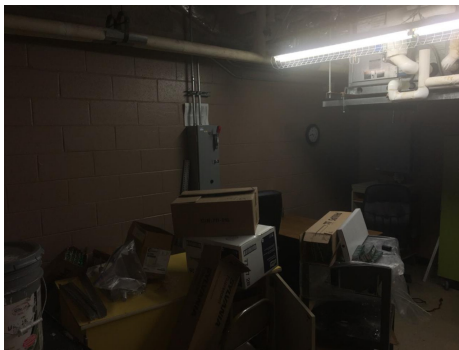
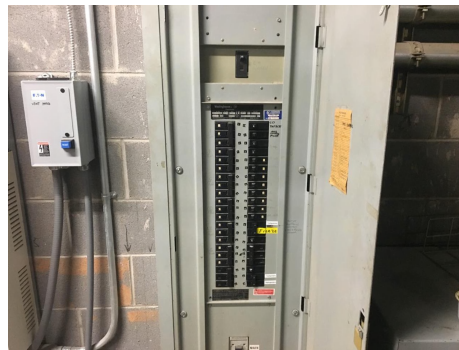
System: D5020 - Branch Wiring

Note: Exterior building lighting is original to building (installed 1987).

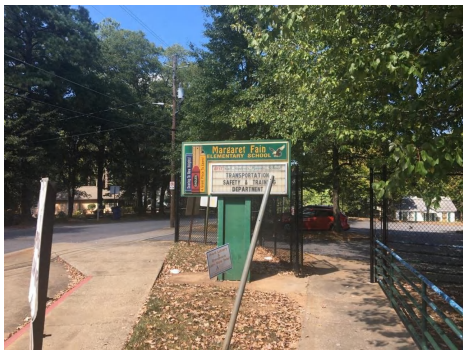
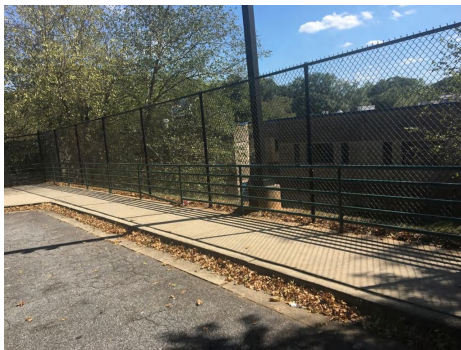
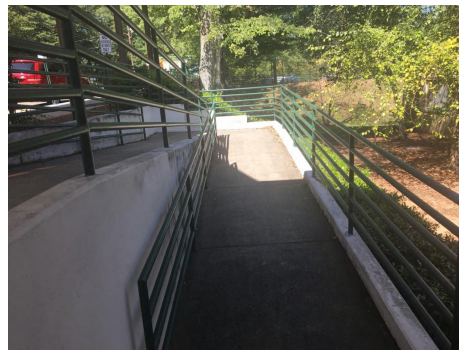
System: G2040105 - Fence & Guardrails

Notes: The fences and gates are beyond their service life and rusting and should be scheduled for replacement.

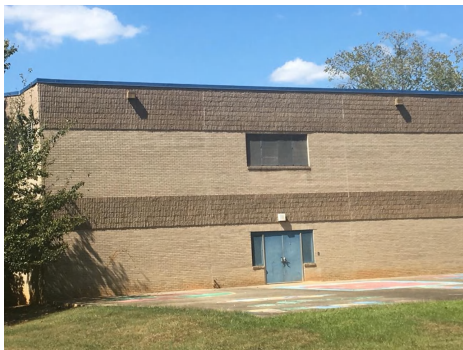
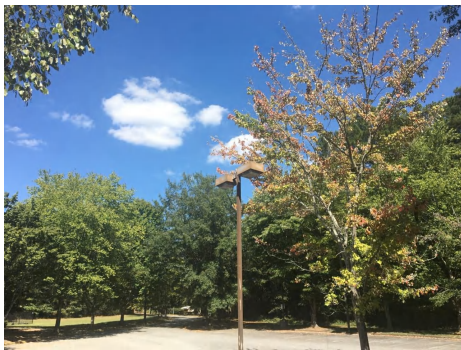
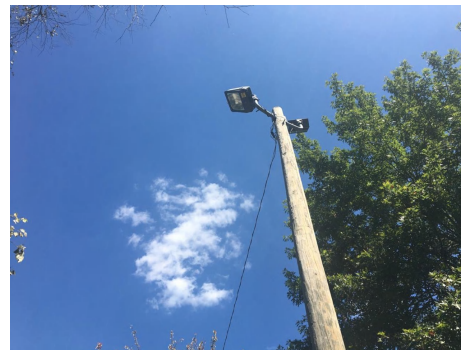
System: G4020 - Site Lighting

Notes: The existing site lighting system consists of a building mounted lighting program support by a few pole-mounted lights. Additional lighting is recommended. Replace the existing lights and add a new lighting program to provide for the entire site.

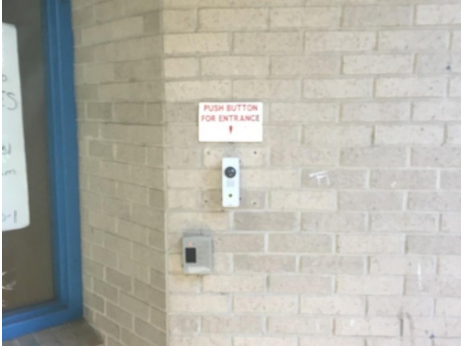
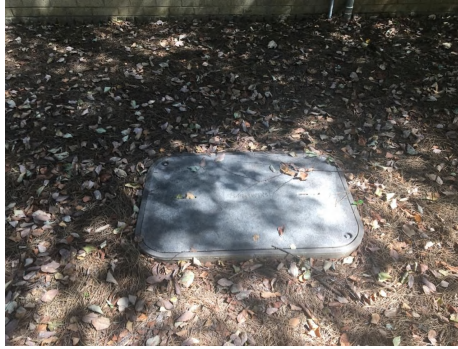
System: G4030 - Site Communication and Security

Note: No security cameras installed on exterior of building.
