Atlanta Public Schools/ Therrell Cluster

Fickett Elementary School

School Assessment Report

March 26, 2021

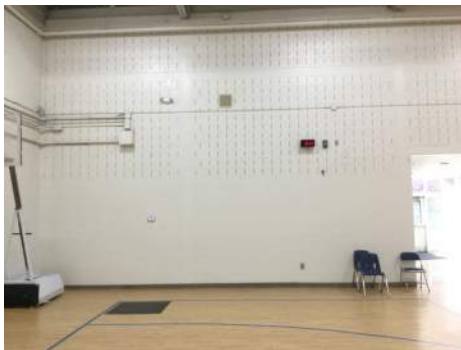
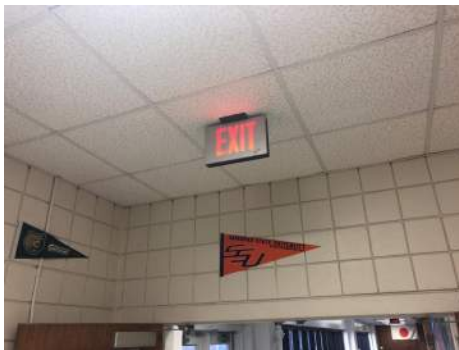
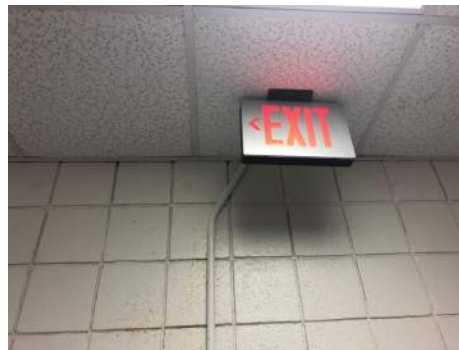
System: D5090 - Other Electrical Systems

Note: Used total campus square footage to generate a total cost for the emergency generator system for both buildings.
