Atlanta Public Schools/ Carver Cluster

Gideons Elementary School

School Assessment Report

March 10, 2021

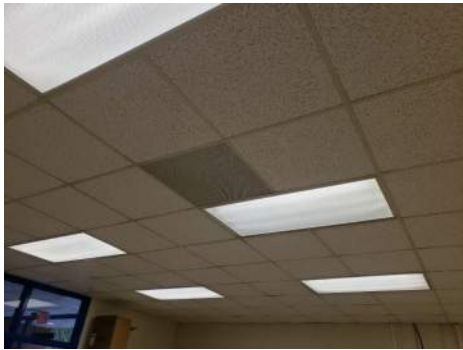
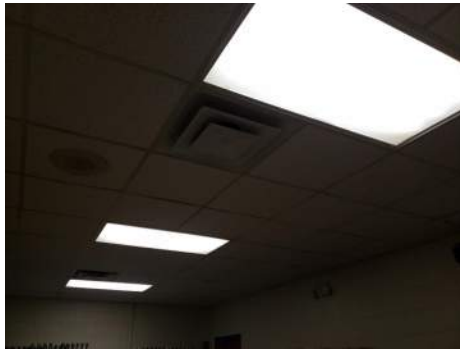
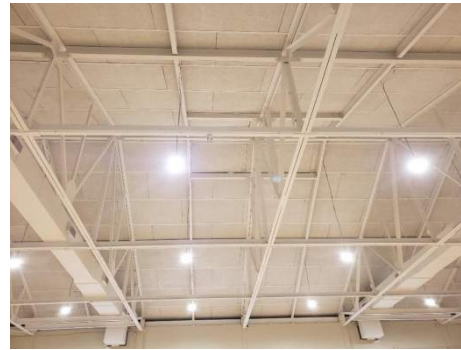
System: D5020 - Lighting

Notes: This lighting system is beyond its expected service life and upgrades are recommended.

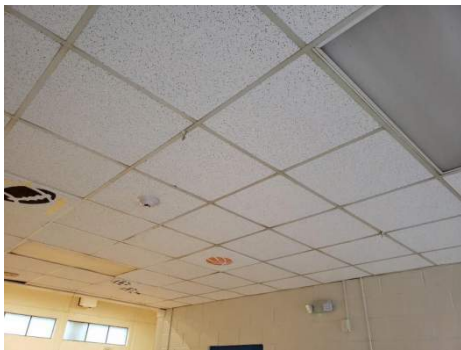
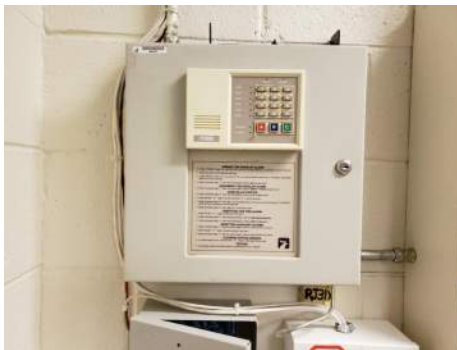
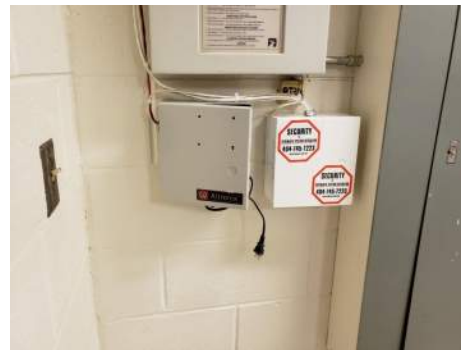
System: D5030810 - Security & Detection Systems

Notes: This facilities security and alarm system is beyond its expected service life and upgrades are recommended for the system.

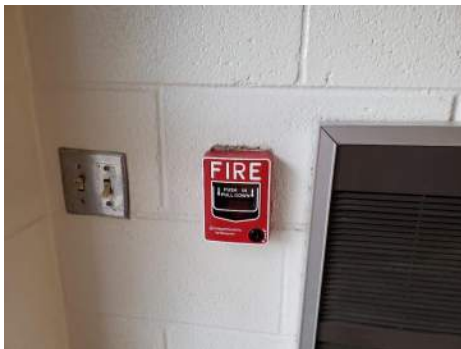
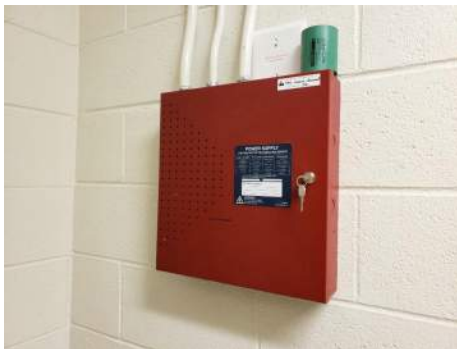
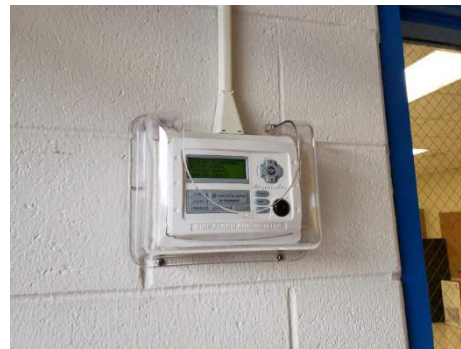
System: D5030910 - Fire Alarm Systems

Notes: This fire alarm system is beyond its expected service life and upgrades are recommended for the system.

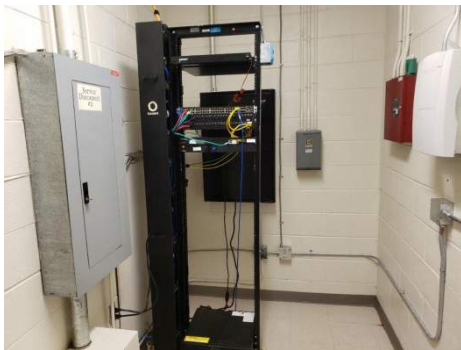
System: D5030920 - Data Communication

Notes: This facility has a data communications system that provides access to the internet. The system is beyond its expected service life and the installation of a new data system is recommended.

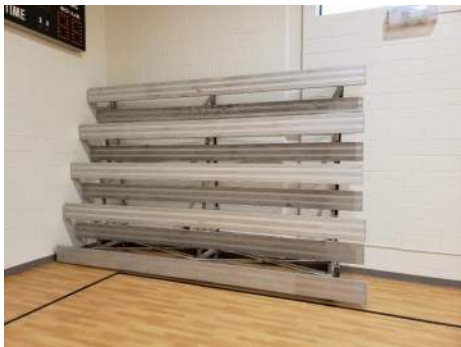
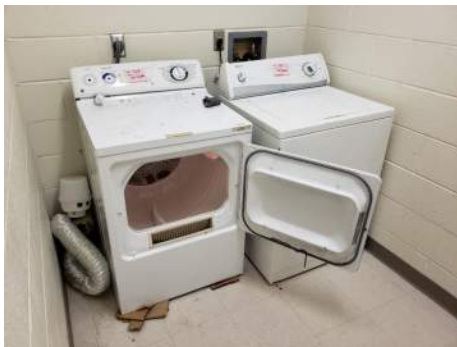
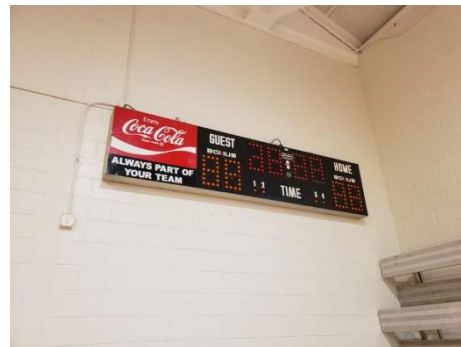
System: E1090 - Other Equipment

Notes: The other equipment is beyond its expected service life and upgrades are recommended for the system.

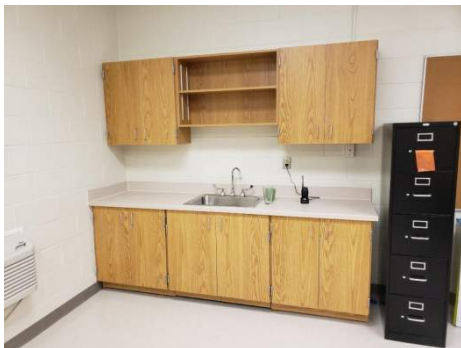
System: E2010 - Fixed Furnishings

Notes: The fix furnishings are beyond its expected service life and upgrades are recommended for the system.
