Atlanta Public Schools/ Grady Cluster

Grady High School

School Assessment Report

November 10, 2020

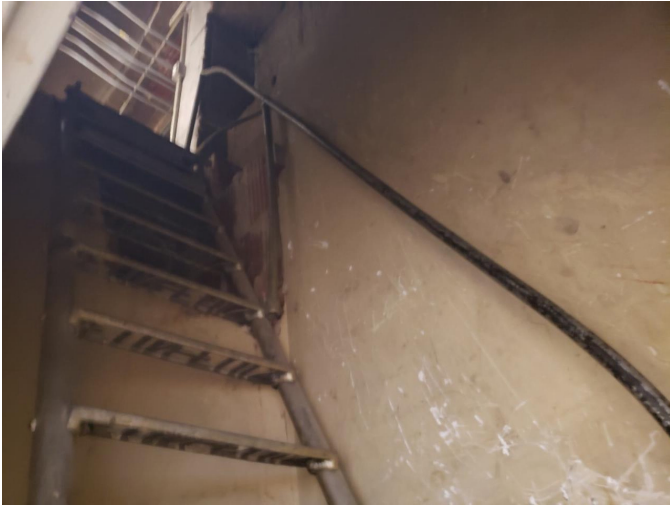
System: B3020 - Roof Openings

Location: Roof
Distress: Inadequate
Category: Safety
Priority: 2 - Trending Critical (Year 1)
Correction: Renew System
Qty: 66,005.00
Unit of Measure: S.F.
Estimate: \$38,481.00
Assessor Name: Eduardo Lopez
Date Created: 08/15/2013

Notes: Several roof areas have no interior access. Those provided are safety hazards due to ladder riser heights, available depth and relationship to adjacent roof planes

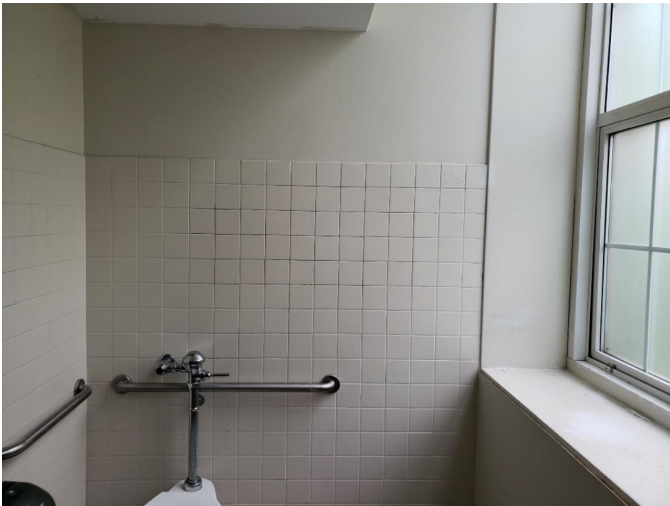
System: C3010220 - Tile

Location: Throughout Building
Distress: Beyond Expected Life
Category: Deferred Maintenance
Priority: 3 - Necessary (Years 2-5)
Correction: Renew System
Qty: 2,638.00
Unit of Measure: S.F.
Estimate: \$36,602.00
Assessor Name: Eduardo Lopez
Date Created: 01/30/2020

Notes: The tile is showing signs of early failure and should be replaced.

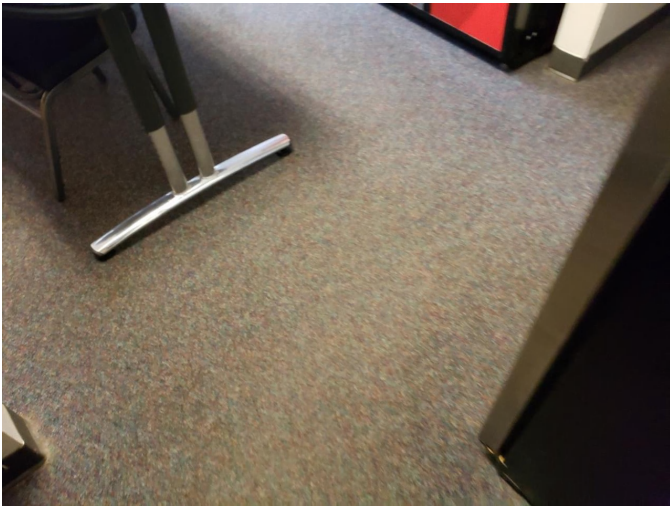
System: C3020901 - Carpet

Location: Throughout Building
Distress: Beyond Expected Life
Category: Deferred Maintenance
Priority: 3 - Necessary (Years 2-5)
Correction: Renew System
Qty: 3,224.00
Unit of Measure: S.F.
Estimate: \$26,598.00
Assessor Name: Eduardo Lopez
Date Created: 01/30/2020

Notes: The carpet is stained, showing signs of early failure and should be replaced.

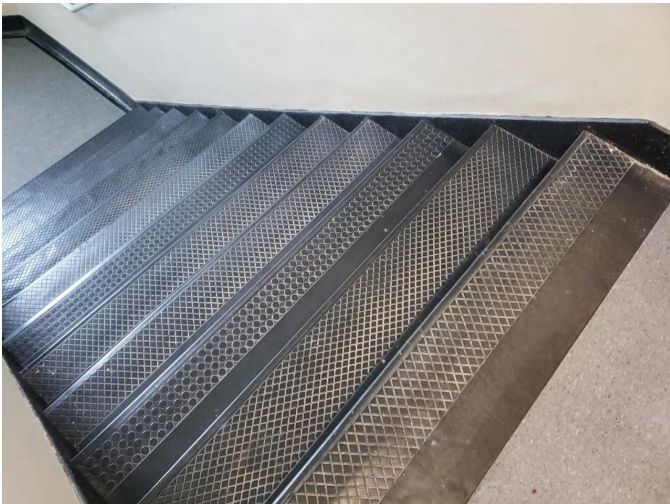
System: C3020999 - Other - Rubber or Neoprene

Location: Throughout Building
Distress: Beyond Expected Life
Category: Deferred Maintenance
Priority: 3 - Necessary (Years 2-5)
Correction: Renew System
Qty: 548.00
Unit of Measure: S.F.
Estimate: \$16,077.00
Assessor Name: Eduardo Lopez
Date Created: 01/30/2020

Notes: The rubber flooring system is beyond its expected service life and should be scheduled for replacement.

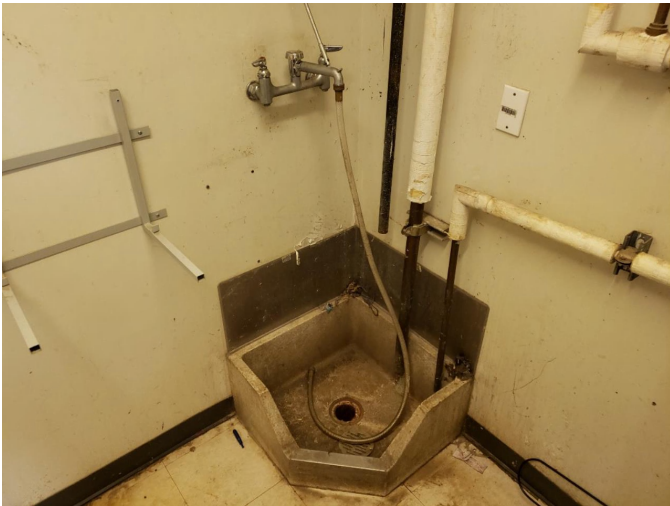
System: D2020 - Domestic Water Distribution

Location: Throughout Building
Distress: Beyond Expected Life
Category: Deferred Maintenance
Priority: 3 - Necessary (Years 2-5)
Correction: Renew System
Qty: 66,005.00
Unit of Measure: S.F.
Estimate: \$55,180.00
Assessor Name: Eduardo Lopez
Date Created: 08/15/2013

Notes: The domestic water distribution system is aged and should be replaced.

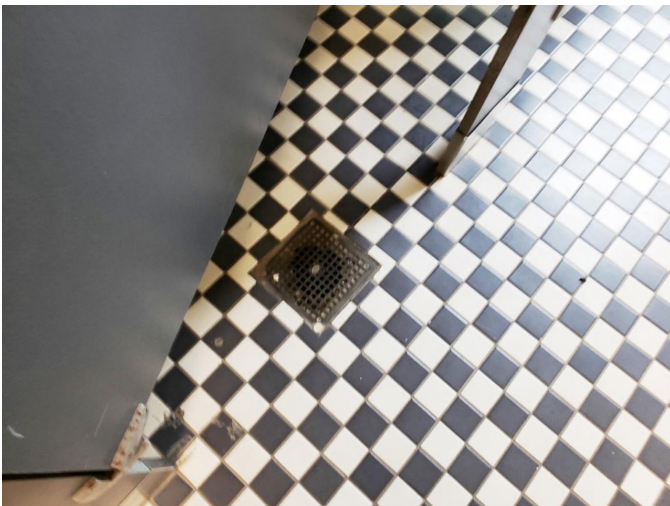
System: D2030 - Sanitary Waste

Location: Throughout Building
Distress: Beyond Expected Life
Category: Deferred Maintenance
Priority: 3 - Necessary (Years 2-5)
Correction: Renew System
Qty: 66,005.00
Unit of Measure: S.F.
Estimate: \$127,060.00
Assessor Name: Eduardo Lopez
Date Created: 09/17/2015

Notes: The sanitary waste system is aged, has reported periodic failures, and should be replaced.

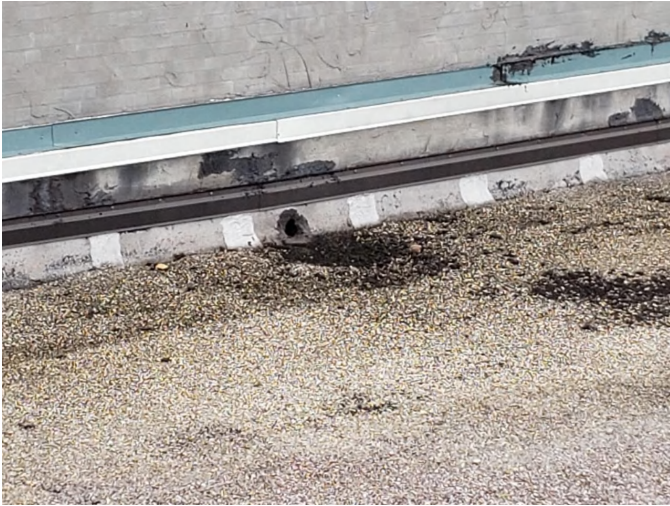
System: D2040 - Rain Water Drainage

Location: Roof
Distress: Beyond Expected Life
Category: Deferred Maintenance
Priority: 3 - Necessary (Years 2-5)
Correction: Renew System
Qty: 66,005.00
Unit of Measure: S.F.
Estimate: \$32,672.00
Assessor Name: Eduardo Lopez
Date Created: 08/15/2013

Notes: The rainwater drainage system is aged, in marginal condition, and should be replaced.

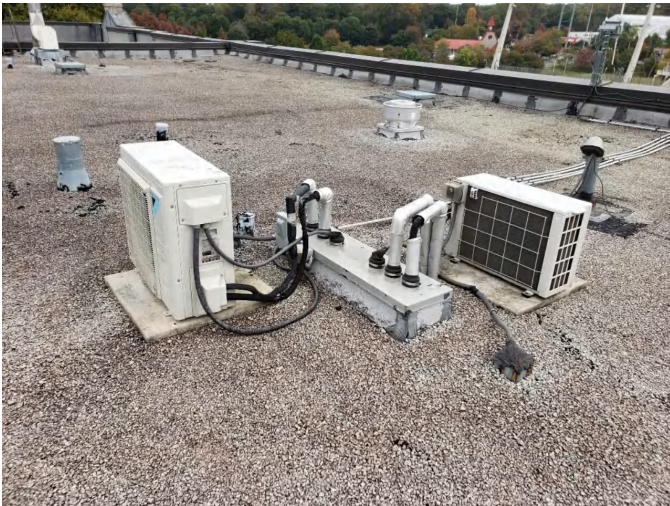
System: D3050 - Terminal & Package Units

Location: Throughout Building
Distress: Beyond Expected Life
Category: Deferred Maintenance
Priority: 3 - Necessary (Years 2-5)
Correction: Renew System
Qty: 66,005.00
Unit of Measure: S.F.
Estimate: \$80,592.00
Assessor Name: Eduardo Lopez
Date Created: 10/01/2019

Notes: The terminal and package units are aged, rusted, not energy efficient, and should be replaced.

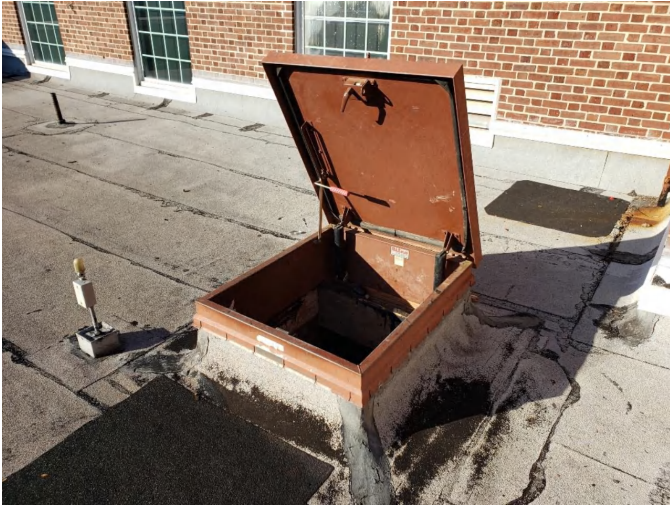
System: B3020 - Roof Openings

Location: Throughout Building
Distress: Failing
Category: Safety
Priority: 1 - Critical Immediate Need
Correction: Renew System
Qty: 33,113.00
Unit of Measure: S.F.
Estimate: \$18,941.00
Assessor Name: Homero Guerrero
Date Created: 08/20/2013

Notes: Roof hatch/ladder assembly is dangerous and poses a safety hazard.

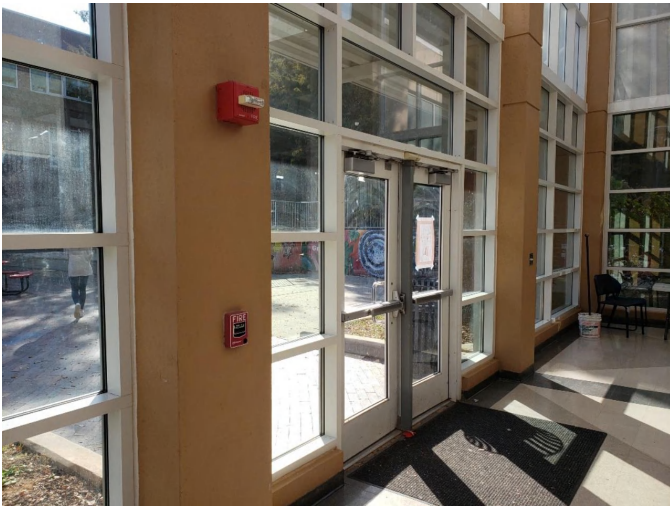
System: D5020 - Lighting

Location: Exit Door
Distress: Missing
Category: Code Compliance
Priority: 1 - Critical Immediate Need
Correction: Replace and/or add Exit Light fixtures w/wiring
Qty: 1.00
Unit of Measure: Ea.
Estimate: \$740.70
Assessor Name: Homero Guerrero
Date Created: 02/16/2020

Notes: Add emergency exit light at main entrance door.

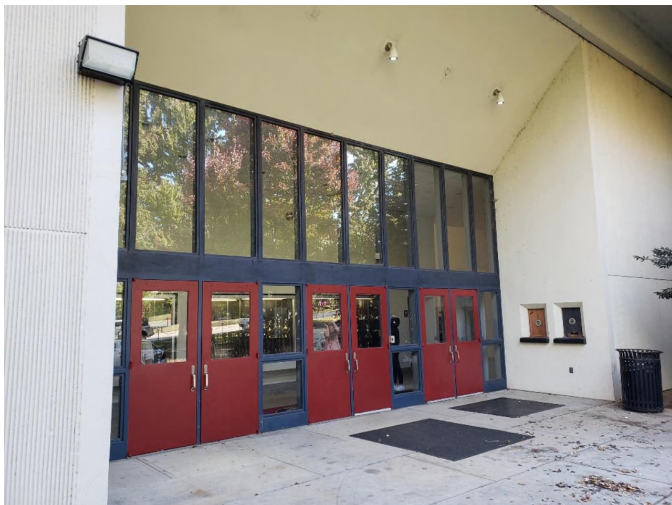
System: B2030 - Exterior Doors

Location: Exterior Walls
Distress: Beyond Expected Life
Category: ADA Compliance
Priority: 3 - Necessary (Years 2-5)
Correction: Renew System
Qty: 44,588.00
Unit of Measure: S.F.
Estimate: \$41,199.00
Assessor Name: Jejuan Hall
Date Created: 02/17/2020

Notes: The original exterior doors are aged, rusted, and should be replaced.

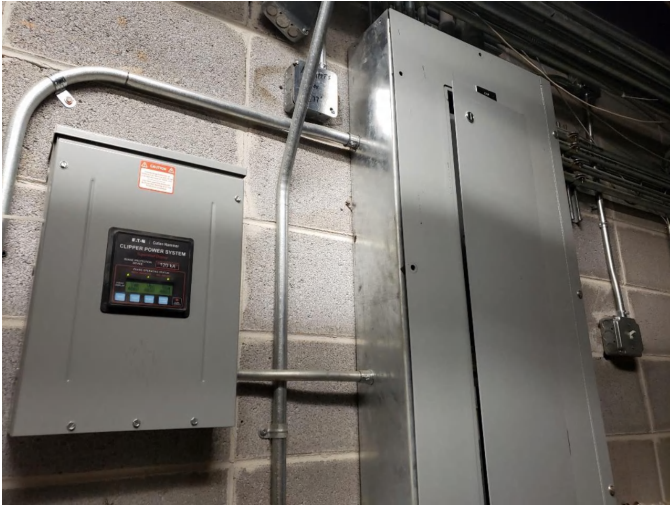
System: D5020 - Branch Wiring

Location: Throughout Building
Distress: Beyond Expected Life
Category: Deferred Maintenance
Priority: 3 - Necessary (Years 2-5)
Correction: Renew System
Qty: 44,588.00
Unit of Measure: S.F.
Estimate: \$244,253.00
Assessor Name: Homero Guerrero
Date Created: 01/30/2020

Notes: The branch wiring system is operating, but is aged, in poor condition, and should be replaced.

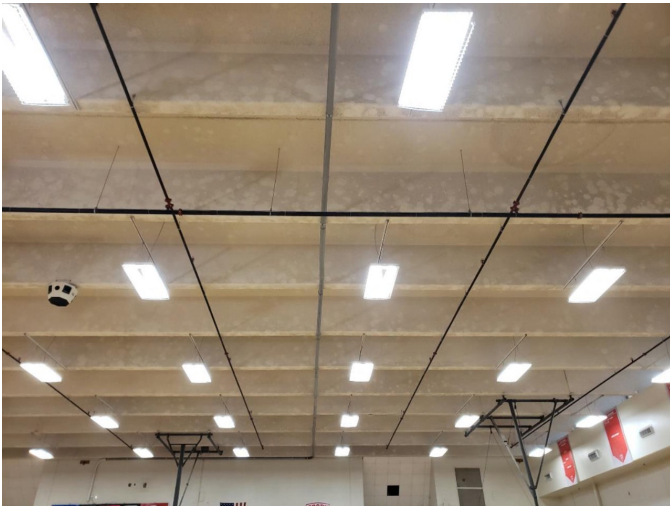
System: D5020 - Lighting

Location: Throughout Building
Distress: Beyond Expected Life
Category: Deferred Maintenance
Priority: 3 - Necessary (Years 2-5)
Correction: Renew System
Qty: 44,588.00
Unit of Measure: S.F.
Estimate: \$366,870.00
Assessor Name: Homero Guerrero
Date Created: 08/13/2014

Notes: The lighting system is operating, but is aged, in poor condition, and should be replaced.

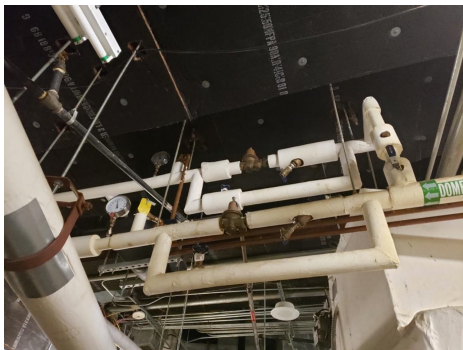
System: D2020 - Domestic Water Distribution

Note: Water distribution serves 2004 Addition restrooms.

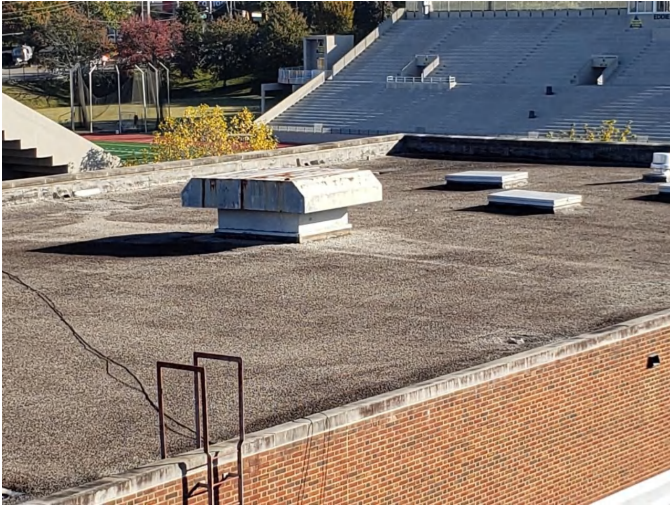
System: B3020 - Roof Openings

Location: Roof
Distress: Beyond Expected Life
Category: Deferred Maintenance
Priority: 3 - Necessary (Years 2-5)
Correction: Renew System
Qty: 25,891.00
Unit of Measure: S.F.
Estimate: \$15,094.00
Assessor Name: Homero Guerrero
Date Created: 09/17/2015

Notes: Roof openings are beyond expected service life and should be replaced.

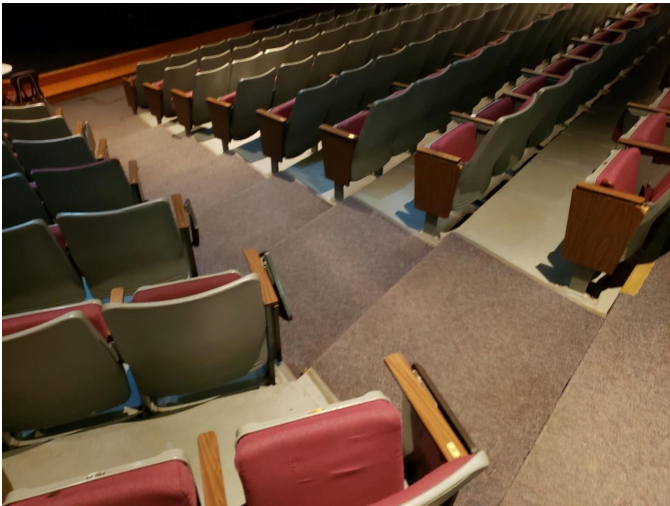
System: C3020405 - Epoxy

Location: Throughout Building
Distress: Beyond Expected Life
Category: Deferred Maintenance
Priority: 3 - Necessary (Years 2-5)
Correction: Renew System
Qty: 2,515.00
Unit of Measure: S.F.
Estimate: \$51,341.00
Assessor Name: Homero Guerrero
Date Created: 01/30/2020

Notes: The epoxy flooring is beyond its expected service life and should be scheduled for replacement.

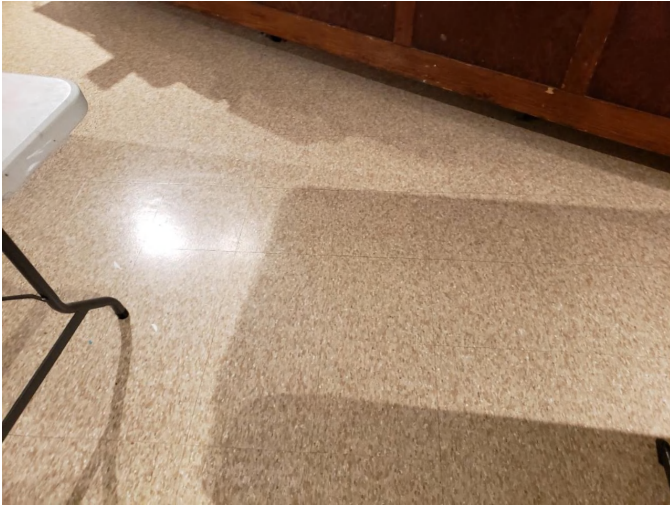
System: C3020903 - VCT

Location: Throughout Building
Distress: Beyond Expected Life
Category: Deferred Maintenance
Priority: 3 - Necessary (Years 2-5)
Correction: Renew System
Qty: 15,609.00
Unit of Measure: S.F.
Estimate: \$84,195.00
Assessor Name: Homero Guerrero
Date Created: 01/30/2020

Notes: The VCT flooring is beyond service list and should be replaced.

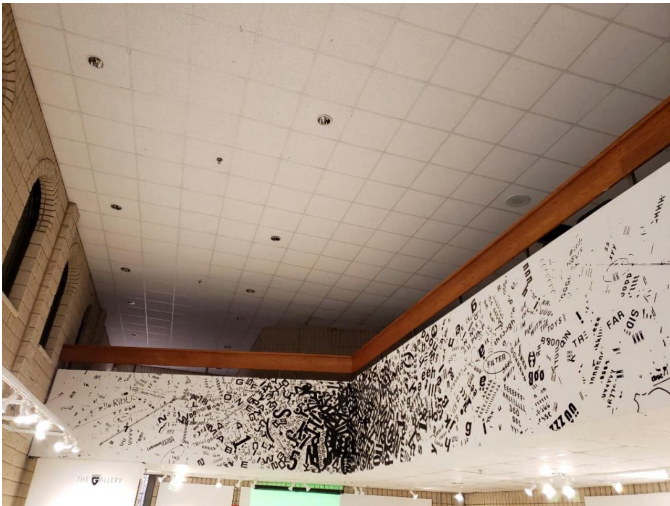
System: C3030 - Ceiling Finishes

Location: Throughout Building
Distress: Beyond Expected Life
Category: Deferred Maintenance
Priority: 3 - Necessary (Years 2-5)
Correction: Renew System
Qty: 25,891.00
Unit of Measure: S.F.
Estimate: \$263,726.00
Assessor Name: Homero Guerrero
Date Created: 02/17/2020

Notes: The original ceiling finishes are aged, failing and should be replaced.

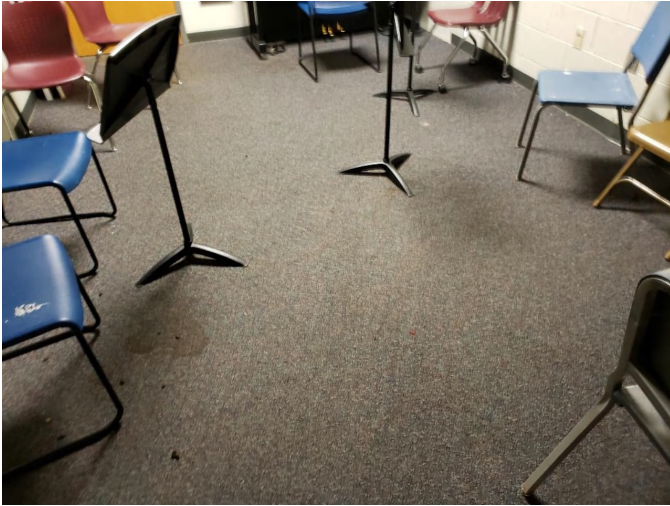
System: C3020901 - Carpet

Location: Throughout Building
Distress: Beyond Expected Life
Category: Deferred Maintenance
Priority: 3 - Necessary (Years 2-5)
Correction: Renew System
Qty: 5,606.00
Unit of Measure: S.F.
Estimate: \$46,250.00
Assessor Name: Homero Guerrero
Date Created: 01/30/2020

Notes: The carpet is stained, showing signs of early failure and should be replaced.

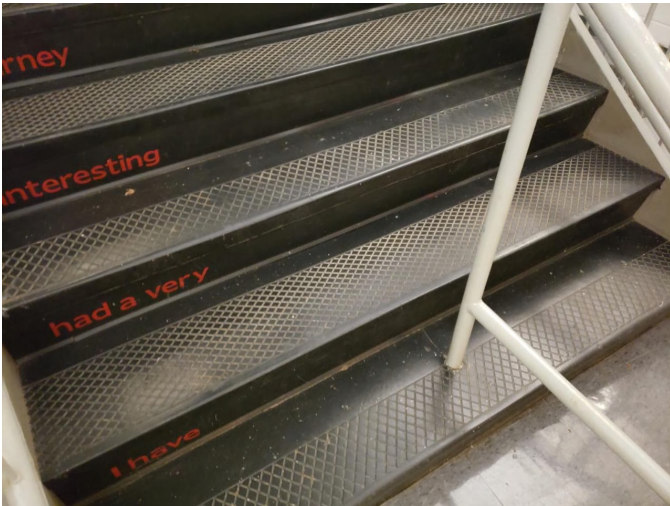
System: C3020999 - Other - Rubber or Neoprene

Location: Throughout Building
Distress: Beyond Expected Life
Category: Deferred Maintenance
Priority: 3 - Necessary (Years 2-5)
Correction: Renew System
Qty: 300.00
Unit of Measure: S.F.
Estimate: \$8,801.00
Assessor Name: Homero Guerrero
Date Created: 02/16/2020

Notes: The rubber flooring system is beyond its expected service life and should be scheduled for replacement.

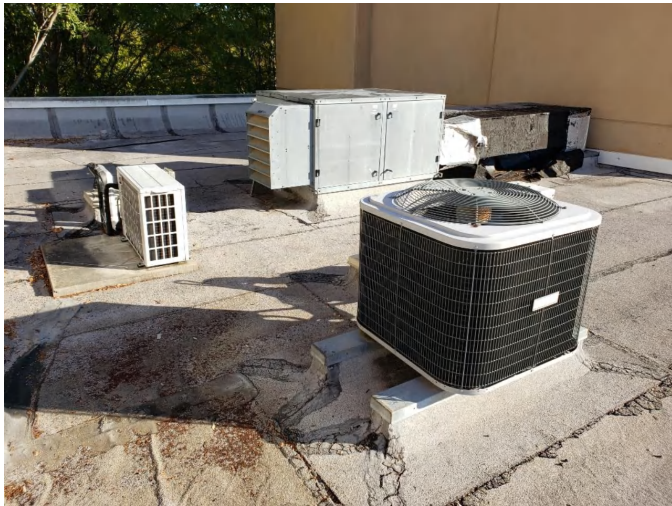
System: D3050 - Terminal & Package Units

Location: Throughout Building
Distress: Beyond Expected Life
Category: Deferred Maintenance
Priority: 3 - Necessary (Years 2-5)
Correction: Renew System
Qty: 87,633.00
Unit of Measure: S.F.
Estimate: \$156,162.00
Assessor Name: Homero Guerrero
Date Created: 10/01/2019

Notes: The terminal and package units are aged, rusted, not energy efficient, and should be replaced.

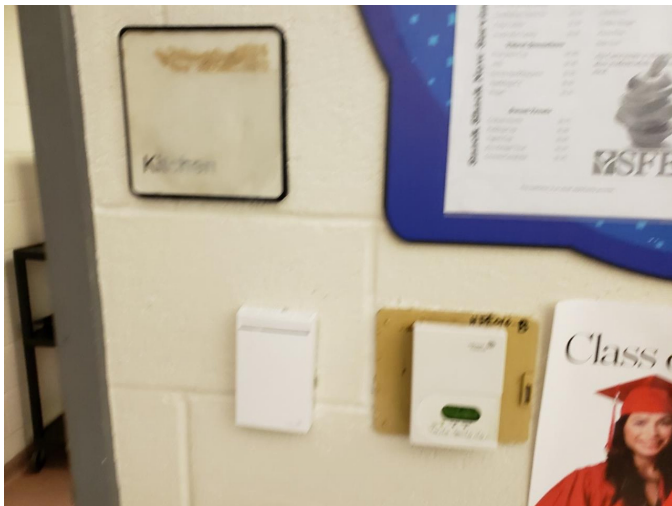
System: D3060 - Controls & Instrumentation

Location: Throughout Building
Distress: Beyond Expected Life
Category: Deferred Maintenance
Priority: 3 - Necessary (Years 2-5)
Correction: Renew System
Qty: 87,633.00
Unit of Measure: S.F.
Estimate: \$211,108.00
Assessor Name: Homero Guerrero
Date Created: 10/01/2019

Notes: The system is beyond its expected service life and should be scheduled for replacement.

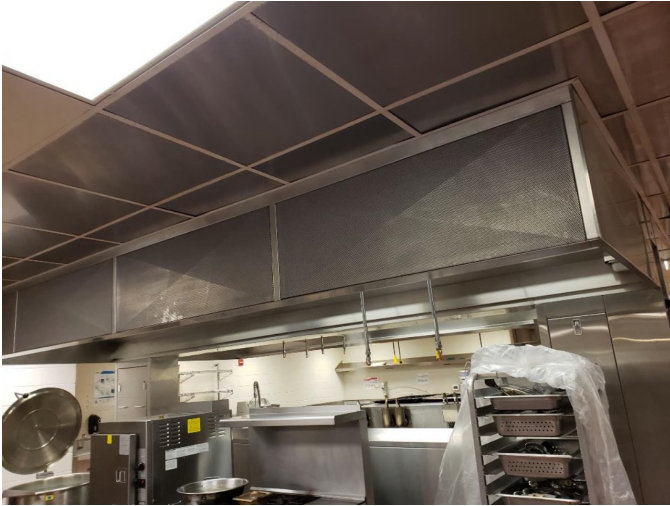
System: D4090 - Other Fire Protection Systems

Location: Kitchen
Distress: Beyond Expected Life
Category: Deferred Maintenance
Priority: 3 - Necessary (Years 2-5)
Correction: Renew System
Qty: 87,633.00
Unit of Measure: S.F.
Estimate: \$58,802.00
Assessor Name: Homero Guerrero
Date Created: 10/01/2019

Notes: The system is beyond its expected service life and should be scheduled for replacement.

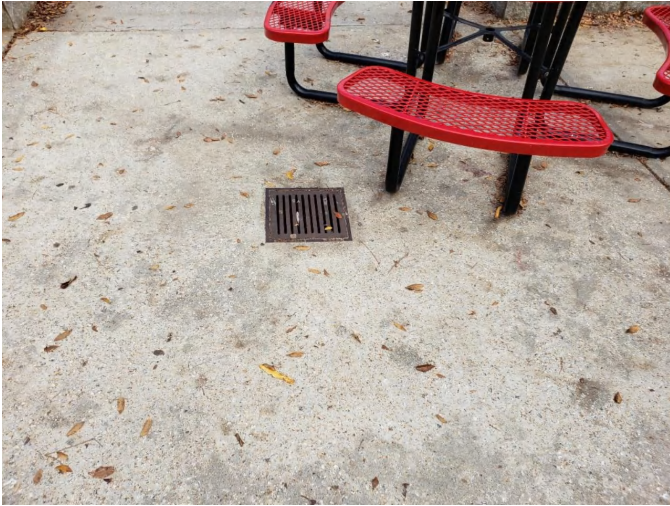
System: G3030 - Storm Sewer

Location: Site
Distress: Beyond Expected Life
Category: Deferred Maintenance
Priority: 3 - Necessary (Years 2-5)
Correction: Renew System
Qty: 257,230.00
Unit of Measure: S.F.
Estimate: \$353,691.00
Assessor Name: Eduardo Lopez
Date Created: 02/17/2020

Notes: Excessive surface water drainage causes erosion over sidewalks creating a safety hazard.

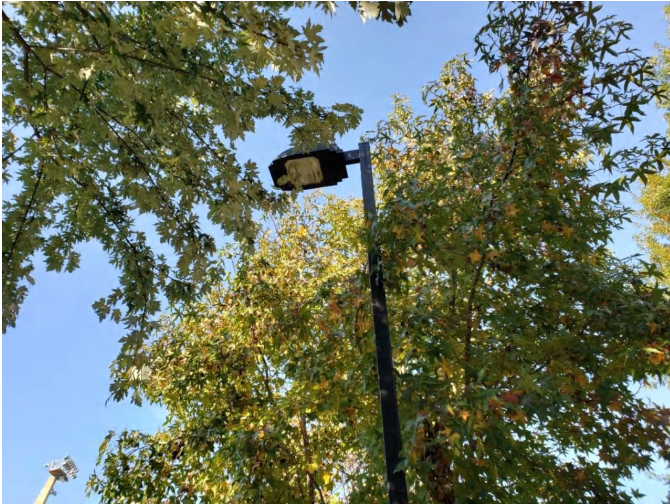
System: G4020 - Site Lighting

Location: Site
Distress: Beyond Expected Life
Category: Deferred Maintenance
Priority: 3 - Necessary (Years 2-5)
Correction: Renew System
Qty: 257,230.00
Unit of Measure: S.F.
Estimate: \$843,200.00
Assessor Name: Eduardo Lopez
Date Created: 08/15/2013

Notes: Site lighting is inadequate, beyond its service life and should be replaced.
